Stream Corridor Assessment Survey for the Deer Creek Watershed, Harford County, Maryland

Department of the Environment
1800 Washington Boulevard, Suite 540
Baltimore MD 21230-1718

April 2006

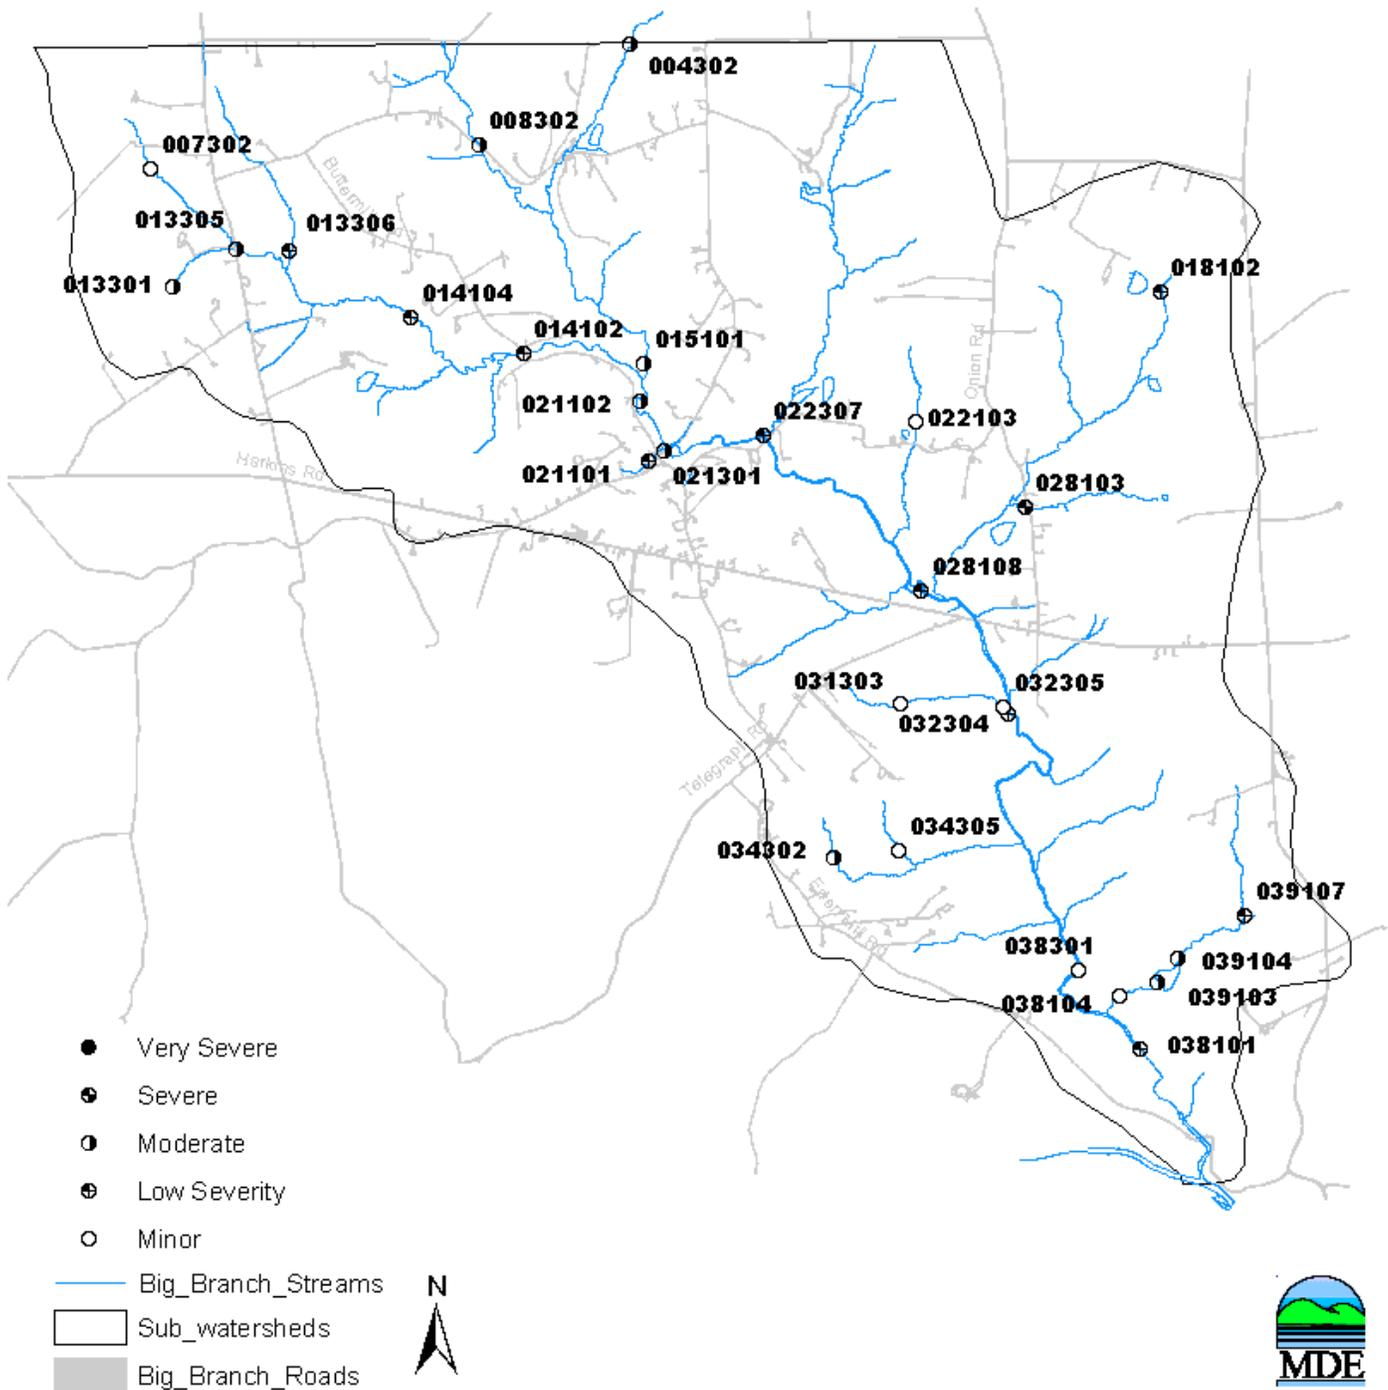
Figure 5b: Map showing the locations of Erosion Sites in Big Branch

The SCA survey found 77 eroding stream banks over the length of 77,228 feet (14.63 miles) of stream. The severity and location of erosion sites is shown in Figure 5b, and 5c. Two sites are ranked as very severe (Figure 5a). These severe sites were Site 028103 and Site 073101.

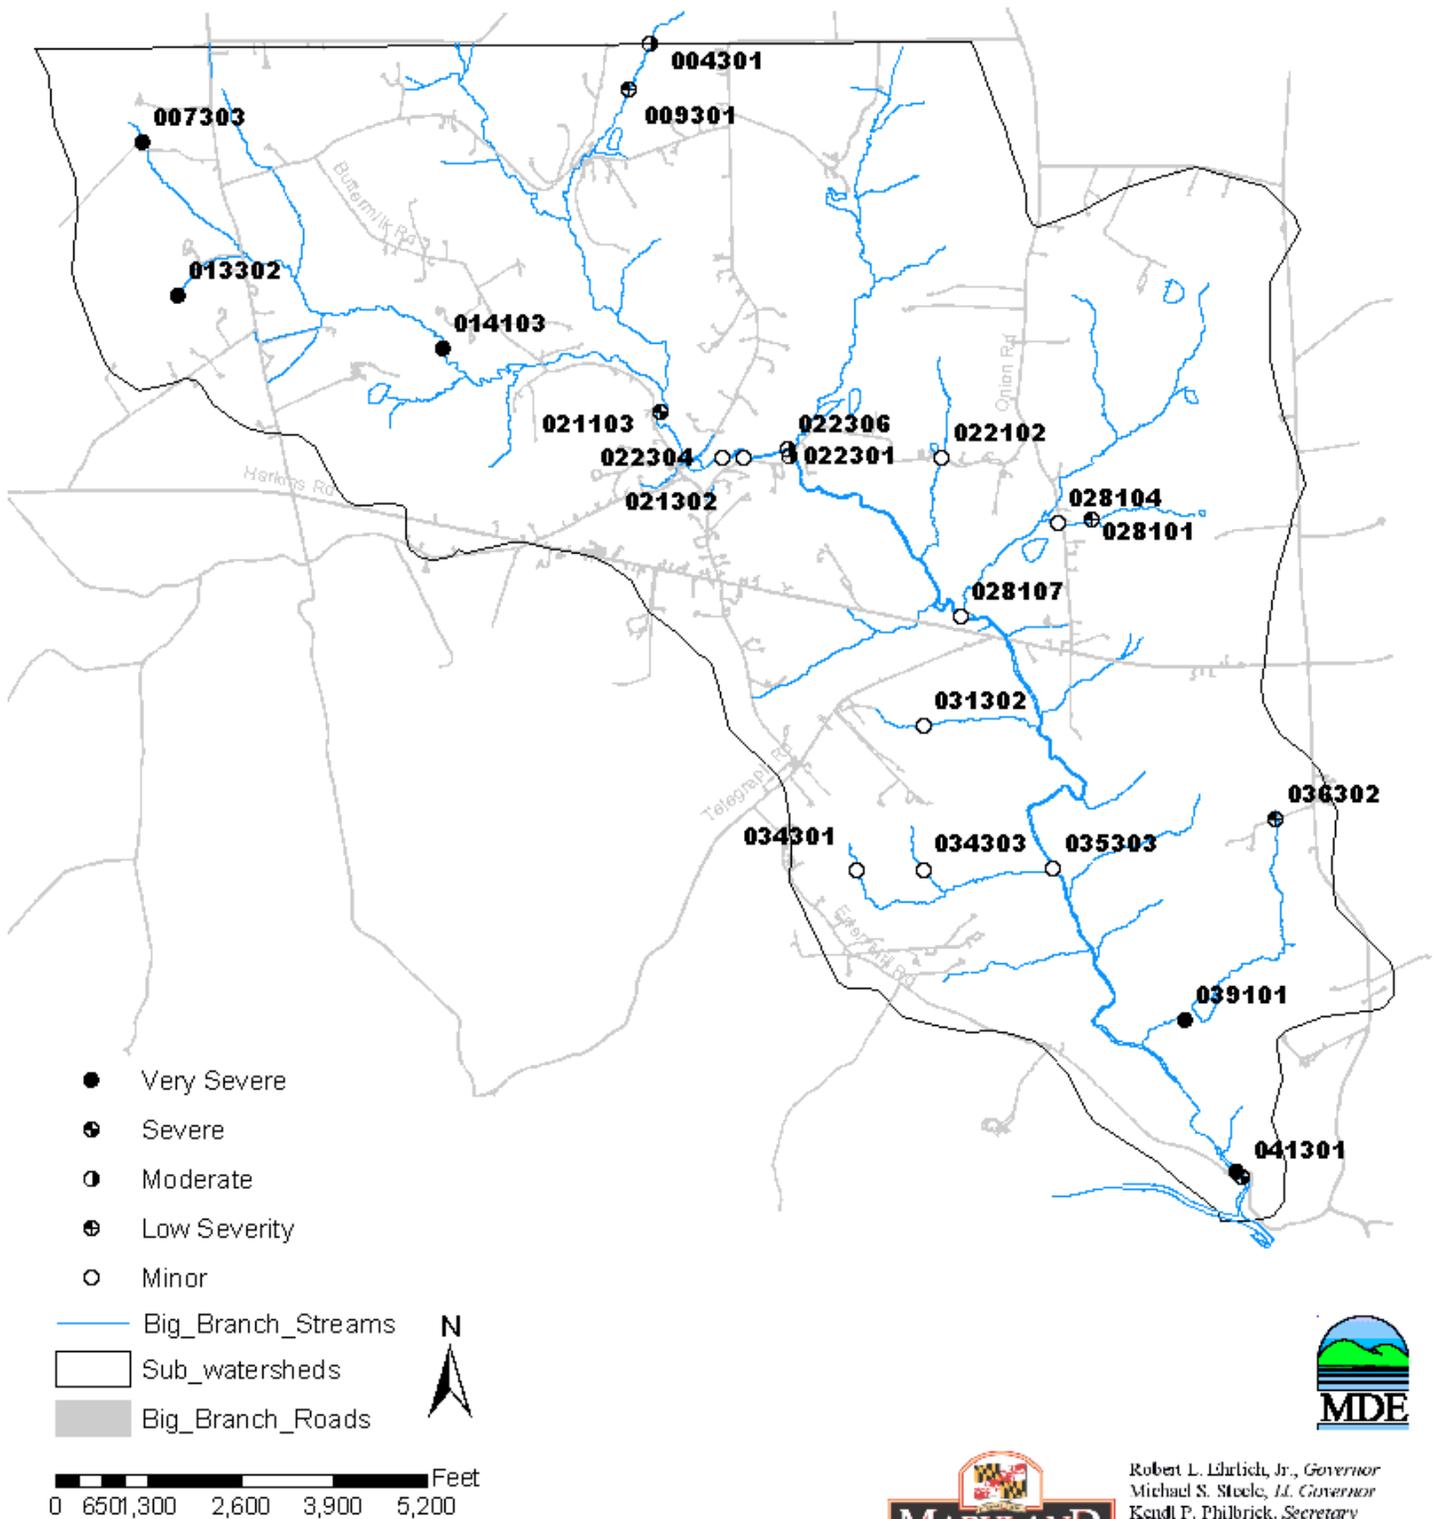
Figure 6b: Map showing the locations of Inadequate Buffers in Big Branch

Survey crews identified 65 inadequate buffer sites with a total length of 72,125 feet (13.66 miles). The severity and location of inadequate buffer sites is shown in Figure 6b, and 6c. Eighteen of these sites are ranked as very severe or severe, while the other sites are moderate, of low severity, or minor (Figure 6a). Land use along the stream at inadequate buffer sites, were reported as mostly shrubs and small trees, lawn and pasture.

Any inadequate buffer site would benefit from the restoration of trees along both stream banks. For sites on agricultural land, farmers also may qualify for federal and state government financial incentives for allowing 50-foot forest buffers to grow on their farmland. Those sites that may have particular natural resource value are headwater streams, or those that form gaps in existing forested buffer areas.

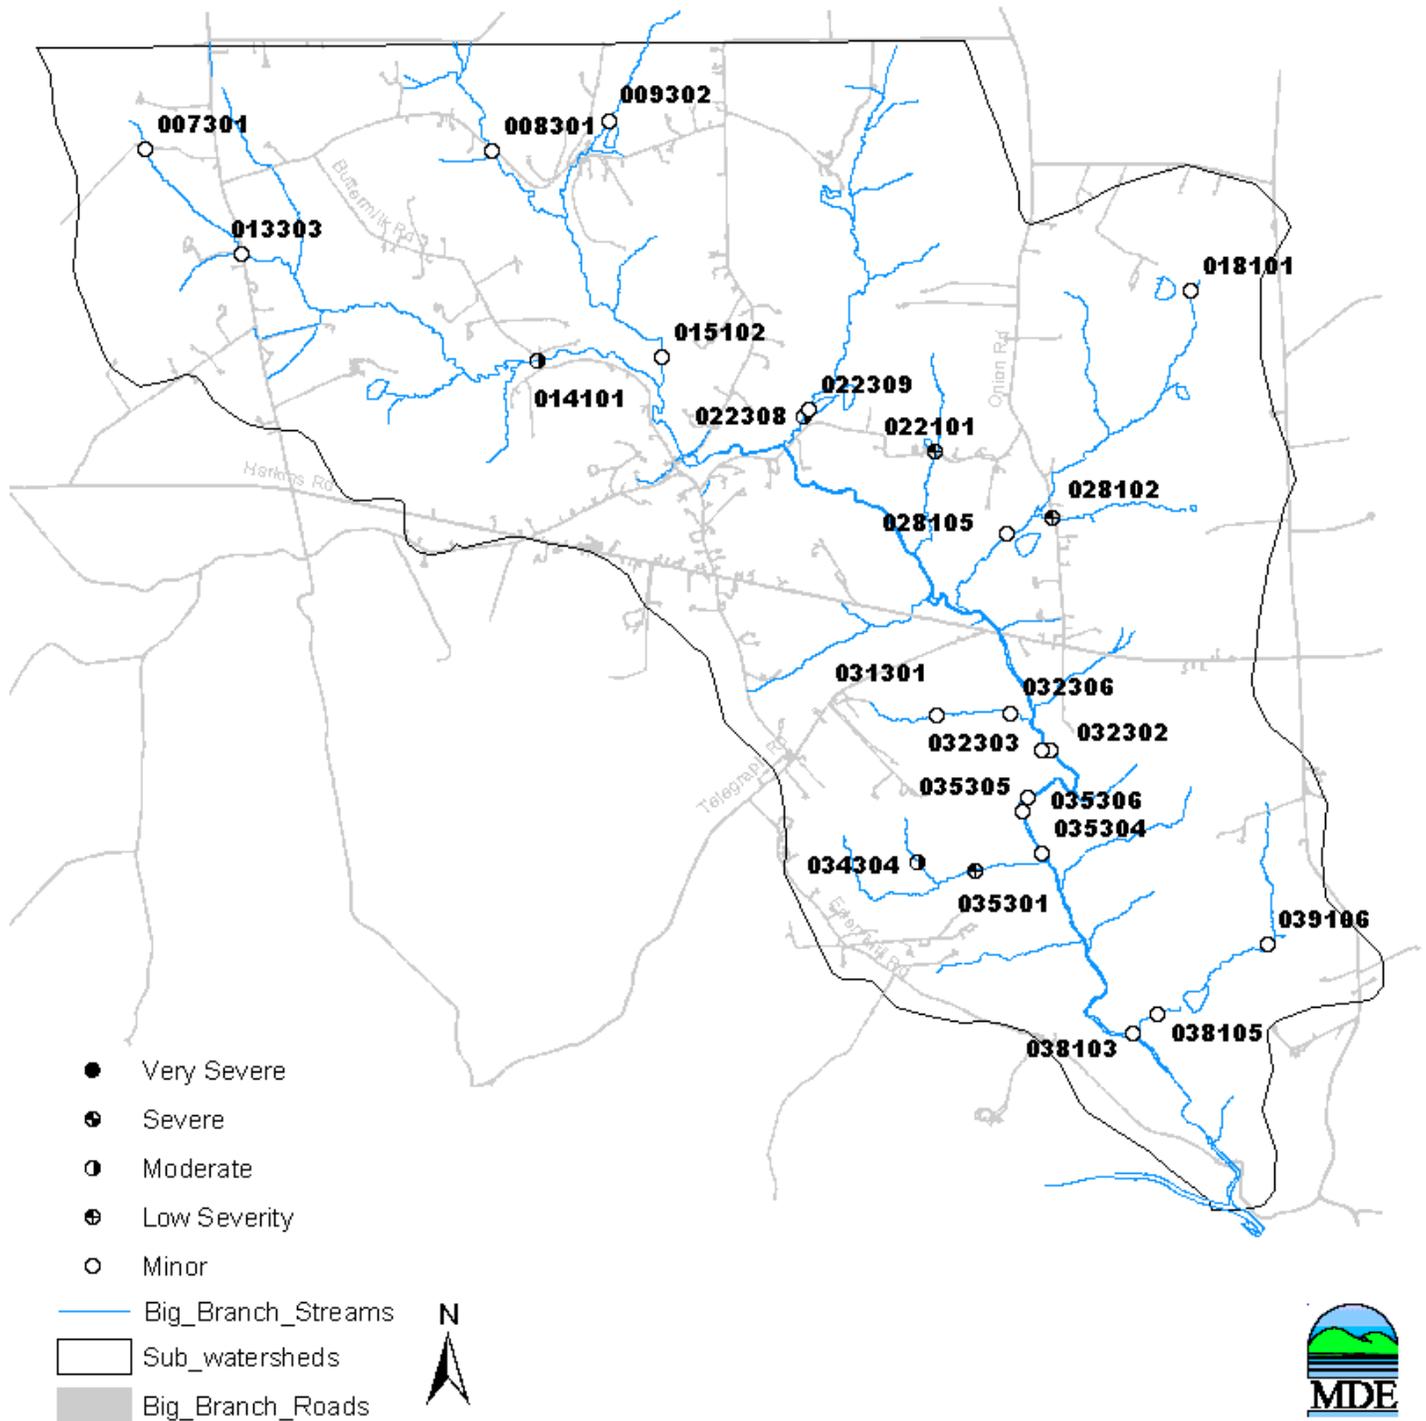
Figure 7b: Map showing the locations of Fish Barriers in Big Branch

The Deer Creek SCA survey found 50 fish migration barriers. The locations of fish blockages are shown in Figure 7b and 7c. Fish barriers in this watershed are due natural falls (17), road crossings (15), beaver dams (2), and debris dams (12), instream ponds (2) and other causes (2). Five of these sites received a moderate rating. In Big Branch the barriers will be to resident fish, because of the dam at Eden Mill.

In restoration work, priority is given to removing fish barriers that will yield access to the greatest quality and quantity of upstream habitat per dollar spent. The mainstem is ideally kept as barrier-free as possible, allowing anadromous fish to migrate to spawn and a source of fish species for tributaries in the event of a disturbance. Restoration planning includes targeting barriers for removal that isolate entire tributaries, those that isolate significant portions of the upper tributary, and those that isolate quality fish habitat. The best restoration sites also are far from other existing fish barriers.

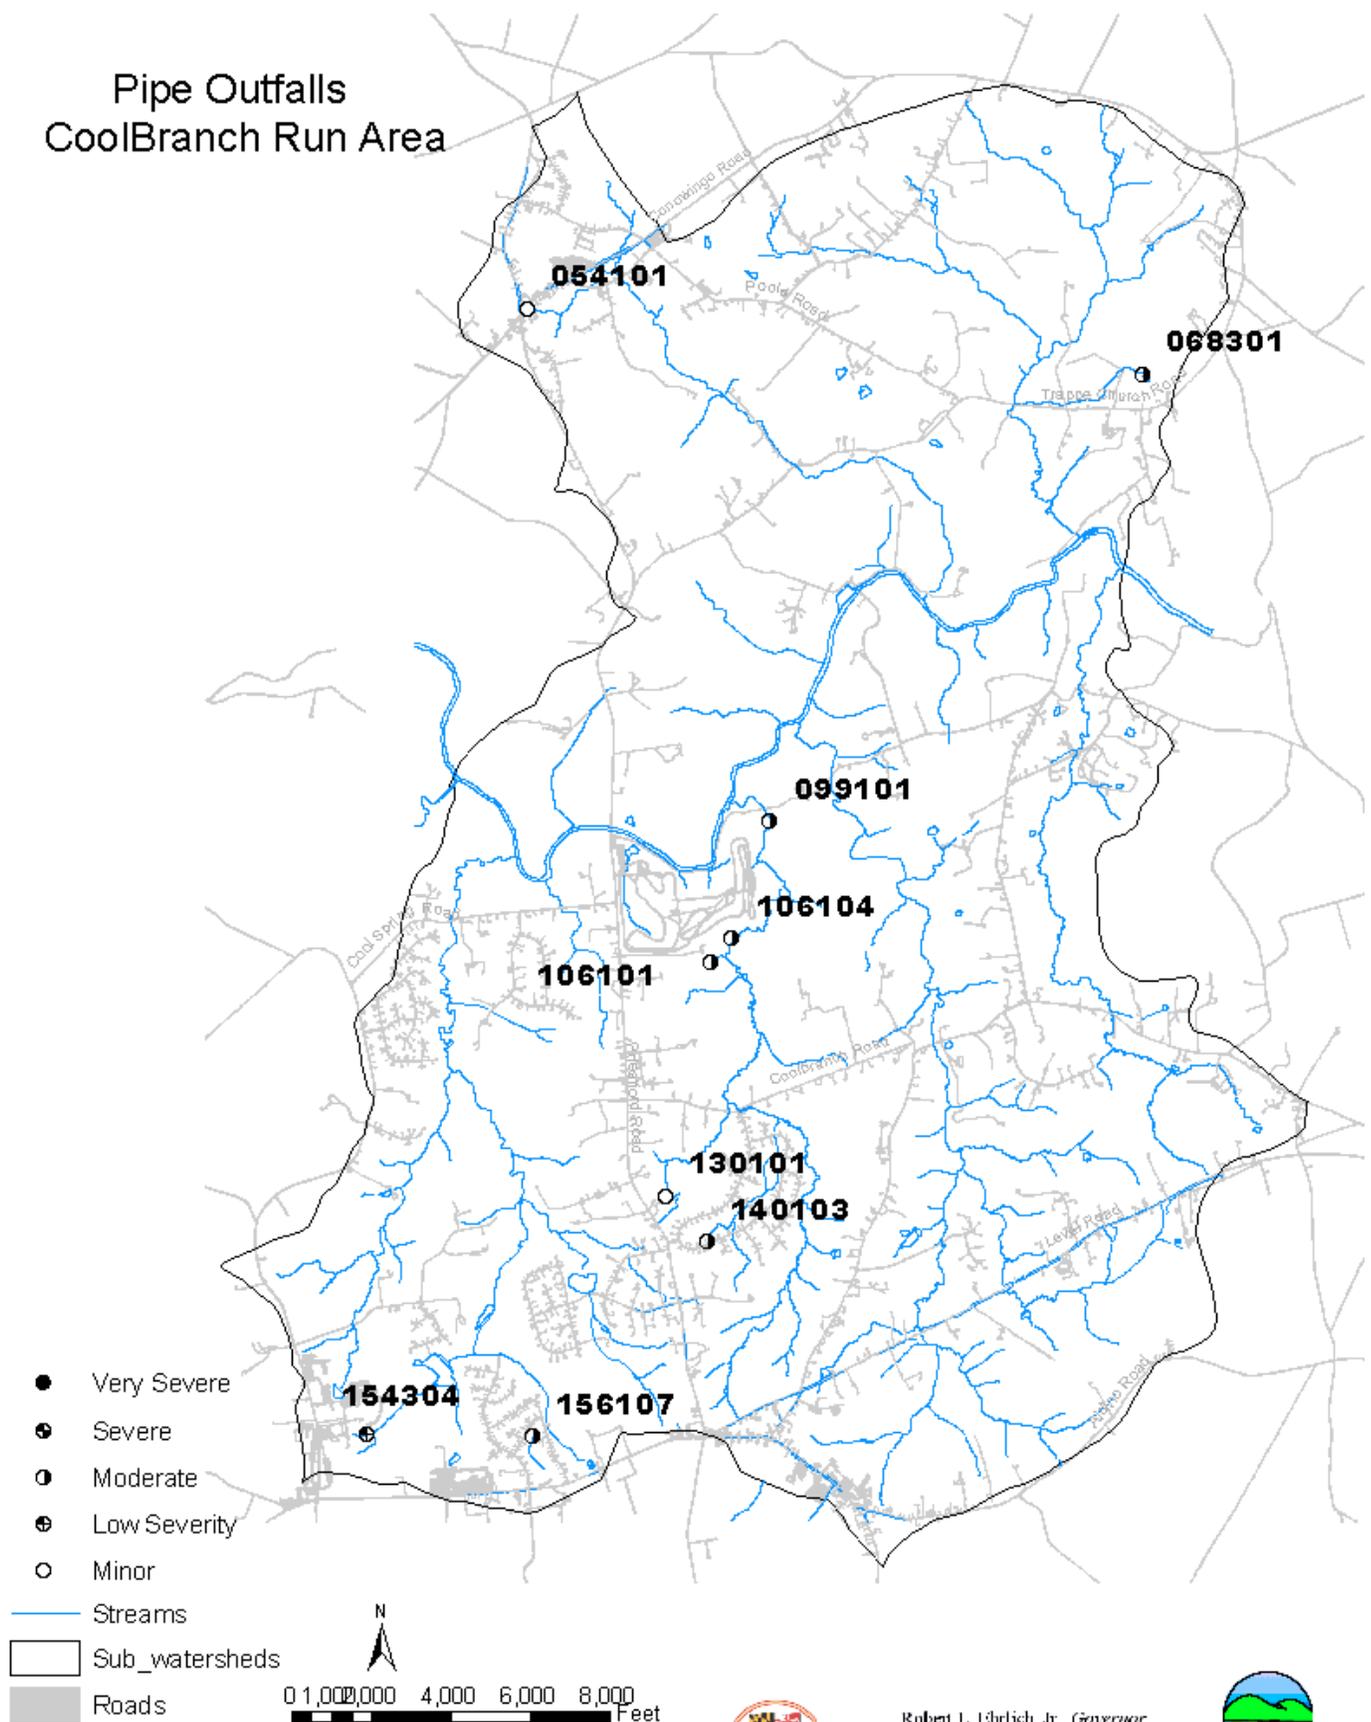
Figure 8b: Map showing the locations of Pipe Outfalls in Coolbranch Area

Six of the pipes had a discharge. All were clear with no odor. The pipes were rated as moderate. The remaining pipes did not have any discharge.

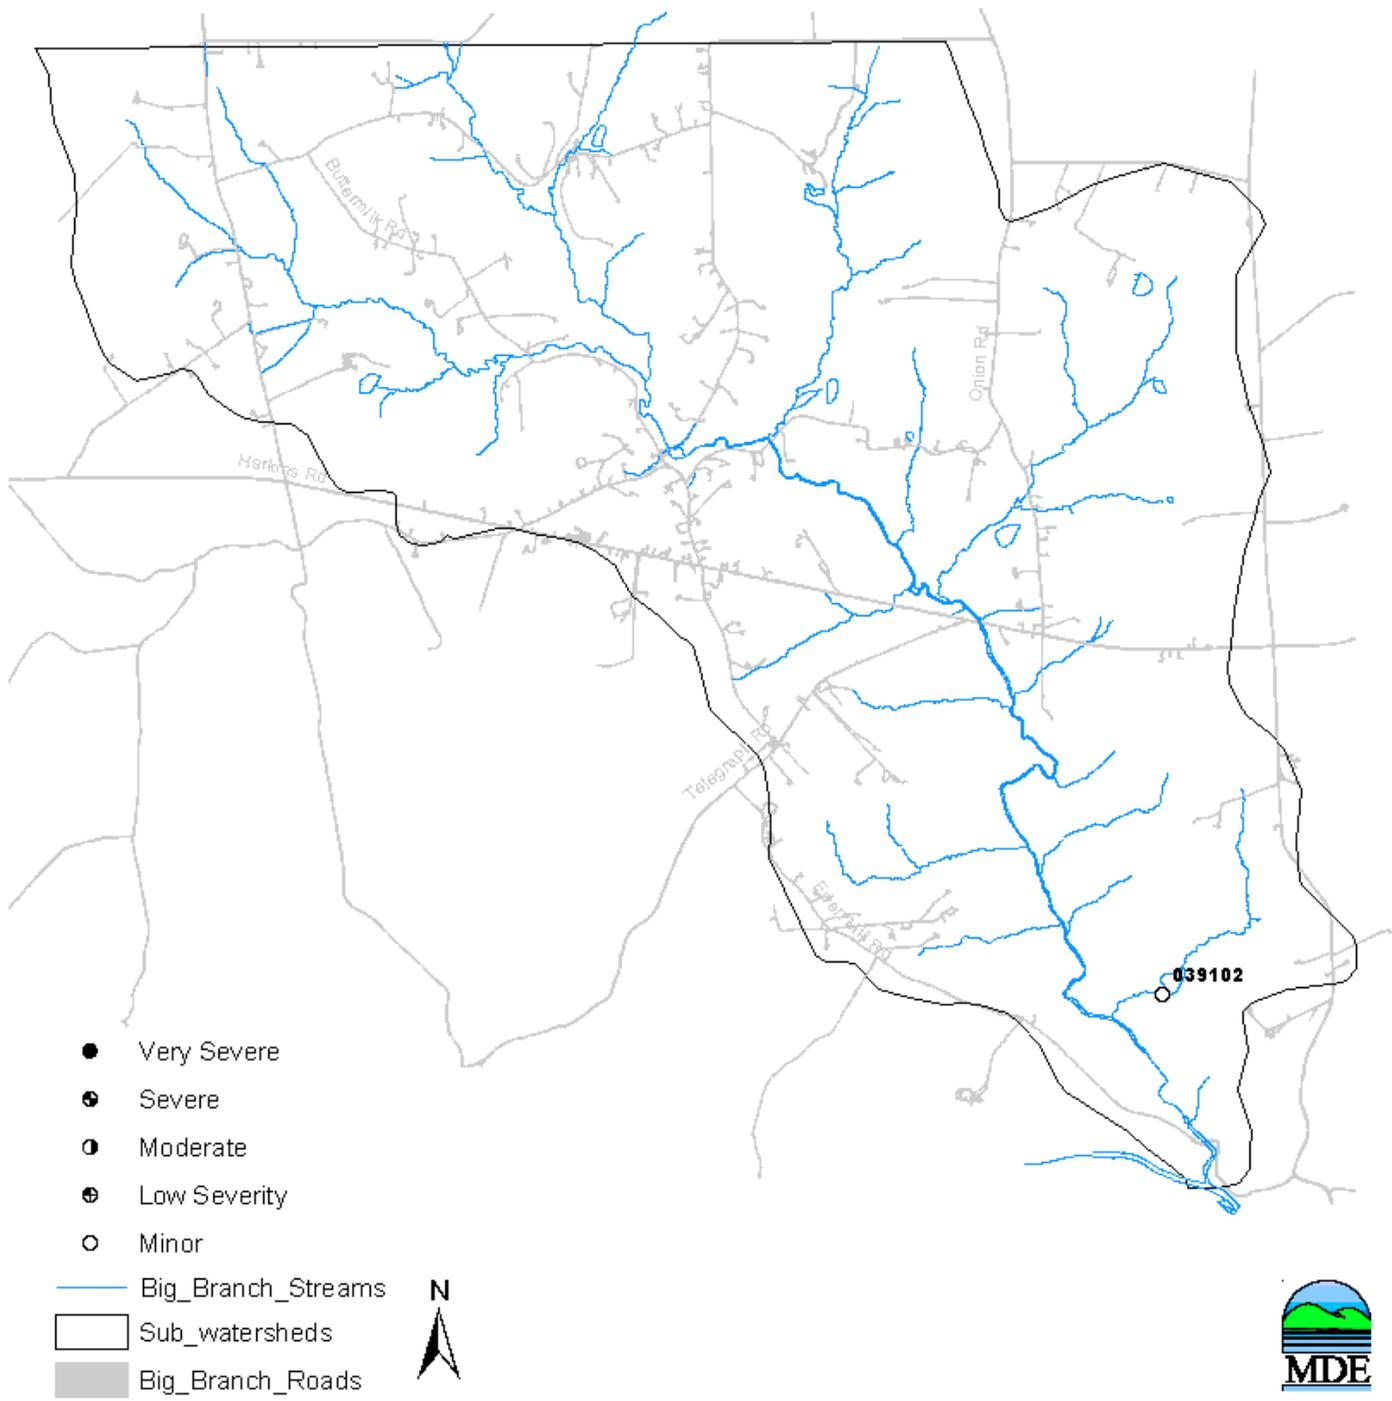
Figure 10a: Map showing the locations of Trash Dumping Sites in Big Branch

Survey crews found four trash dumping sites (Figure 10a, and 10b). Site 039102 was a dumping site for residential trash. It was given a minor severity rating. Site 063205 was residential trash. It was rated moderate in severity and had 5 truckloads of trash. Site 111104 was a dumping site for residential trash. It was given a low severity rating. Site 139101 had 1 truckload of metal barrels, and was given a minor severity rating.

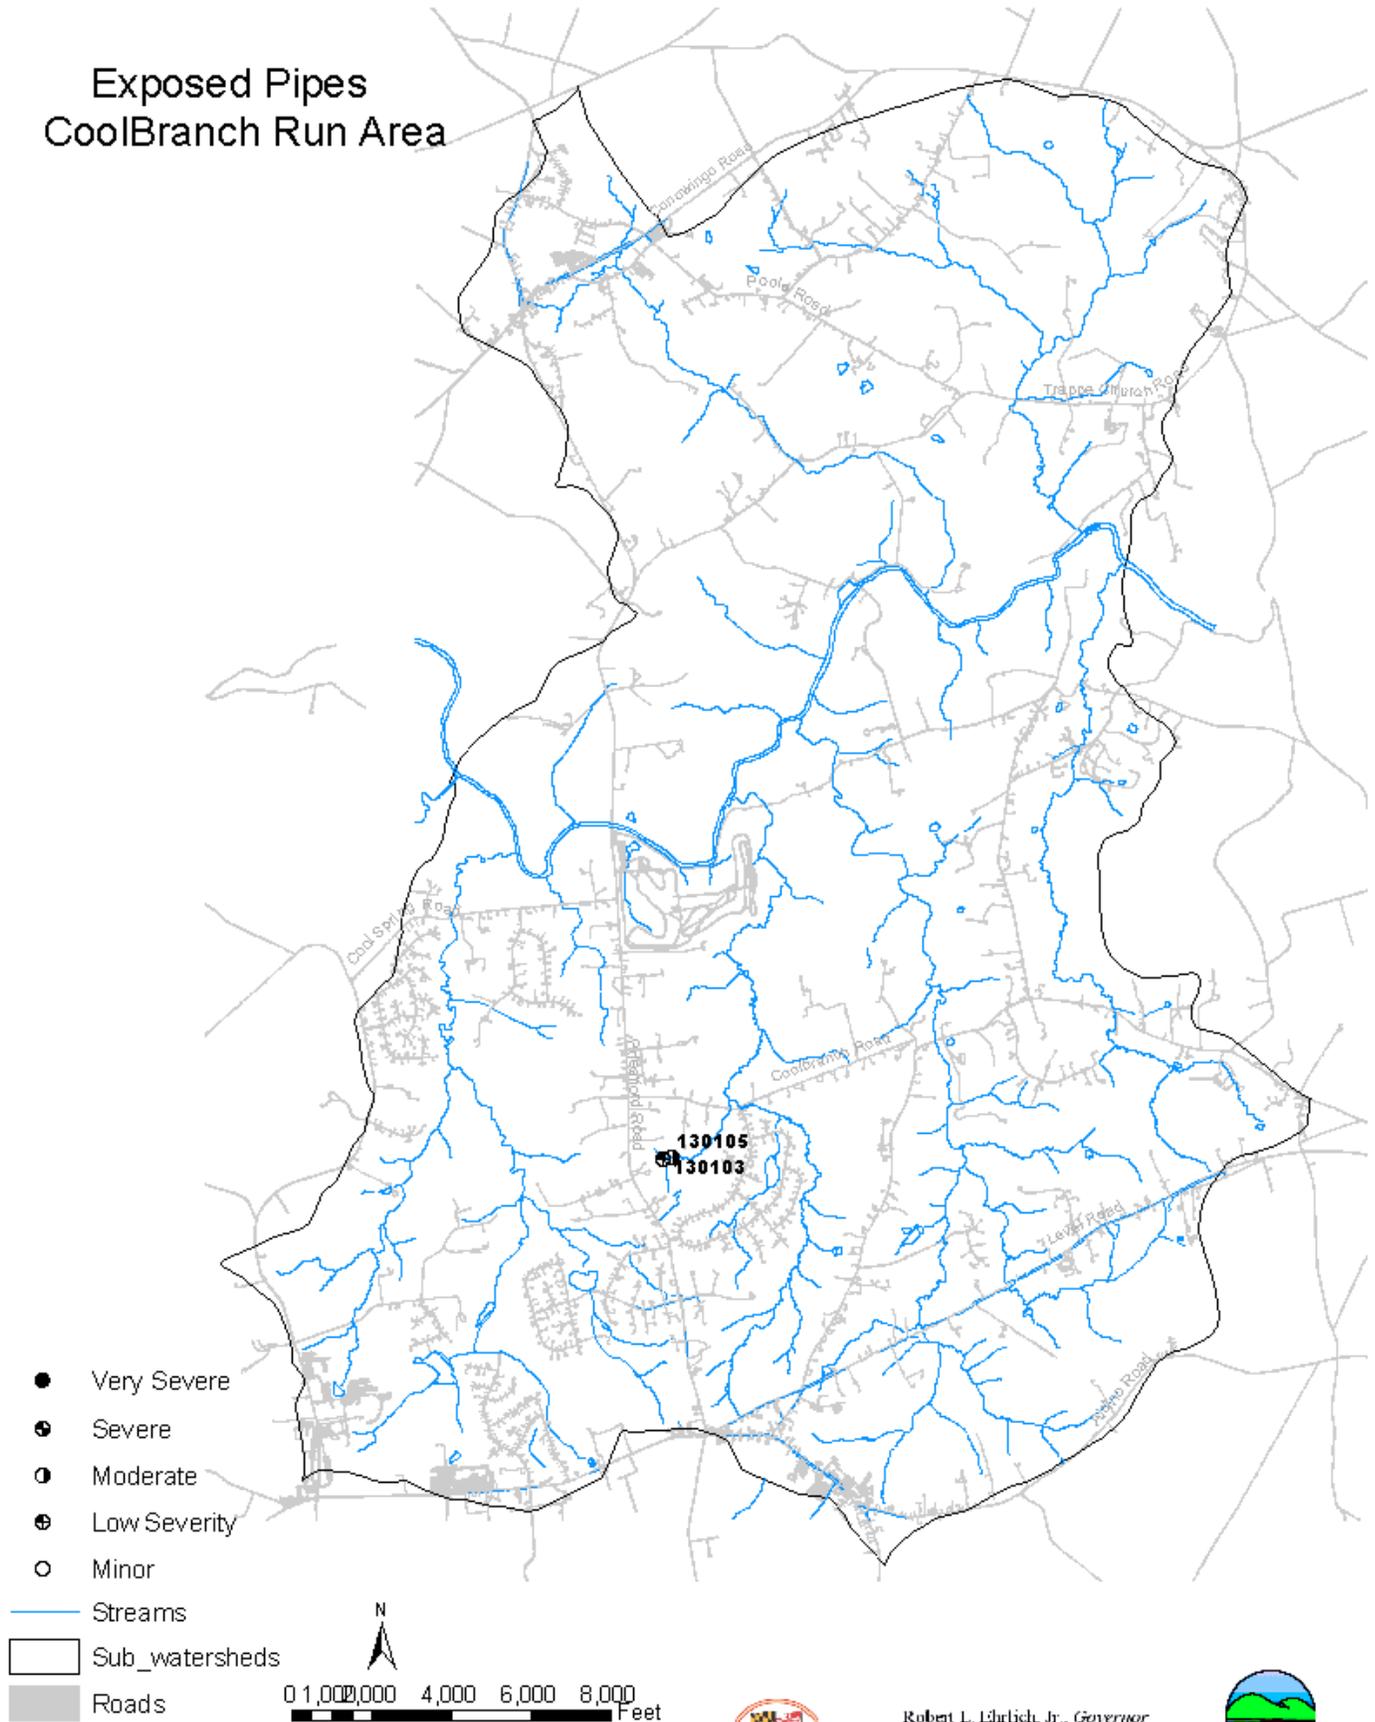
Figure 11: Map showing the locations of Exposed Pipes in Coolbranch Area

Field crews observed 2 exposed pipes during the survey. One pipe was rated moderate in severity and the other was rated low severity. Locations of these sites are shown in Figure 11.

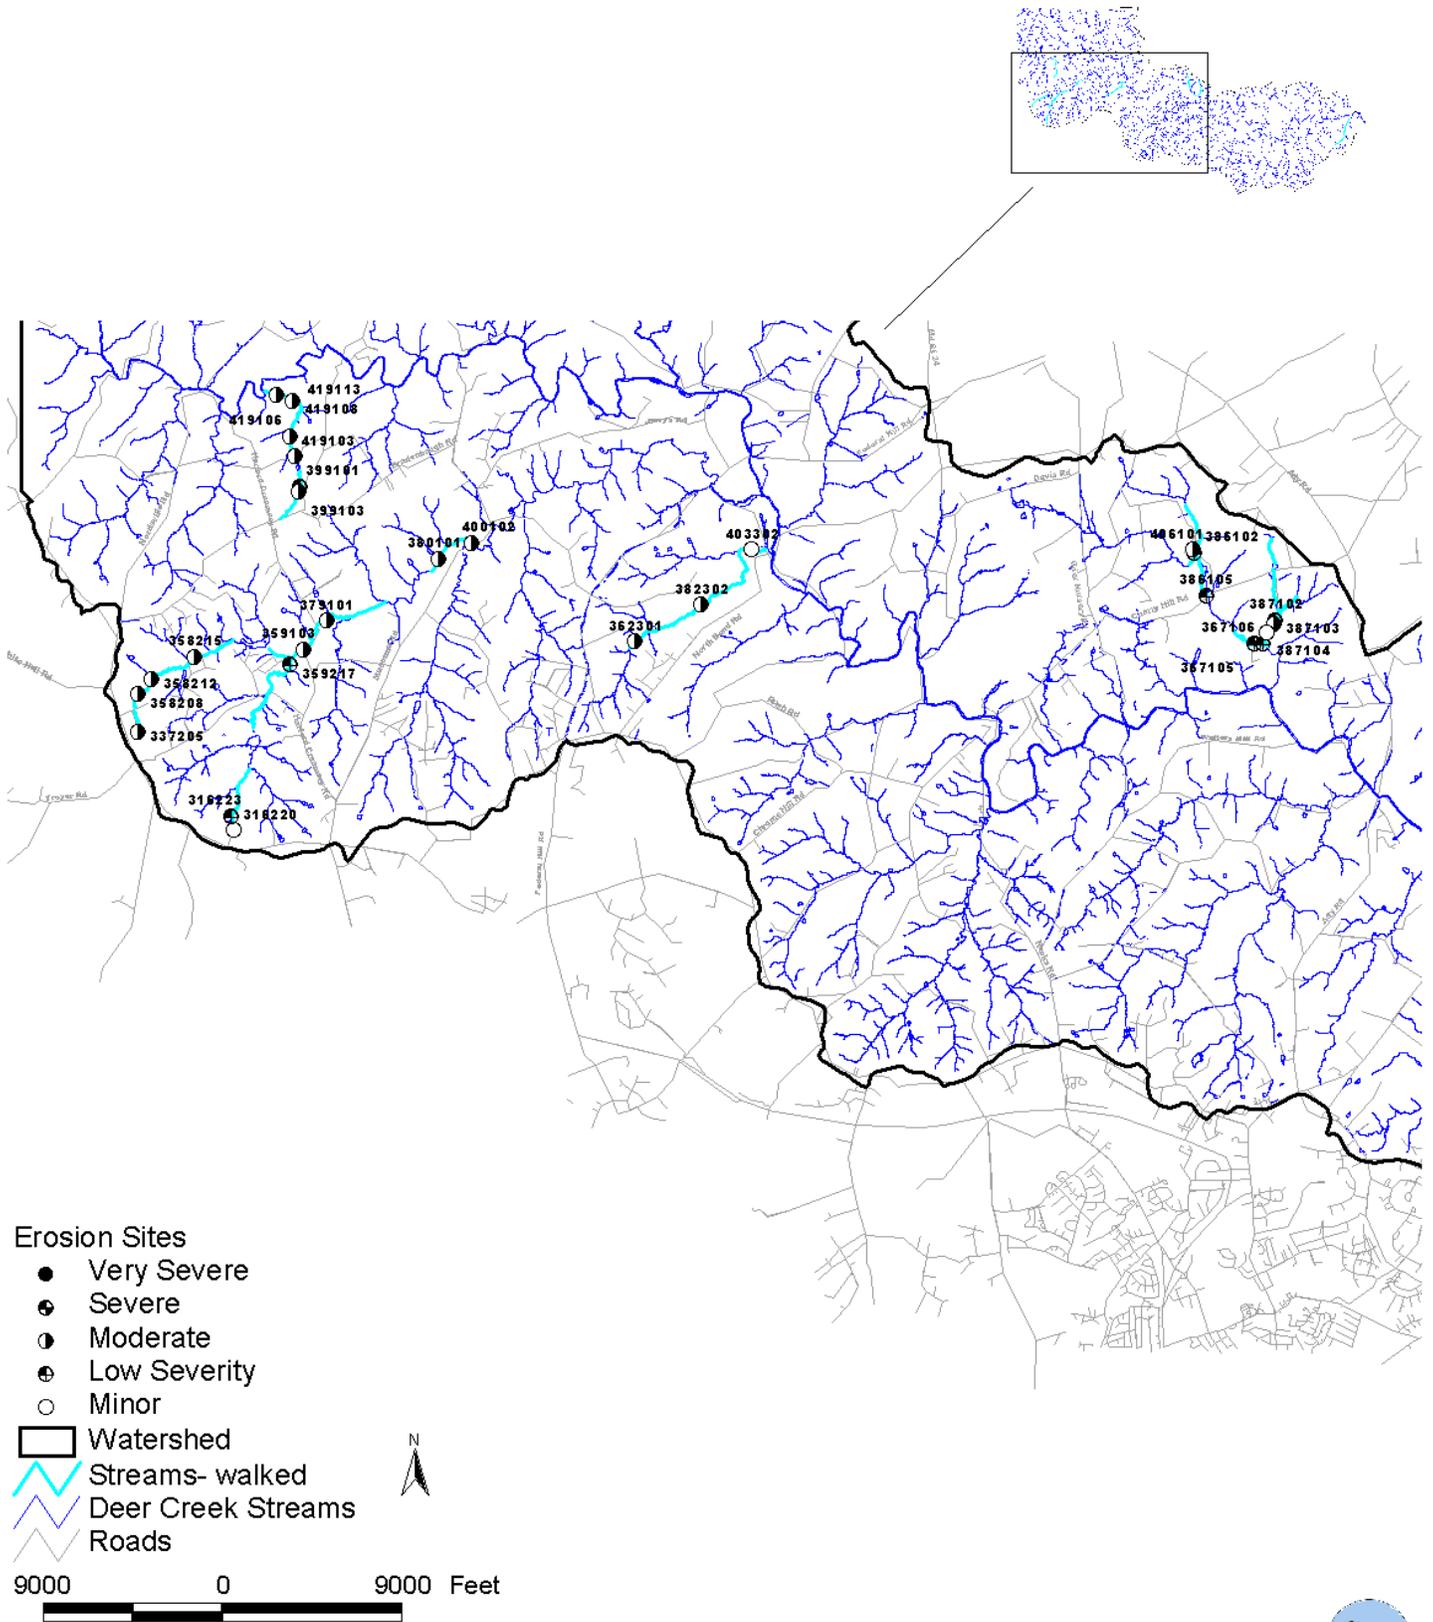
Figure 14b: Map showing the locations of the Erosion Sites in the second round of fieldwork in the Deer Creek Watershed

The survey found 32 eroding stream banks over the length of 23,740 feet (4.5 miles) of stream. The severity and location of erosion sites is shown in Figure 14b, and 14c.

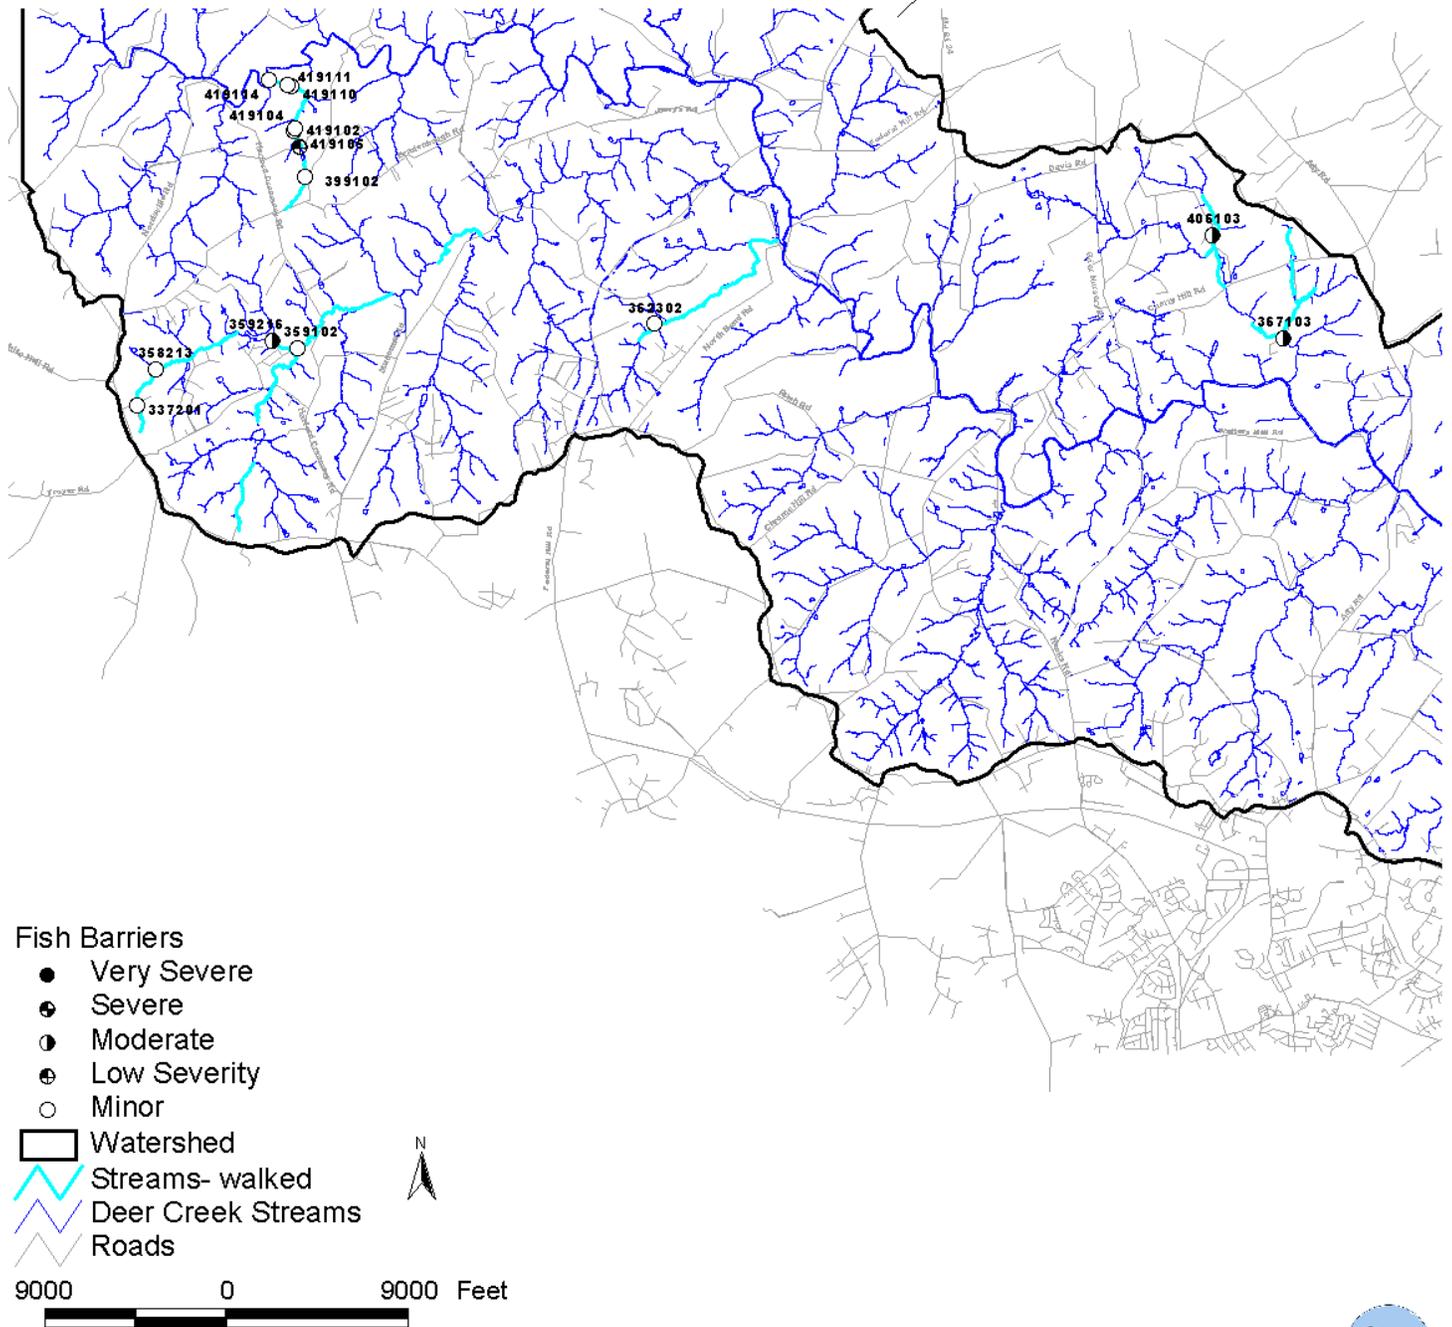
Figure 16b: Map showing the locations of the Fish Barriers in the second round of fieldwork in the Deer Creek Watershed

The survey identified 17 fish migration barriers. The locations of fish blockages are shown in Figure 16b and 16c. Fish barriers in this watershed are due natural falls (4), road crossings (3), debris dams (8), and instream ponds (1). Three of these sites received a moderate rating.

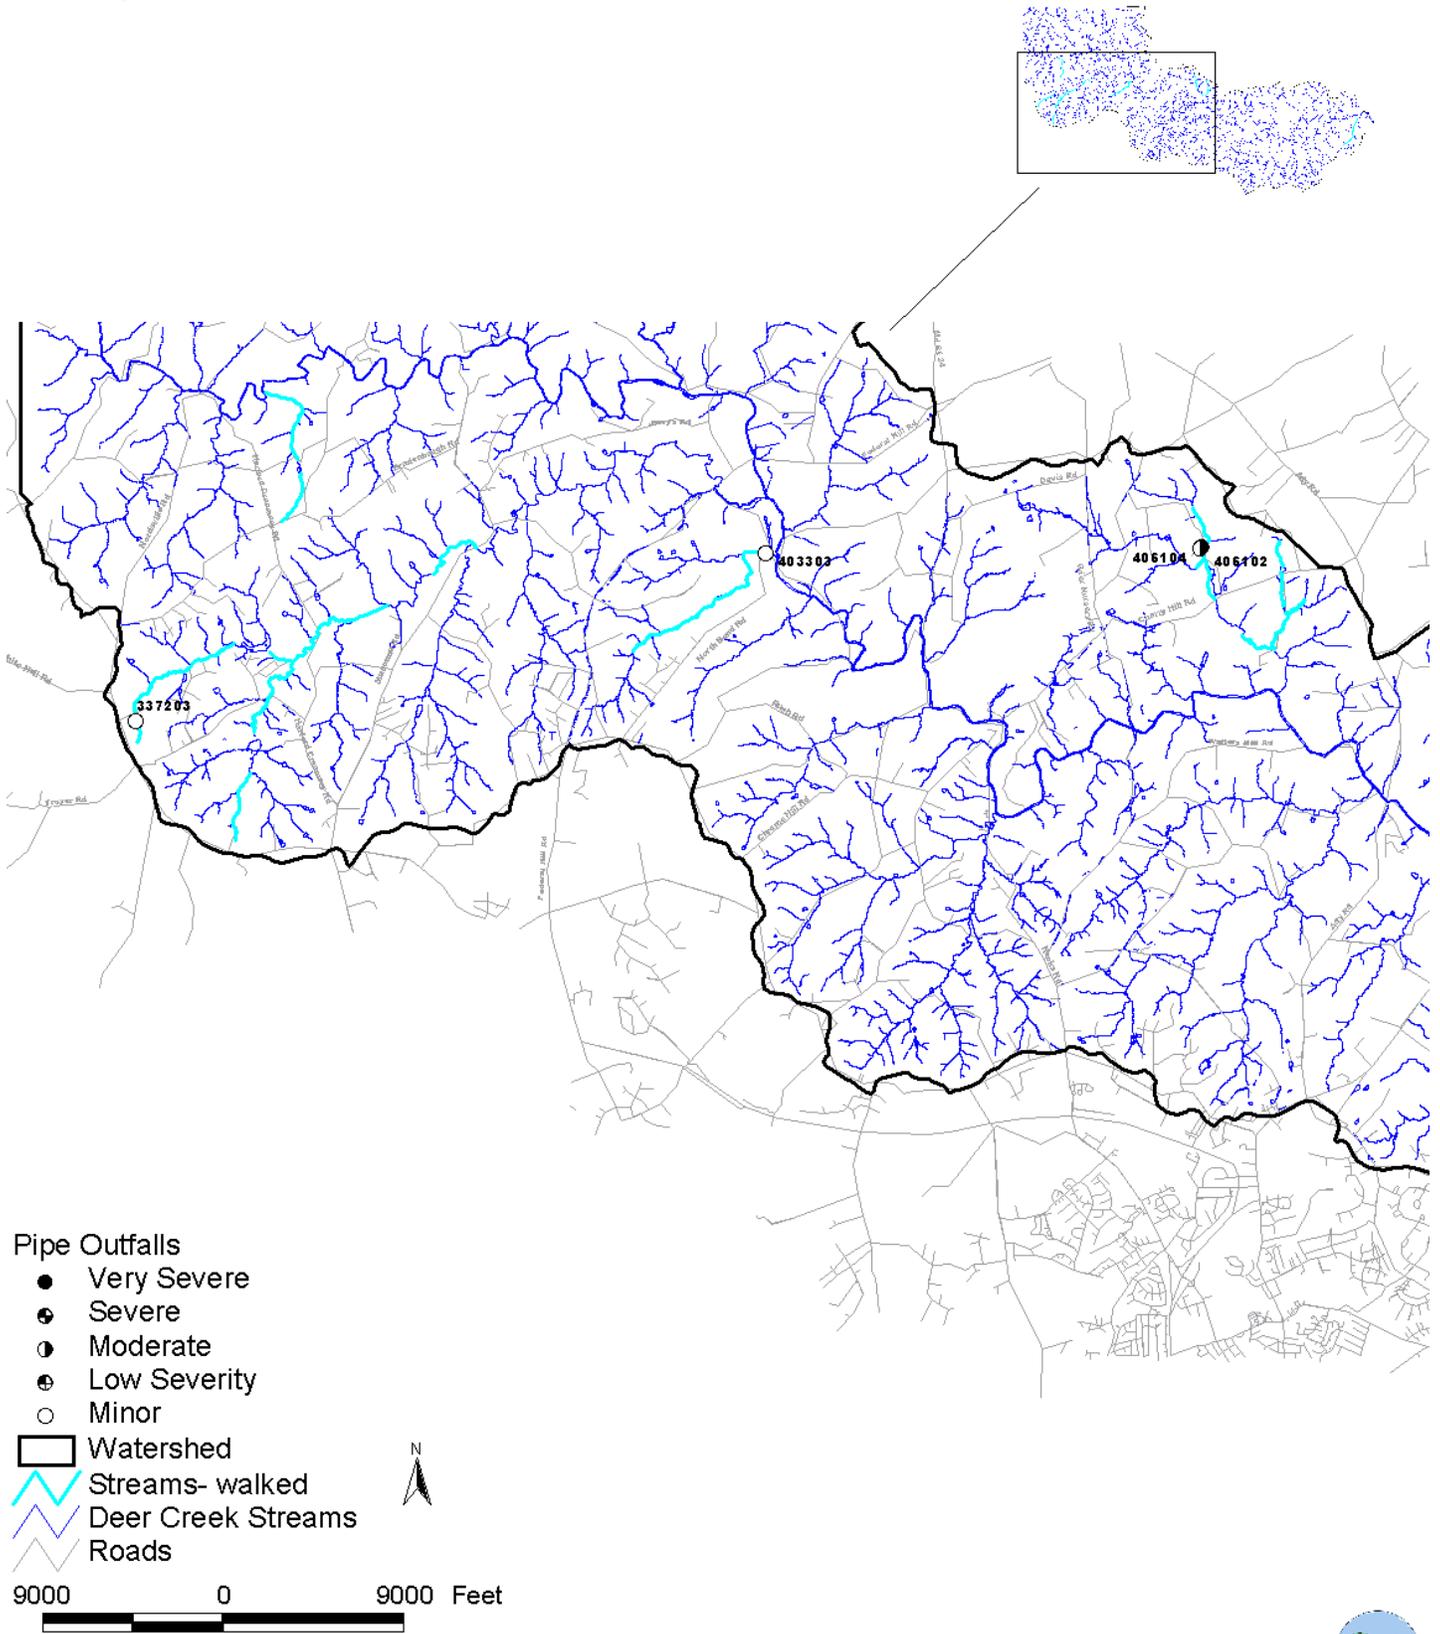
Figure 17b: Map showing the locations of the Pipe Outfalls in the second round of fieldwork in the Deer Creek Watershed

The survey crew identified a total of 7 pipe outfalls. The severity and location of pipe outfall sites is shown in Figure 17b and 17c. Two of the pipes had a discharge. Both were clear with no odor. The pipes were rated as moderate. The remaining pipes did not have any discharge.

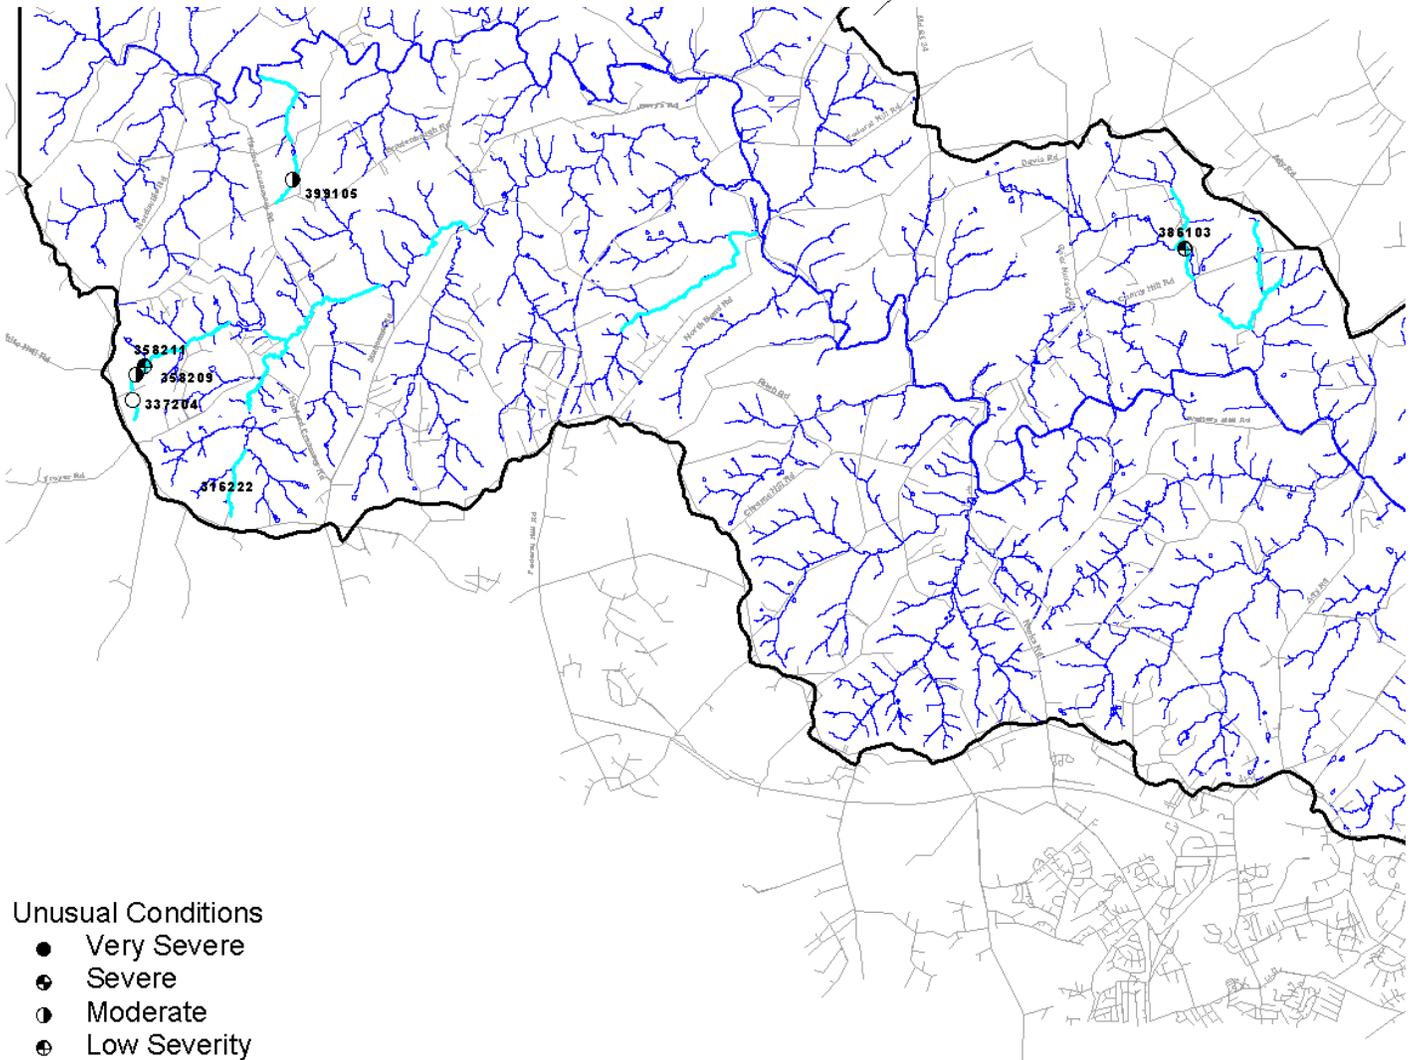
The survey crew identified 6 unusual conditions and 1 comment. The severity and location of unusual condition sites is shown in Figure 18b. Two unusual conditions were where there were tractor/truck stream crossings. One of which was indicated to have some sediment issues. Site 399105 was reported to have excessive algae. Site 358211 was an area where the stream has been piped. Site 386103 is a place where sand bags have been placed in the stream to enhance a stone weir to create a pond. Site 337204 is an area where rocks have been placed as bank stabilization.
