Stream Corridor Assessment Survey for the Deer Creek Watershed, Harford County, Maryland

Department of the Environment
1800 Washington Boulevard, Suite 540
Baltimore MD 21230-1718

April 2006

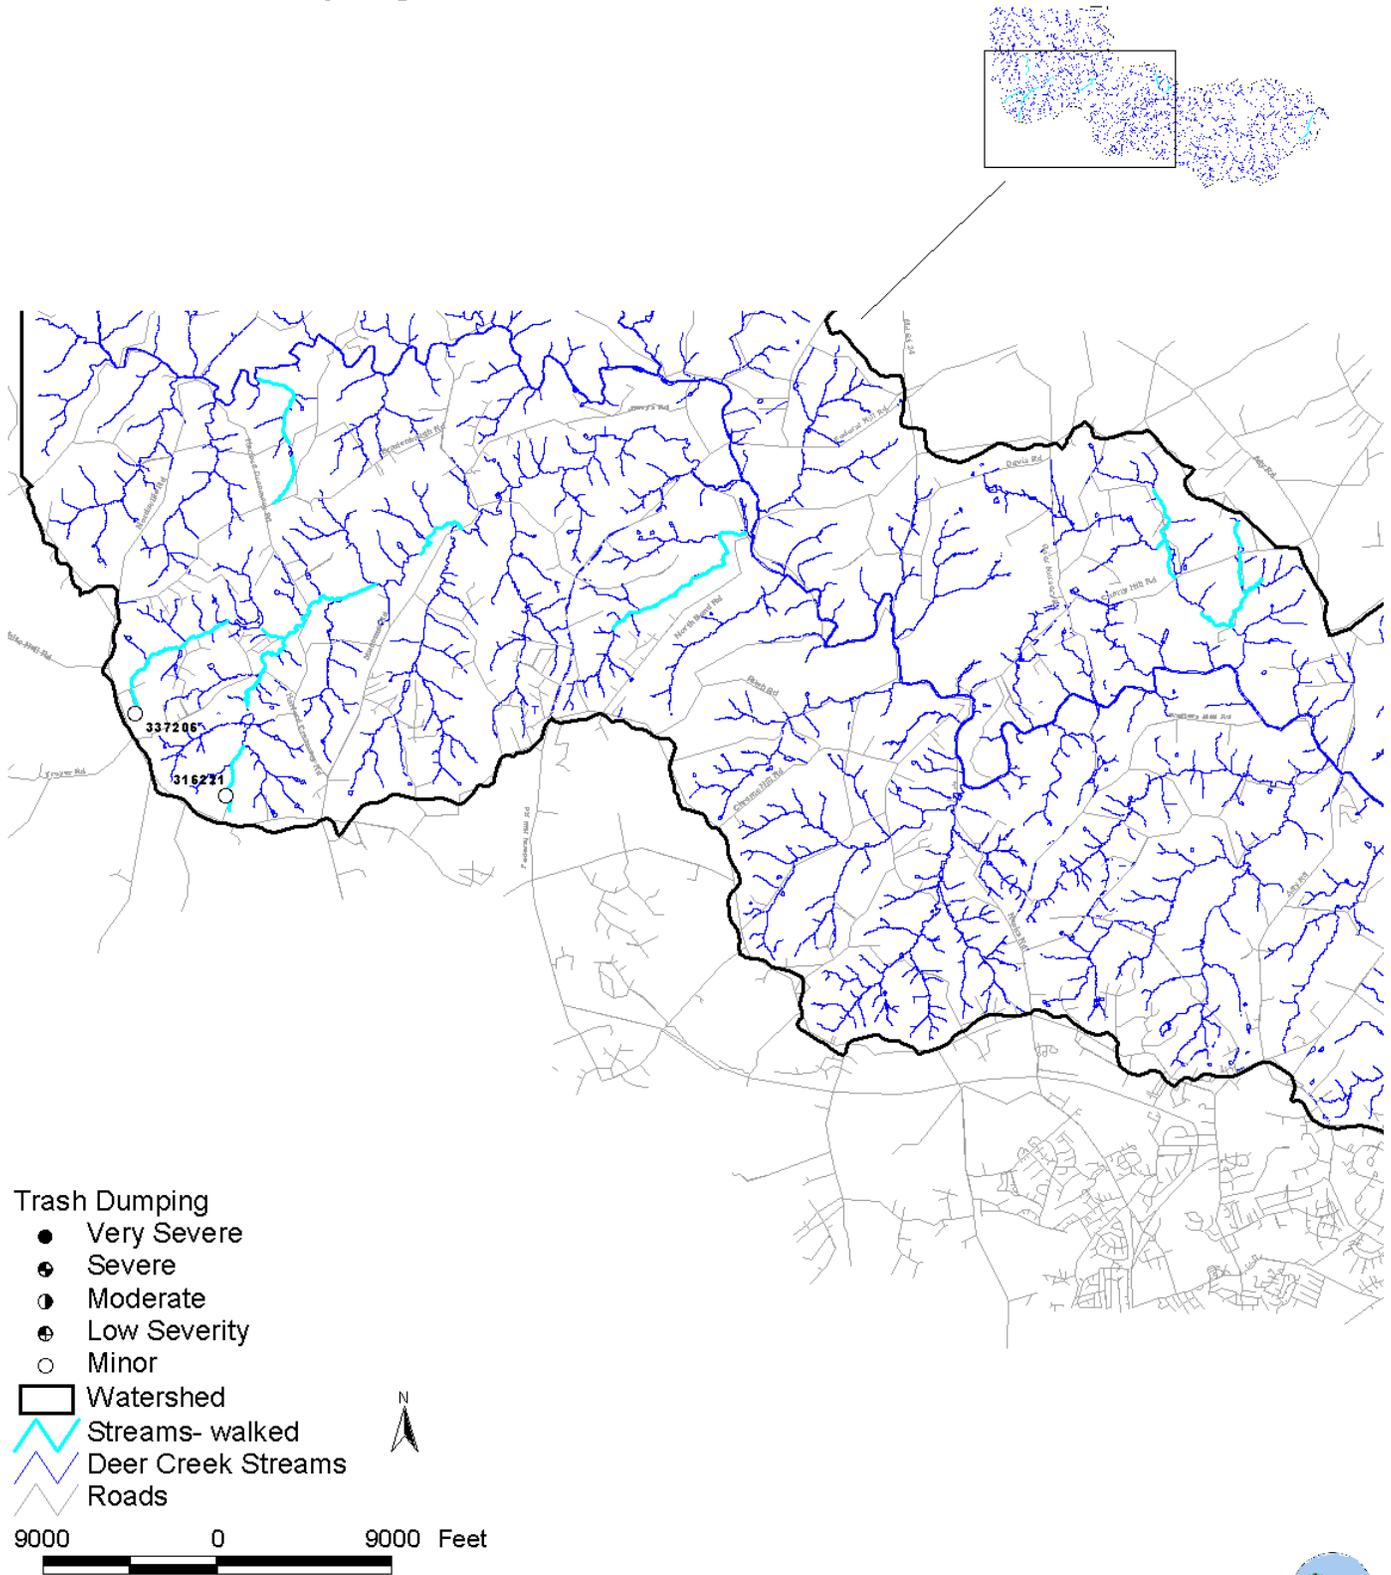
Figure 20: Map showing the locations of the Trash Dumping in the second round of fieldwork in the Deer Creek Watershed

Survey crews found two trash dumping sites (Figure 20). At Site 316221 some construction trash had been dumped. At Site 337206 fencing had been dumped. Both sites were given minor severity ratings.
