Stream Corridor Assessment Survey Of The Little Patuxent River In Howard County

Watershed Restoration Division
Chesapeake & Coastal Watershed Services
Maryland Department of Natural Resources
September 2001

**STREAM CORRIDOR
ASSESSMENT SURVEY
OF THE
LITTLE PATUXENT RIVER
IN HOWARD COUNTY**

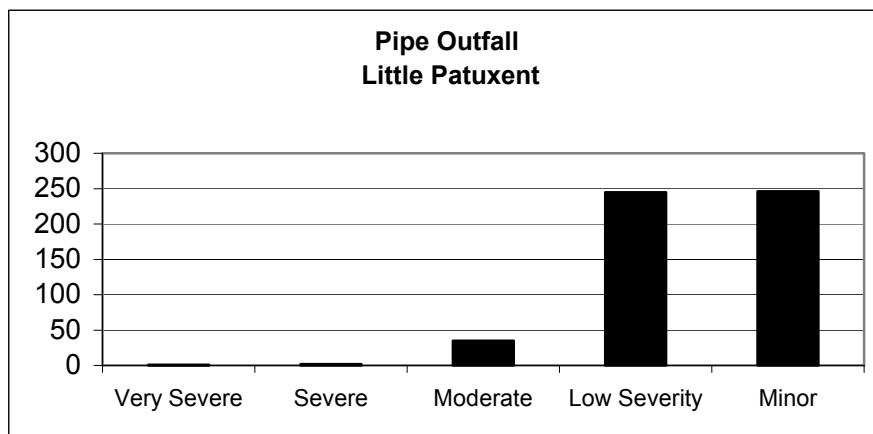
Figure 4c shows the frequency of the severity rating given to pipe outfalls during the survey. As can be seen from the graph, the majority of the pipe outfalls were given either a very low or minor severity rating. Only one problem at Site LP110234 received a very severe rating. During the survey, field crews found an open manhole that was discharging sewage at a rapid rate at this site. This problem was reported to Howard County and was corrected immediately. Two other sites (Sites LP022308 and LP082342) received a severe rating and at both of these sites, a colored discharge and a sewage smell were reported. There were no estimates of the amount of fluid coming from the pipes. No immediate follow up actions were taken as part of this study to determine the source of the color or smell coming from any of the pipes. In some cases, coloration or smell from a storm drainpipe may be a sporadic occurrence. This is especially true in areas where there is no stormwater management system present.

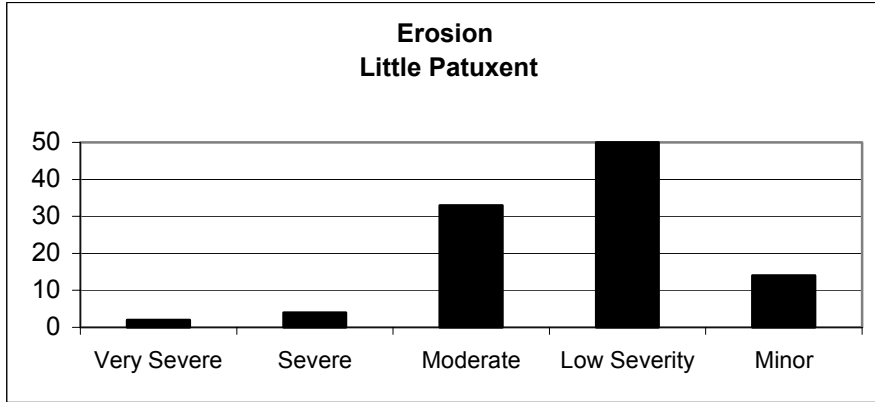
Unstable eroding streams are areas where the stream banks are almost vertical and the roots from the vegetation along the stream's banks are unable to hold the soil on the banks. Unstable eroding stream banks were reported at 103 sites during the survey (Figure 6a). The majority of the erosion sites showed moderate to minor erosion that extended over long distances. The lengths of stream segments that were recorded as having unstable banks varied from 6 feet in some areas, to other areas where up to 2 miles of stream was found to have an erosion problem (Appendix C). Overall, results indicate approximately 9.7 miles of unstable eroding banks in the Little Patuxent watershed. Figure 6b shows the frequency of the severity rating given to erosion sites. Only two sites received a very severe rating and five other sites were rated as severe.

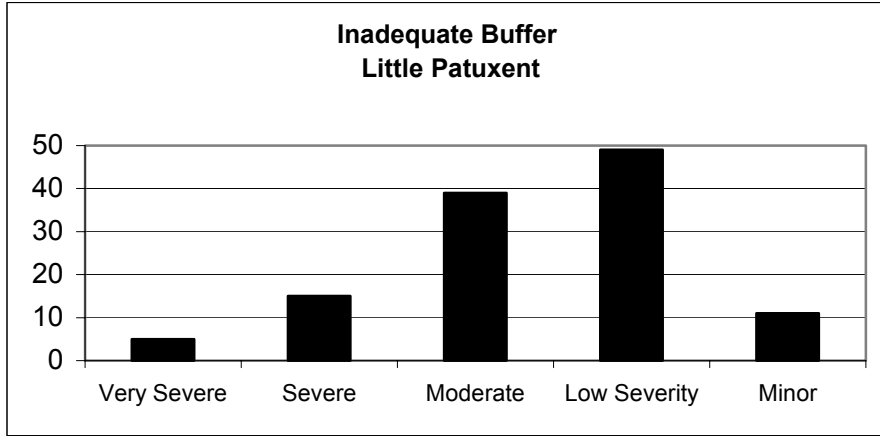
Figure 7b

Survey results indicate that there are several possible locations on both public and private lands where forested buffers could be reestablished. Sites LP097230 and LP091120 received the highest severity rating possible and should be investigated to determine if establishing a forested buffer would be possible. In some locations, including Sites LP041304, LP042310, and LP128106, bike paths come close to the stream and there may be opportunities to plant trees between the bike path and the stream to allow for larger buffers in these areas. Another area that should be further investigated is site LP162204, which is above Centennial Lake. A vegetated stream buffer in this area could help reduce nutrient input to the lake. Centennial Lake was constructed in the early 1980's and algae growth, which could be caused by excess nutrients, is a problem in the lake. Based on the survey's initial results, a buffer planting has already been done at site LP128106 and site LP128105, inside of Altholton Park in October 2000.

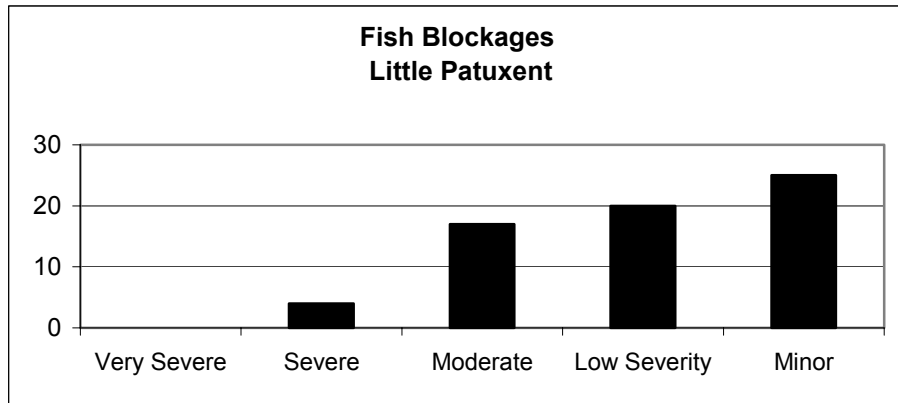
Figure 8b

Sixty-seven fish migration barriers were reported during the survey. The locations of fish migration blockages are shown in Figure 8a. The blockages were due to a number of reasons including small dams (10), road crossings (17), pipe crossings (5), channelized stream sections (5), natural falls (8), ponds (7), and debris dams (11). Of the remaining fish blockages, gabion baskets and a weir were reported to cause one fish migration blockage each. Most of the sites were given moderate to minor severity ratings (Figure 8b). Overall, the mainstem of the Little Patuxent River is relatively barrier free. The only man made structures on the River's main stem are two small dams (Sites LP110121 and LP105106), which were in the upper portion of the watershed. Downstream of the area that was surveyed there is a dam at the Fort Meade Wastewater Treatment plant. This dam, however, does have a working fish ladder and the migration of Blueback herring and alewife through the ladder has been documented. Once these anadromous fish pass through the fish ladder at Fort Meade, there are no presently known blockages to their migration until they reach Savage Mill. Savage Mill is located at the fall line between the Coastal Plain and Piedmont physiographic provinces and there is a natural waterfall present at Site LP049501. The waterfall is composed of a series of greater than 1-foot water drops and it is presently believe that alewife and herring would have difficulty migrating upstream through this area. This site was given a minor ranking because it is a natural barrier.

Any strategy to remove fish migration barriers in the Little Patuxent River should first attempt to keep the mainstem of the River as barrier free as possible. In addition, barriers that isolate large sections of tributaries from the mainstem, such as Site LP121109, or barriers that isolate significant portions of the upper portion of a tributary, such as Site LP099247, should also be targeted.

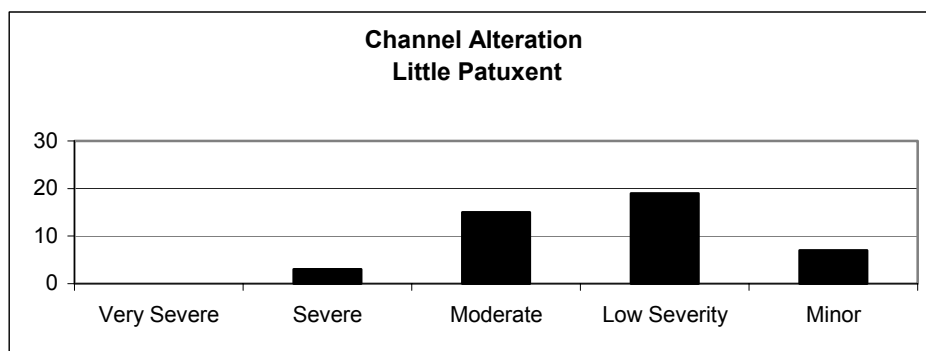
Figure 9b

Results of this survey indicate that the stream has been recognizably altered in 45 areas and their locations are shown in Figure 9a. The total length of stream affected by channelization was estimated to be 14,262 feet or about 2.7 miles. There were no major stream systems reported in the survey as being extensively channelized and most of the sites were given a moderate to minor severity rating (Figure 9b). Most of the sites identified were also on small channels. Over half of the sites were channelized with concrete (25), while 9 were earthen channels that had been straightened, 8 were armored with rip-rap, 1 channel was lined with gabion baskets, and 2 were lined with wood. The correctability rating given for most of these sites were high because of the difficulty and expense of removing concrete. At one site, LP125301, it appears that the concrete channel is failing and the stream is beginning to flow underneath the concrete. Though this site received a low severity rating because of its short length, extensive gullying could occur beneath the concrete if it is not fixed.

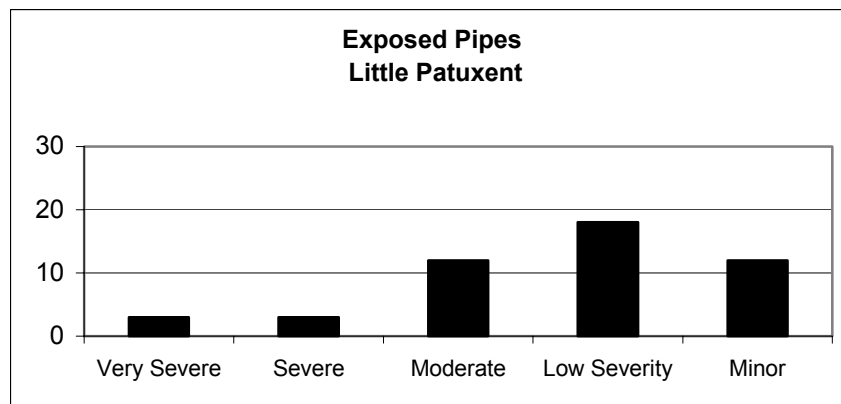
Figure 10b

Exposed pipes were reported at forty-six sites during the survey. Locations of these sites are shown in Figure 10a. Of those, thirteen were manhole stacks, twenty-three were places where pipelines crossing the bottom of the stream had been exposed, seven sites had pipes exposed along the edge of the stream channel, and pipes were located crossing above the stream at 3 sites. Field survey teams reported 2 sites as having very severe problems. Sites LP039303 and LP064305 had discharges with a sewage odor and should be investigated further.

No other discharges were reported during the survey and most sites were give a moderate to low severity rating (Figure 10b). All exposed pipe photos should be reviewed by public works officials and follow-up visits should be done based on their evaluations.

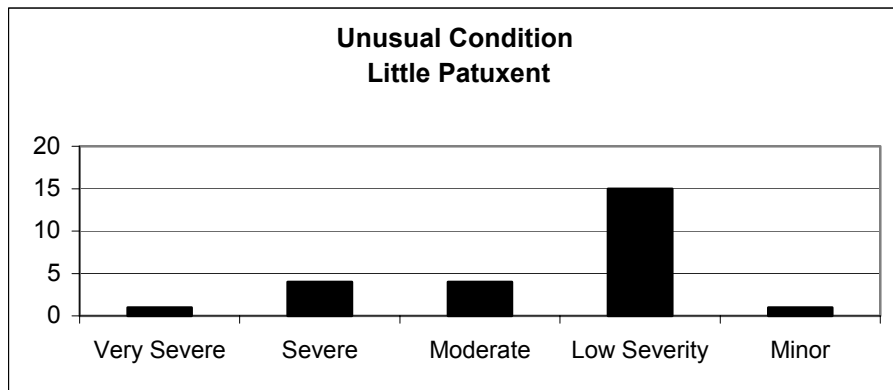
Figure 11b

The unusual condition/comment data sheets are used by survey teams to record the location of anything out of the ordinary seen during the survey or to provide some additional written comments on a specific problem. Twenty-five unusual condition sites were found during the Little Patuxent survey (Figure 11a) and two comment data sheets were filled out. Site LP110234, a manhole discharging sewage, was given the highest severity rating. Three other sites were reported to have a sewage odor, but were not associated with an exposed pipe or pipe outfall. The other problems frequently recorded were red flock and large amounts of algae. These were given lower severity ratings (Figure 11b).

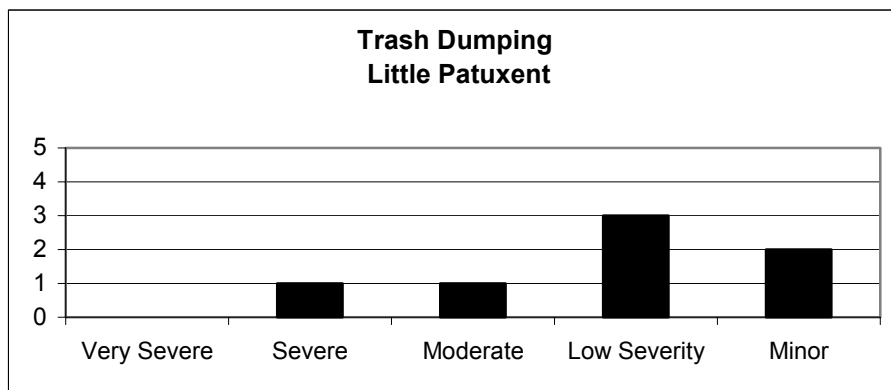
Figure 12b

The trash dumping data sheets are used to record the location of places where large amounts of trash has been dumped inside the stream corridor or to note places where trash tends to accumulate. The field survey crew found seven sites where there was excessive trash and their locations are shown in Figure 12a. Only one was recorded as severe, Site LP031320, which is a construction site. It was estimated to require 15 pick-up truckloads to remove all the trash from this site. Four sites were recorded as having yard waste, one had residential waste and one had industrial waste. These sites were given severity rating ranging from moderate to minor (Figure 12b).
