Middle Chester River Stream Corridor Assessment Survey

Watershed Restoration Division
Chesapeake & Coastal Watershed Services
Maryland Department of Natural Resources
April 2002

MIDDLE CHESTER STREAM CORRIDOR ASSESSMENT SURVEY

April 22, 2002

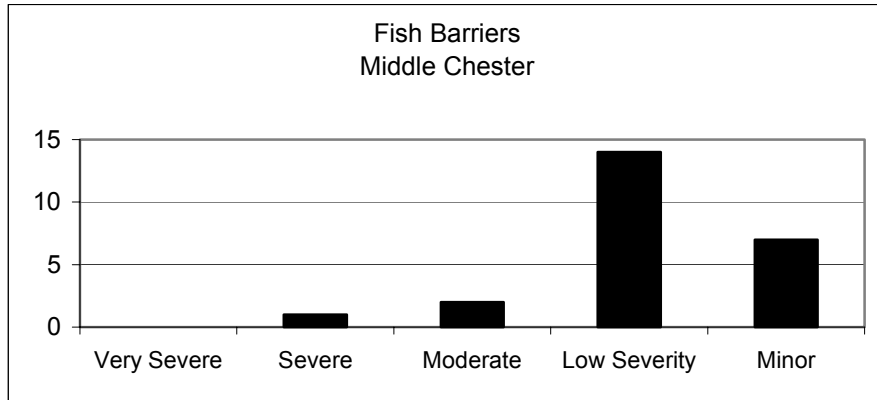
Most sites were given a low to minor severity ratings (Figure 5a). The two exceptions were Site 038505, which is the dam at Urieville Lake and Site 030101, which is a USGS gauging station. Urieville Lake (Site 038505) is located on a side branch of Morgan Creek and it was given a severity rating of severe. The gauging weir at Site 030101 is on the mainstem of Morgan Creek and it was given a moderate severity rating. Earlier surveys of anadromous fish spawning areas that were done by DNR in the late 1970's found yellow perch, white perch and river herring all spawn in Morgan Creek (O'Dell, et al., 1980). The study also reported that while Urieville Lake (Site 038505) blocked upstream migration of all anadromous fish, both river herring and white perch were collected above the USGS Gauging station (Site 30101).

Figure 5a. Histogram showing the frequency of severity ratings given to fish migration barriers sites during the Middle Chester SCA survey.

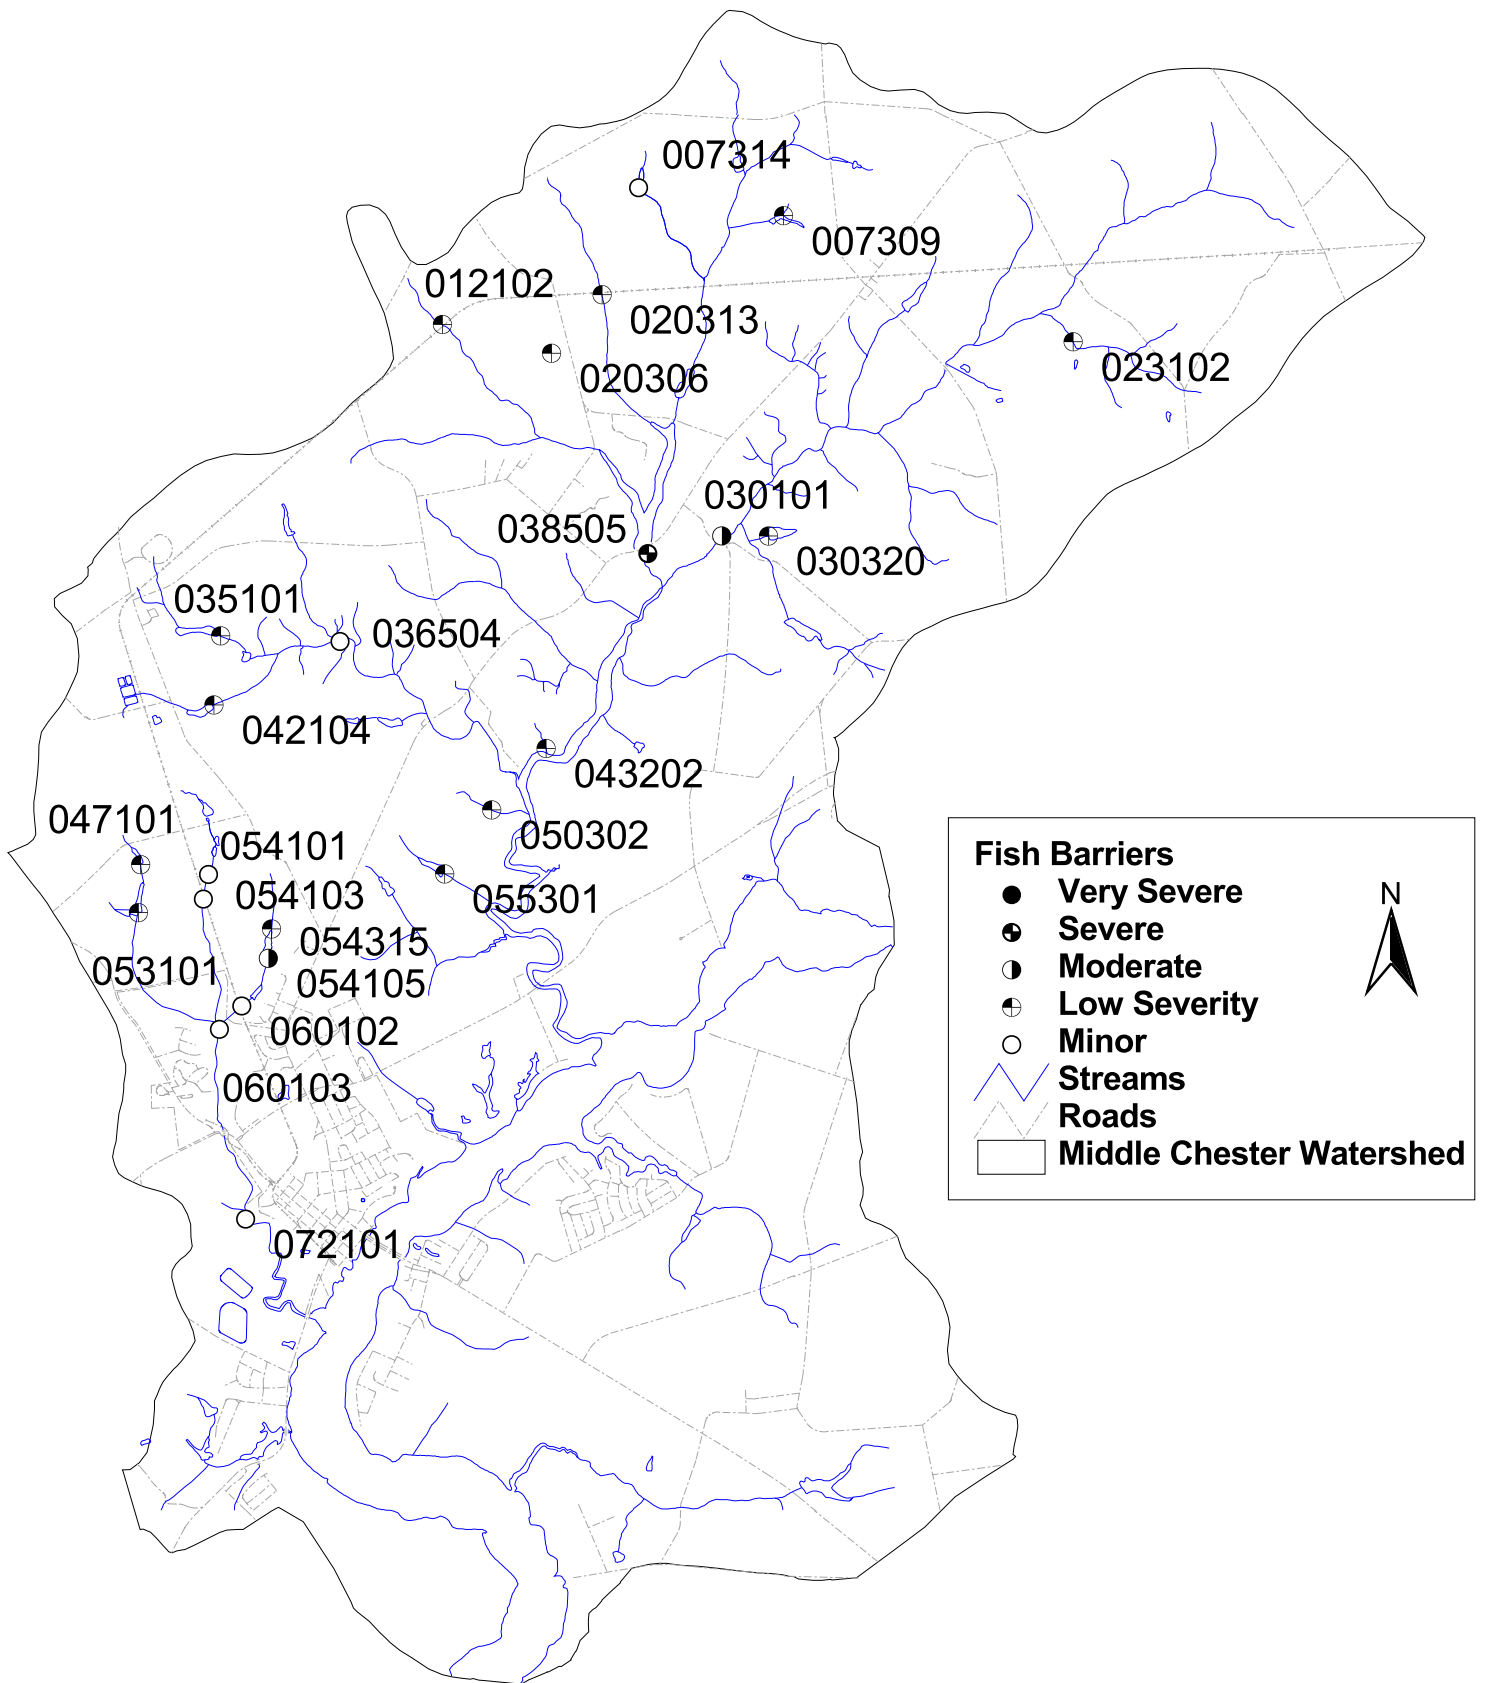
Twenty-four fish migration barriers were reported during the survey, making it the most frequently reported problem. The locations of fish migration blockages are shown in Figure 5b and the data is presented in Appendix B. The blockages were due to a number of reasons including small dams (15), beaver dams (6 sites), a gauging weir (1 site), a road crossing (1 site) and a railroad crossing (1 site).

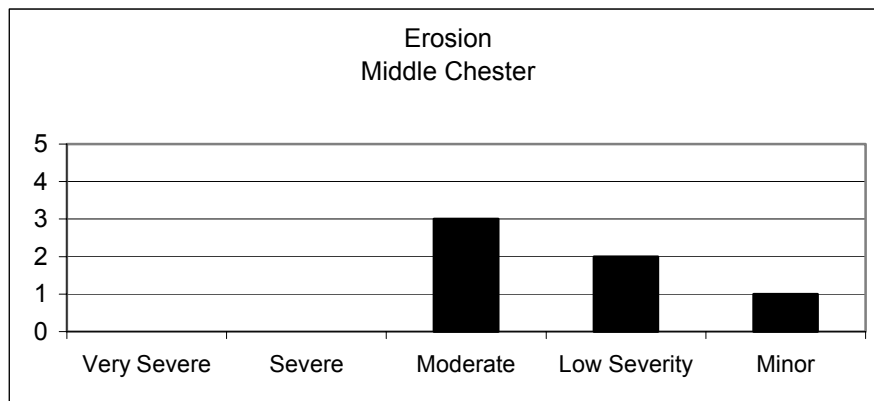
Figure 6a Histogram showing the frequency of severity ratings given to erosion sites during the Middle Chester SCA survey.

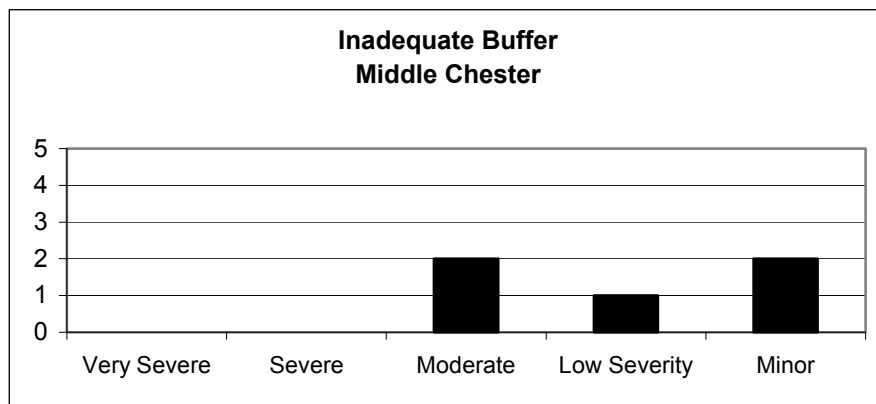
Survey results indicate that there are a few possible locations on private lands where forested buffers could be reestablished or expanded. Sites MC011301 and MC024101 received moderate ratings. MC011301 is in a pasture, while site MC024101 is mixed crop and lawn.

Figure 7a. Histogram showing the frequency of severity ratings given to inadequate buffer sites during the Middle Chester SCA survey.

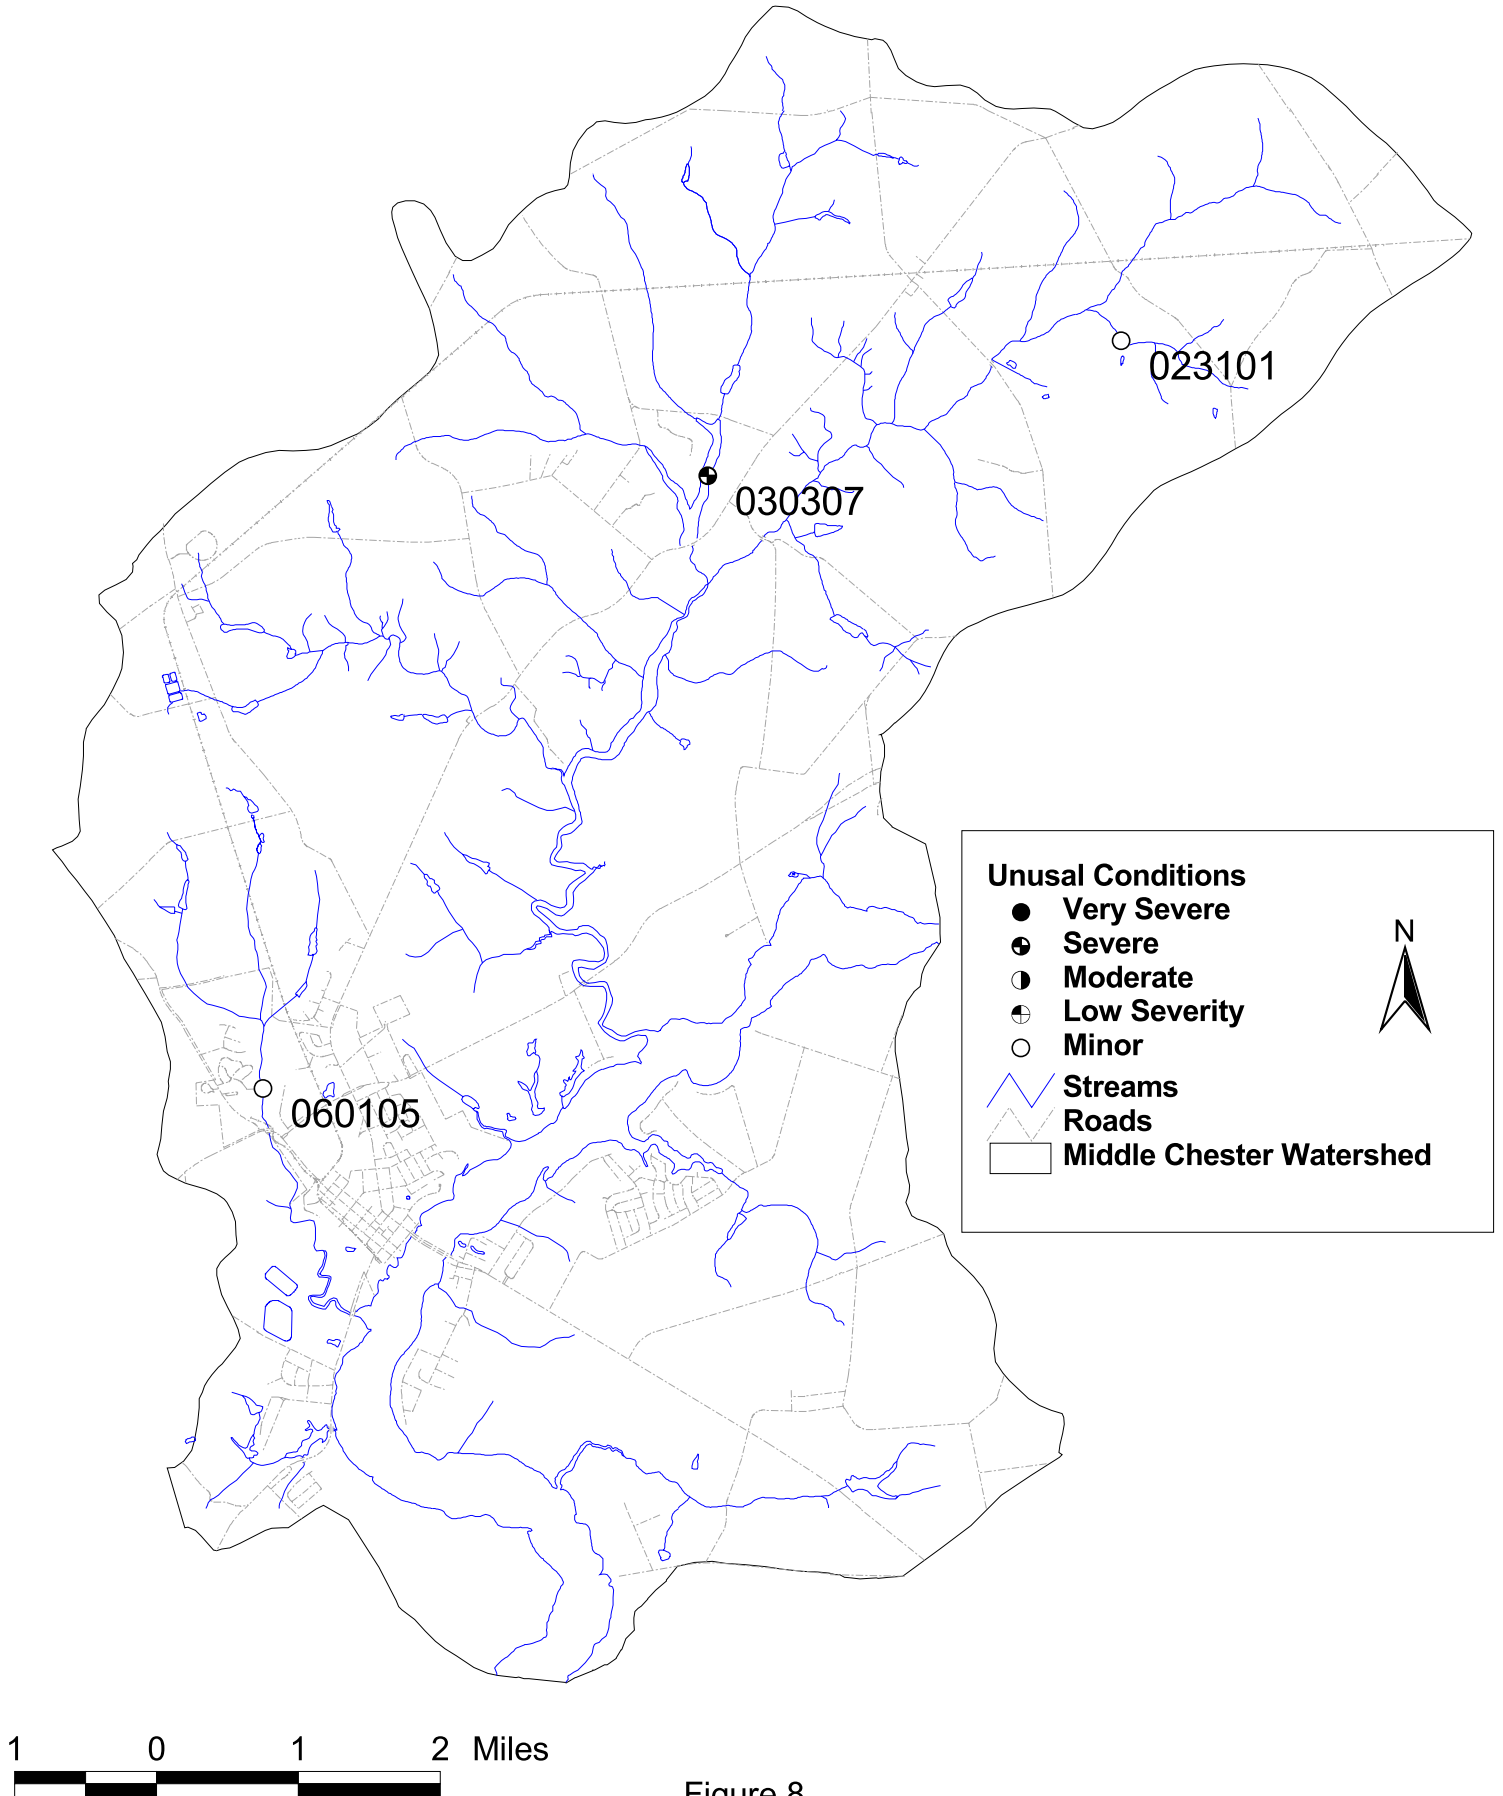
Figure 8

The unusual condition/comment data sheets are used by survey teams to record the location of anything out of the ordinary seen during the survey or to provide some additional written comments on a specific problem. Three unusual condition sites were found during the Middle Chester survey and their locations are shown in Figure 8. The only unusual condition site that was given a severe rating was Site 030307 which is at Urieville Lake. Field crews reported excessive algae present in the lake. Excessive algae grown problems in the watershed may also not be limited to Urieville Lake. During the helicopter survey of the watershed, the survey team reported seeing a number of headwater ponds with what appeared to be large amounts of algae growing in them.

The other unusual condition sites received minor severity ratings. The included an unprotected/exposed cable crossing the stream (Site 023101) and a cloudy discharge from one of the streams banks (Site 060105).

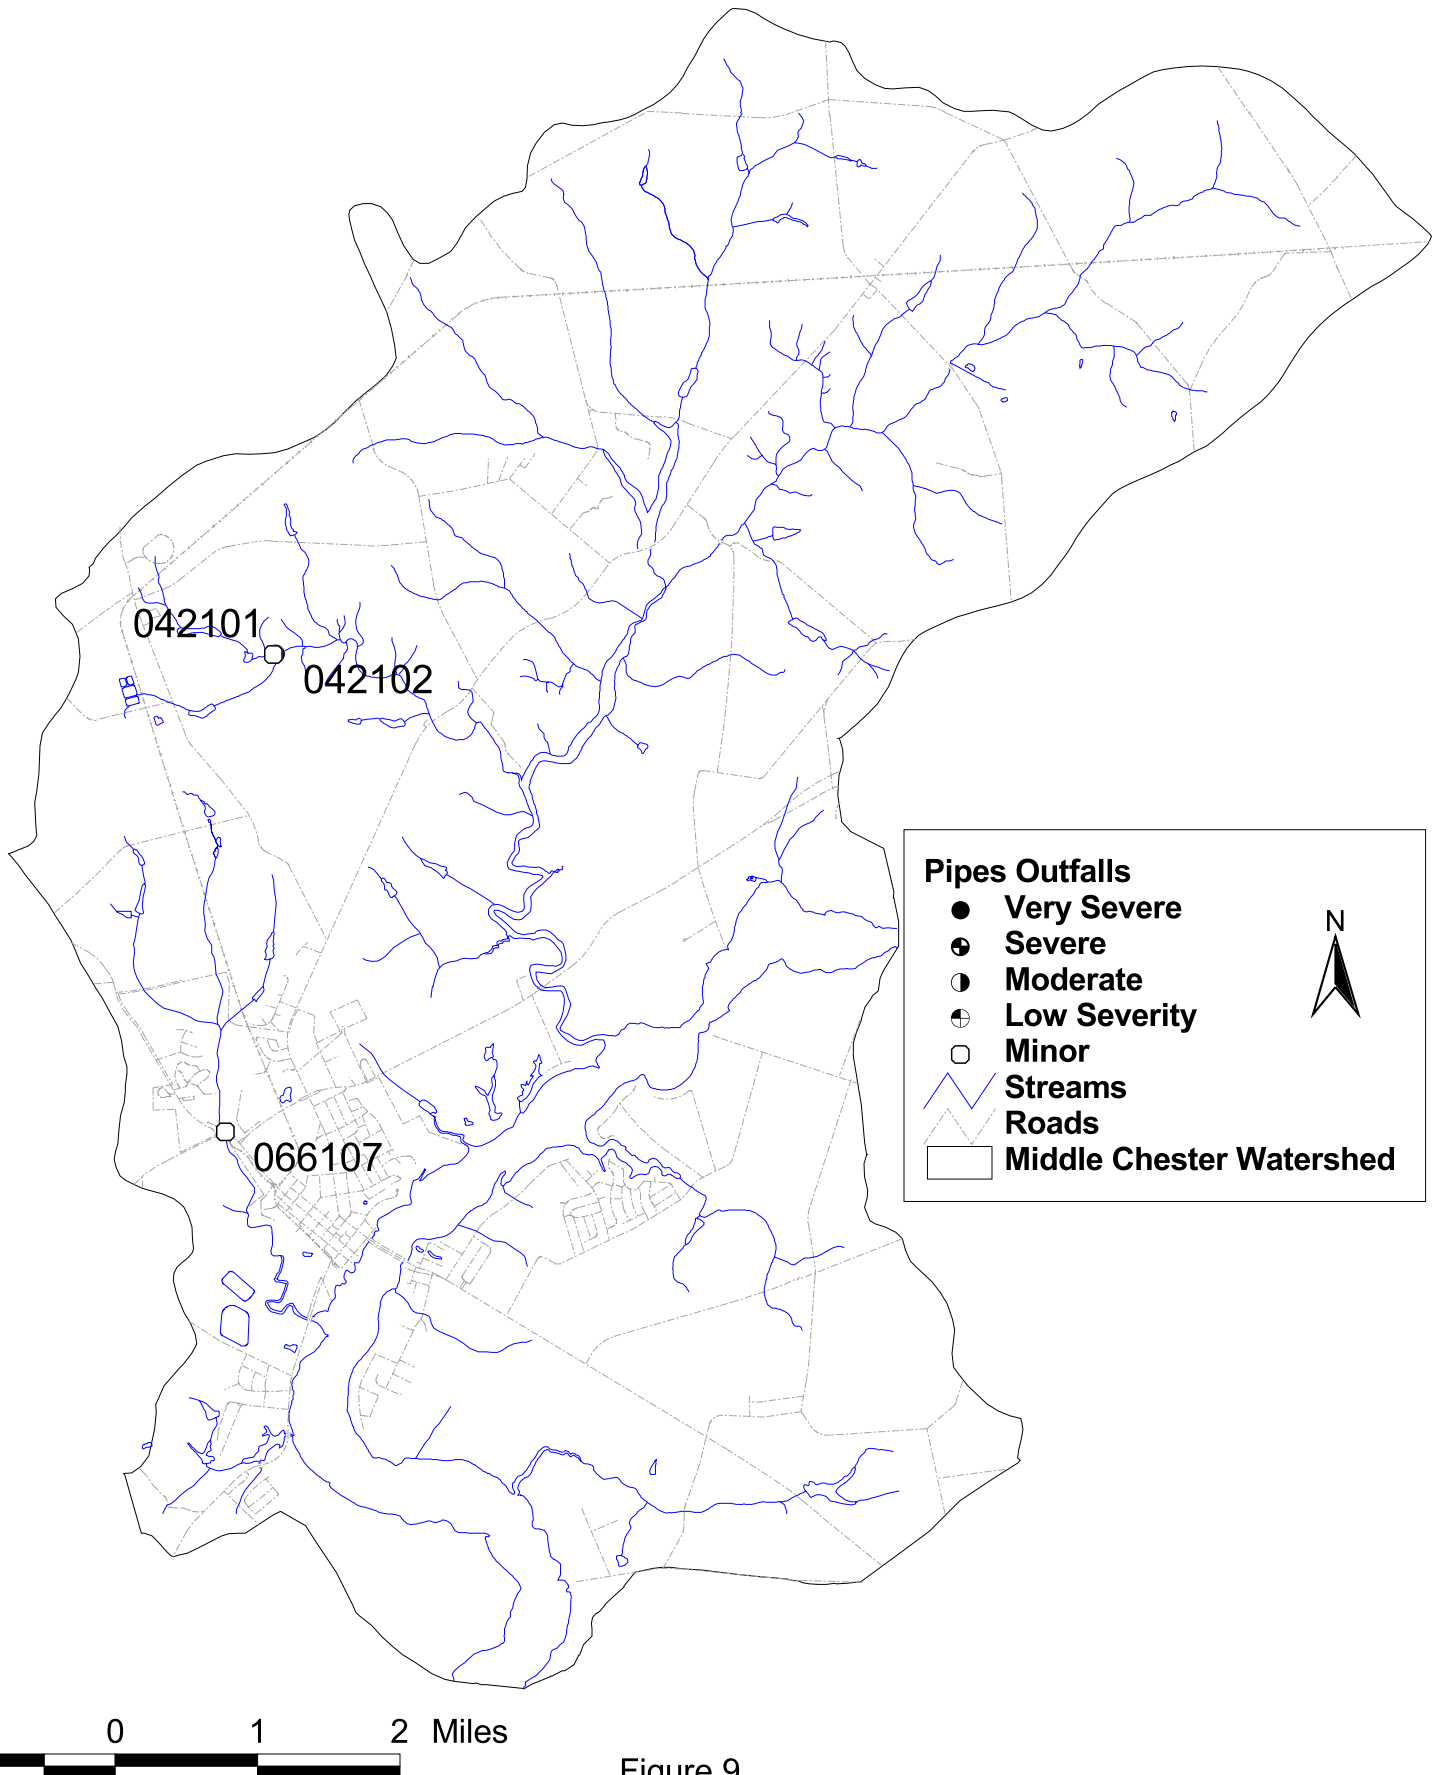
Figure 9

Site 042102 received a moderate rating while the other two sites (Sites 042101 and 066107) received minor rating (Figure 9). At Site 042102 the outfall pipe was reported to be discharging dark colored water that had a musky smell (Appendix B).

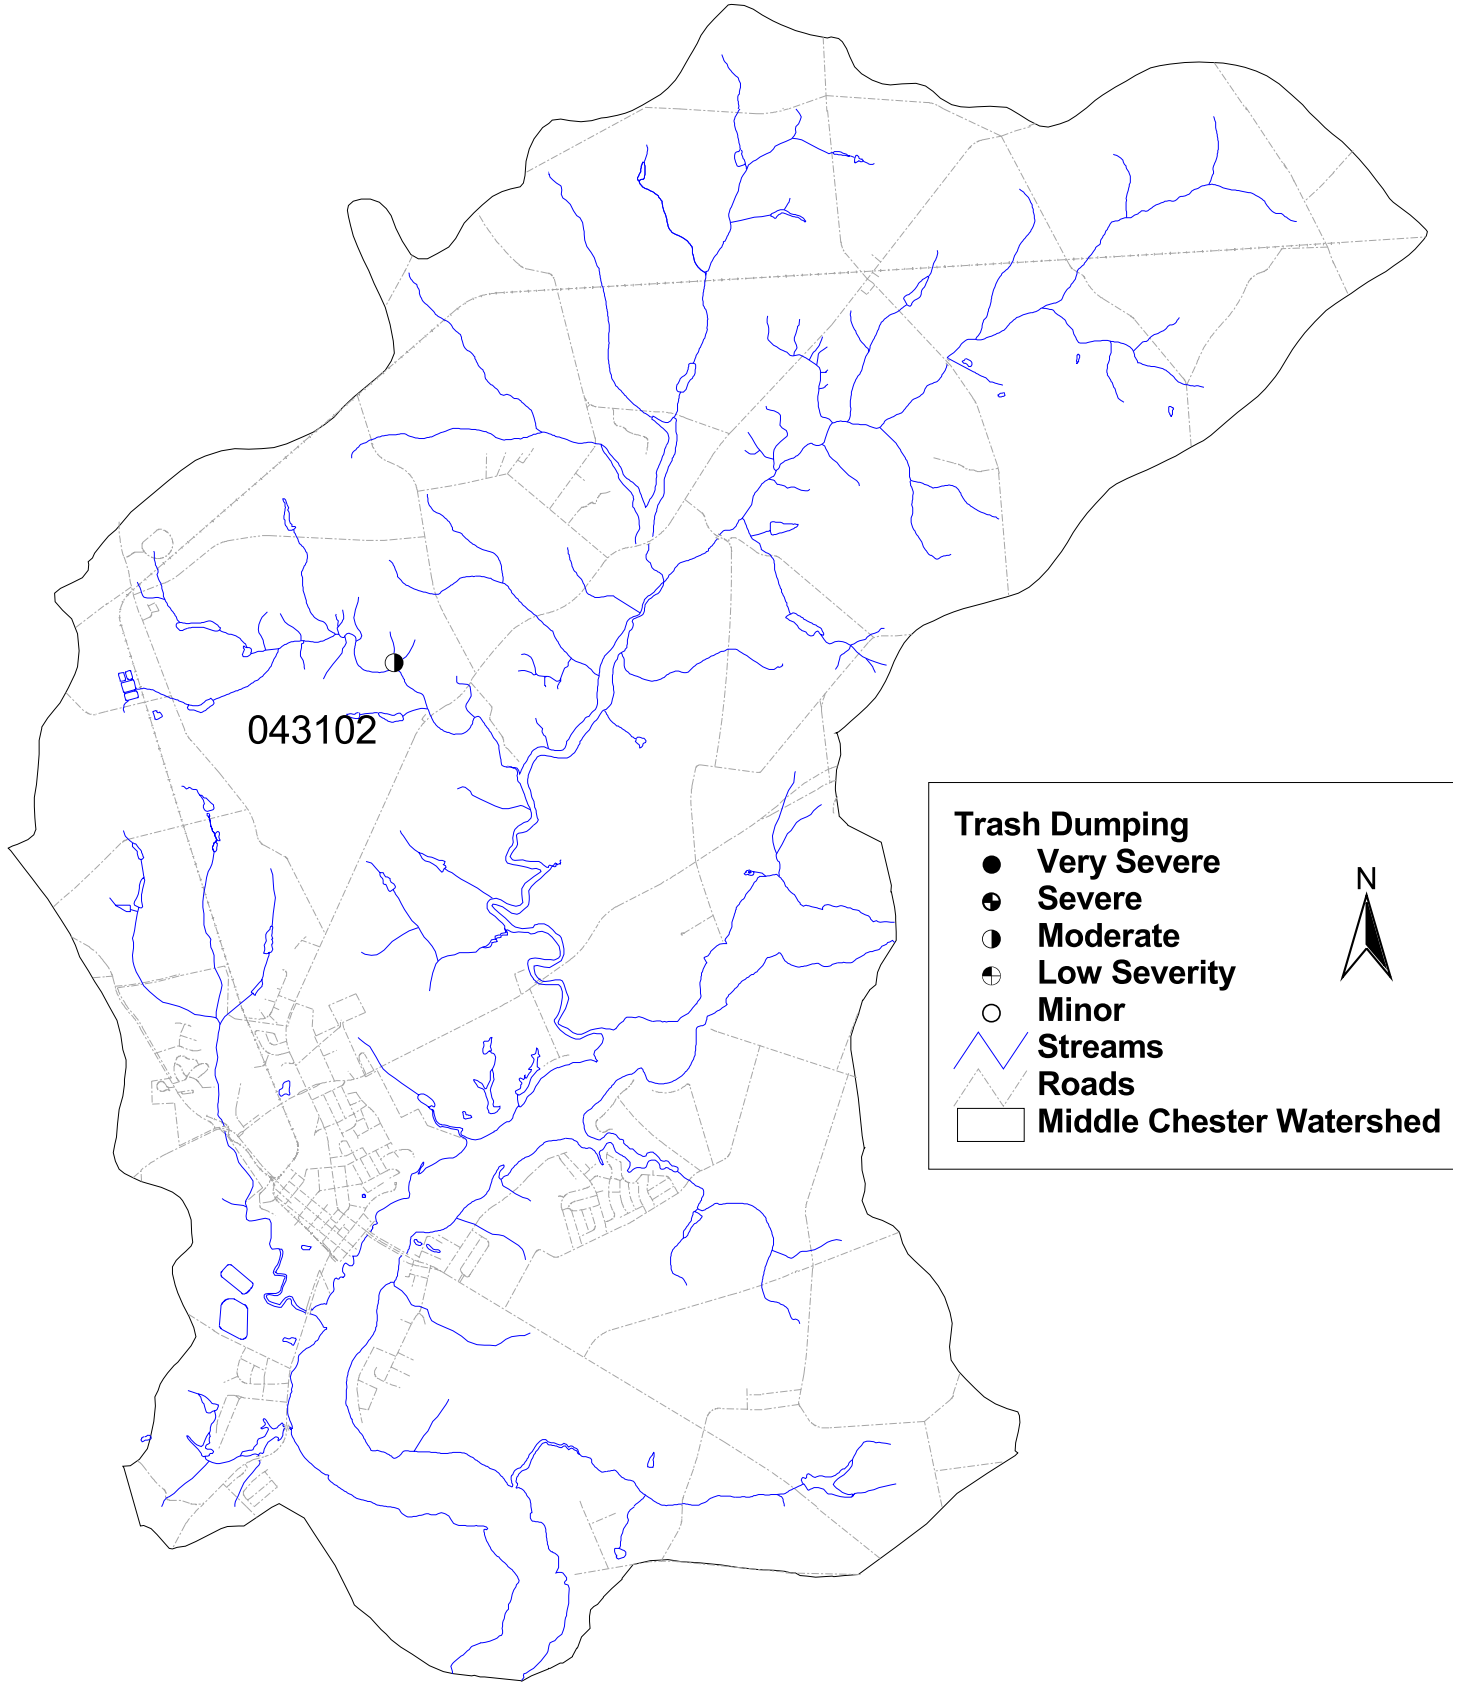
Figure 10

The trash dumping data sheets are used to record the location of places where large amounts of trash has been dumped inside the stream corridor or to note places where trash tends to accumulate. The field survey crew found one site where there was excessive trash and its location is shown in Figure 10. The severity of the problem was reported as moderate. It was estimated to require seven pick-up truckloads to remove all the trash from this site.
