Stream Corridor Assessment Survey for the Miles River Watershed, Talbot County, Maryland

Department of the Environment
1800 Washington Boulevard, Suite 540
Baltimore MD 21230-1718

April 2006

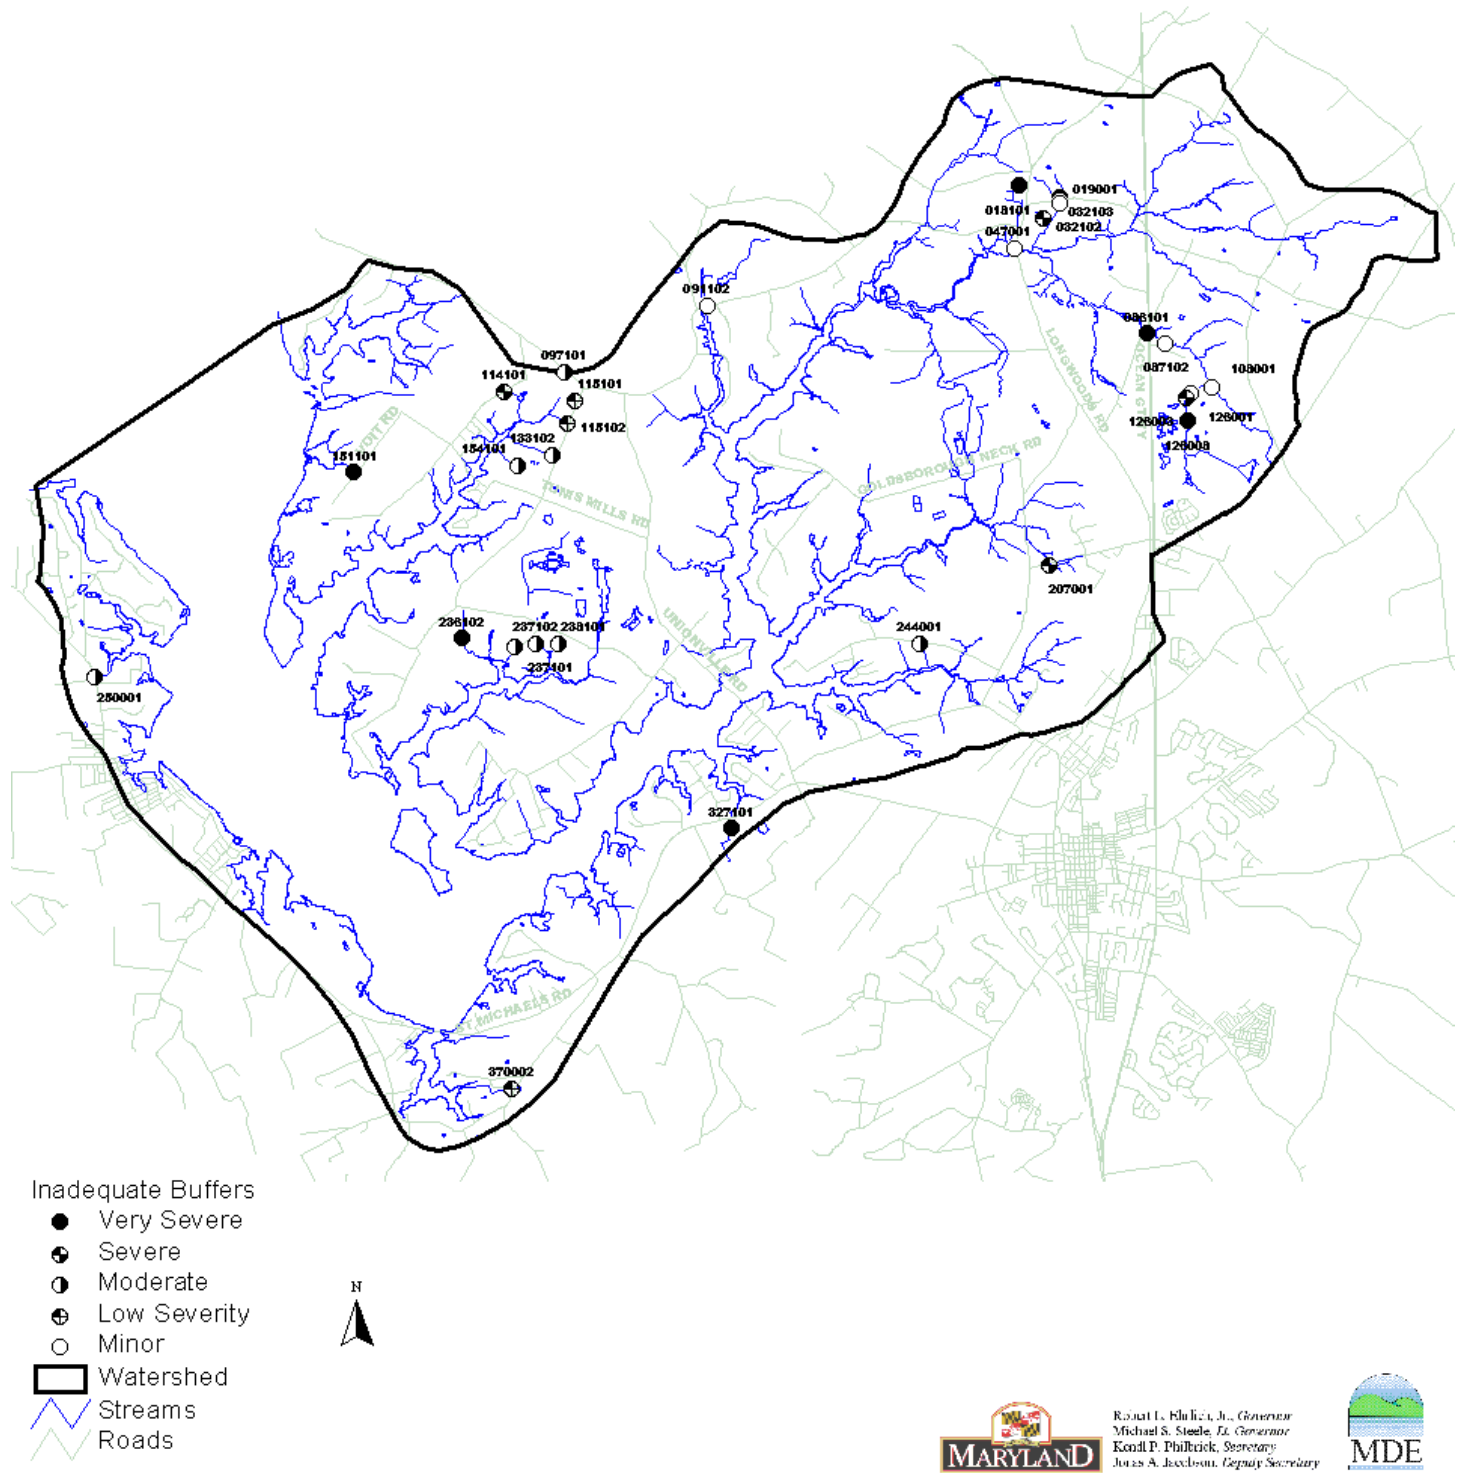
Figure 5b: Map showing the locations of the Inadequate Buffer sites in the Miles River Watershed

Survey crews identified 28 inadequate buffer sites with a total length of 34,650 feet (6.6 miles), or approximately 22 percent of the 30 miles streams surveyed. The severity and location of inadequate buffer sites is shown in Figure 5b. Eleven of these sites are ranked as very severe or severe, while the other fifteen sites are moderate, of low severity, or minor (Figure 5a). Land uses along the stream at inadequate buffer sites were reported as mostly crop fields and golf course.

Any inadequate buffer site would benefit from the restoration of trees along both stream banks. For sites on agricultural land, farmers also may qualify for federal and state government financial incentives for allowing 50-foot forest buffers to grow on their farmland. Those sites that may have particular natural resource value are headwater streams, or those that form gaps in existing forested buffer areas.

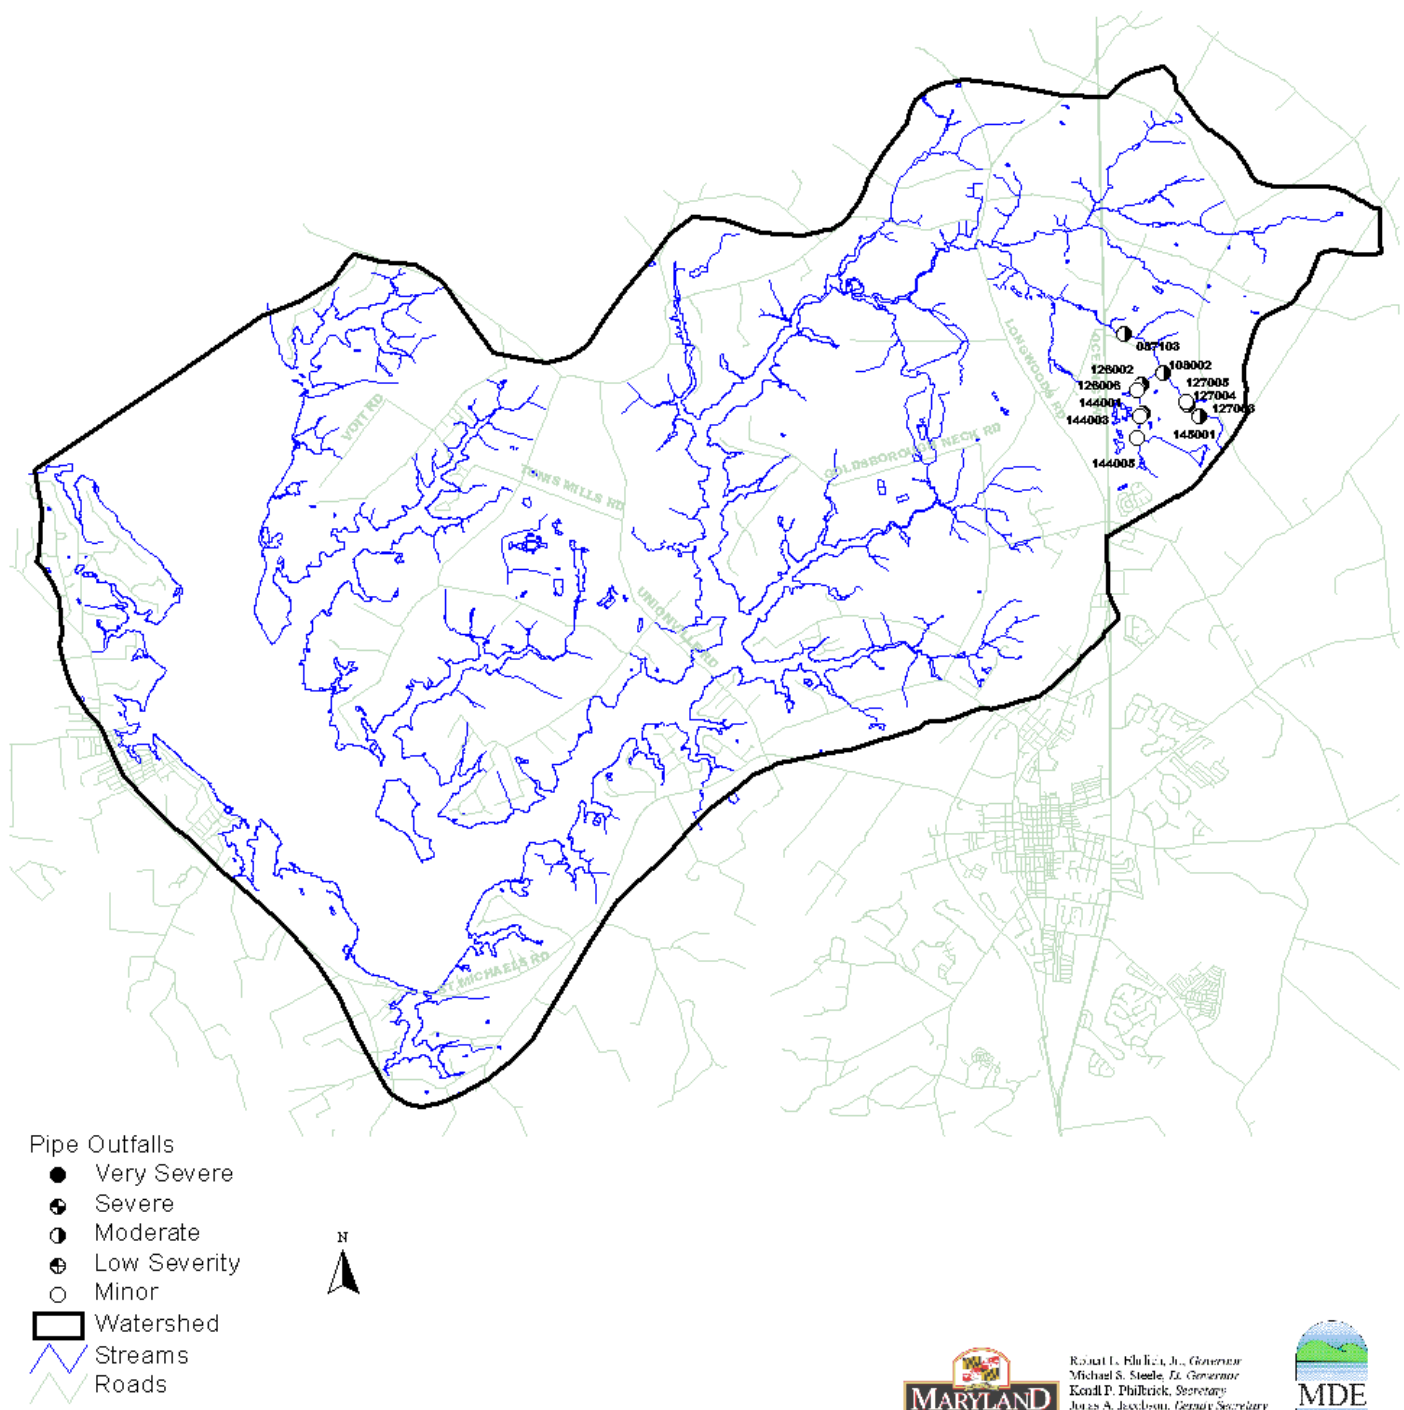
Figure 6b: Map showing the locations of the Pipe Outfall sites in the Miles River Watershed

The survey crew identified a total of 11 pipe outfalls. The severity and location of pipe outfall sites is shown in Figure 6b. Six of the pipes had a discharge. All were clear with no odor. The pipes were rated as moderate. The remaining pipes did not have any discharge.

No immediate follow up actions were taken as part of this study to determine the source of the color coming from the pipe. In addition, we made no estimate of the amount of fluid released from the pipes.

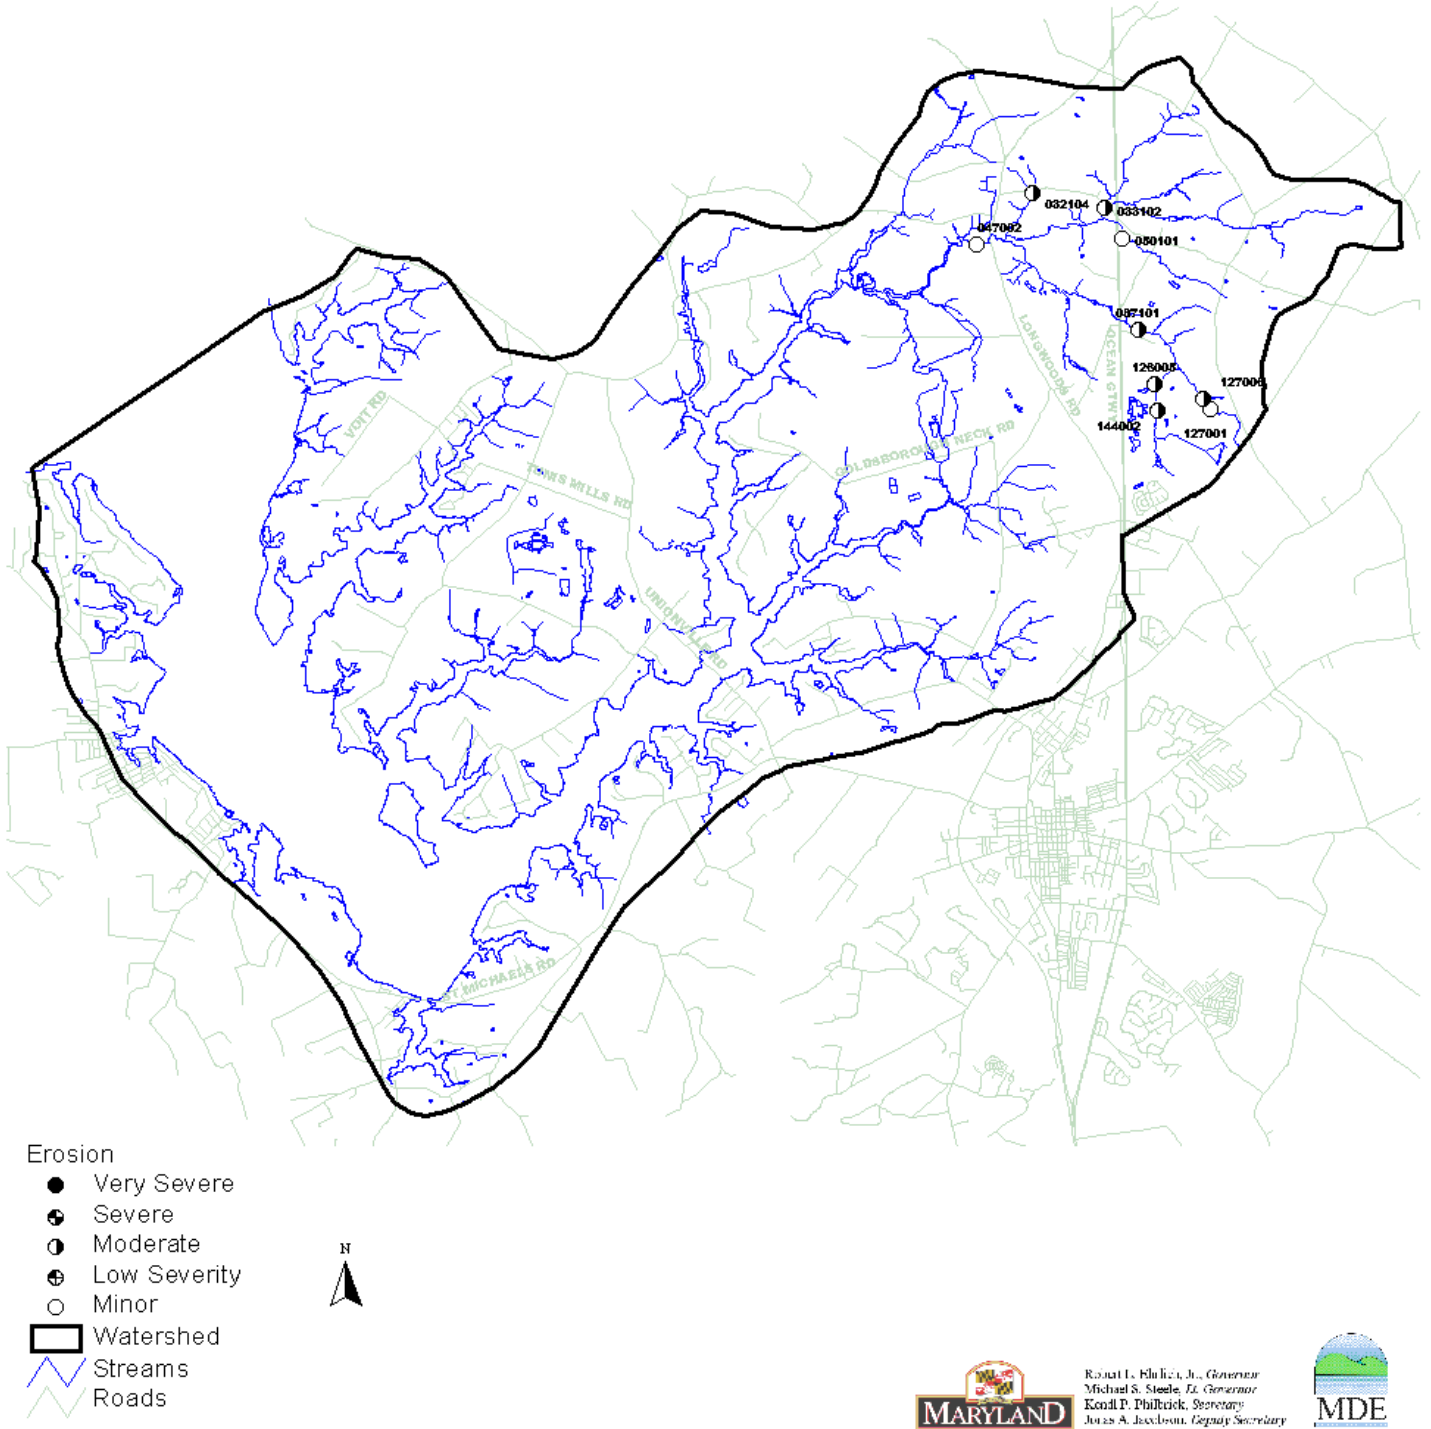
Figure 7b: Map showing the locations of the Erosion sites in the Miles River Watershed

The SCA survey found 9 eroding stream banks over the length of 6,360 feet (1.2 miles) of stream, or about 4 percent of the 30 miles streams surveyed. The severity and location of erosion sites is shown in Figure 7b. All the sites were ranked either moderate or minor in severity. (Figure 7a)

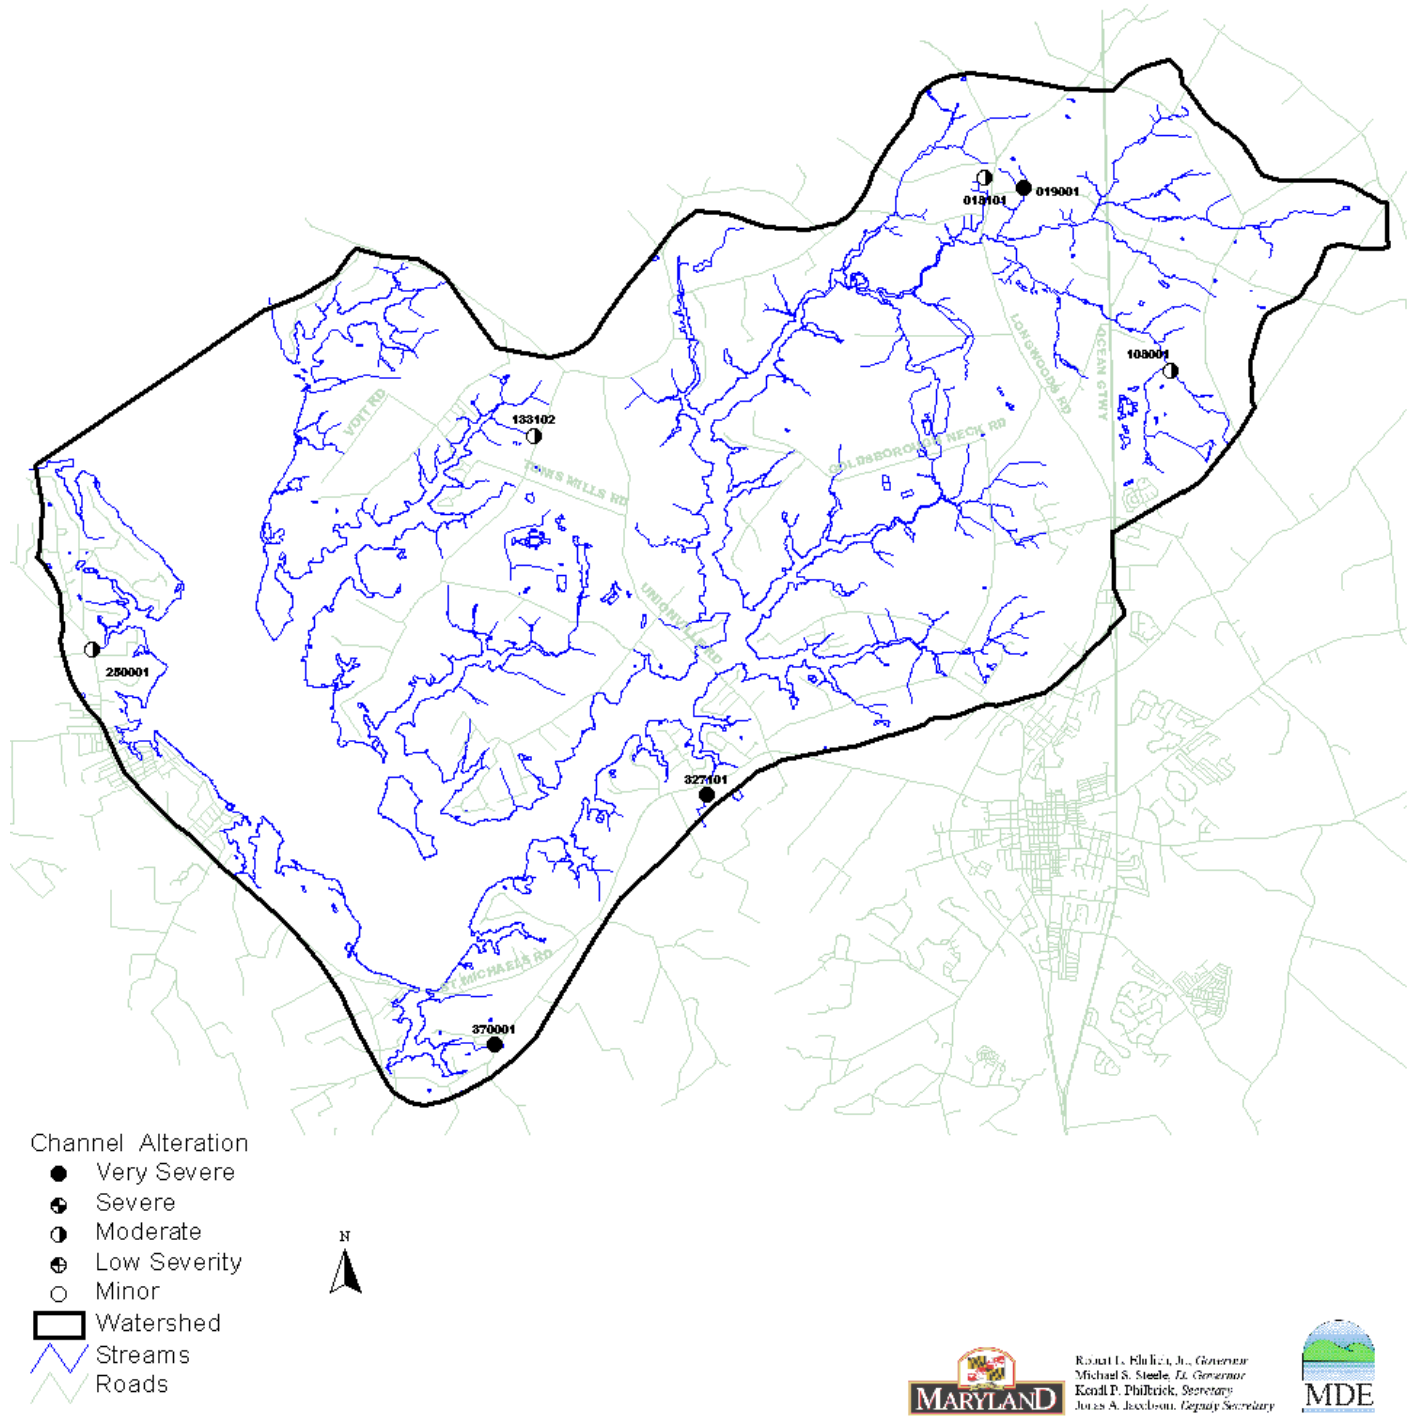
Figure 8b: Map showing the locations of the Channel Alteration sites in the Miles River Watershed

Results of this survey show recognizably altered stream channels at 7 sites. The severity and location of channel alteration sites is shown in Figure 8b. The total length of stream affected by channelization is estimated to be 14,800 feet (2.8 miles). Severity rankings for the sites range from very severe to moderate (Figure 8a).

Restoring channel alteration sites can increase fish and wildlife habitat and may allow for more time for nutrient uptake in the waterway. In its simplest form, restoration for earth channels would include allowing vegetation and/or tree roots to stabilize the sediment along the channel, causing sinuosity to re-form naturally. This sinuosity may reform within the bed of the channelization or along its banks, depending on the site and the depth of the channel alteration.

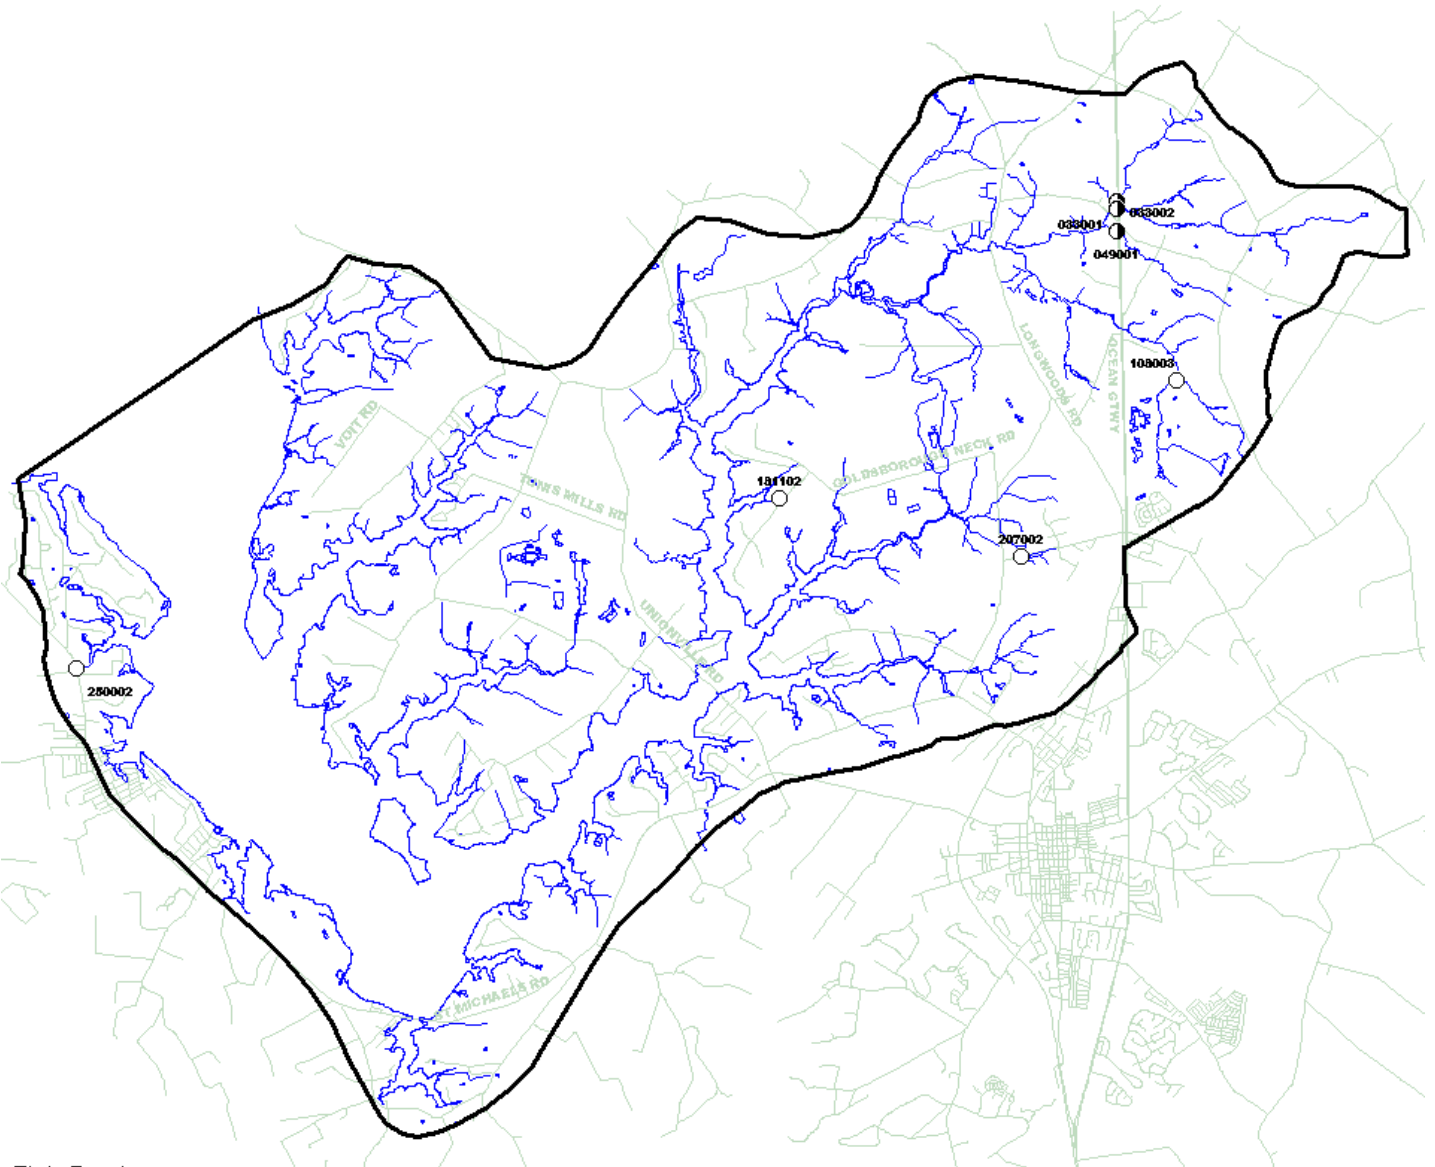
The Miles River SCA survey found 7 fish migration barriers. The locations of fish blockages are shown in Figure 9b. Fish barriers in this watershed are due to road crossings (6), and debris dams (1). Three of these sites received a moderate rating (033001, 033002, 049001). They were all at road crossings. The three moderate sites were all underpasses of Route 50 (Ocean Gateway) north of Easton.

In restoration work, priority is given to removing fish barriers that will yield access to the greatest quality and quantity of upstream habitat per dollar spent. The mainstem is ideally kept as barrier-free as possible, allowing anadromous fish to migrate to spawn and a source of fish species for tributaries in the event of a disturbance. Restoration planning includes targeting barriers for removal that isolate entire tributaries, those that isolate significant portions of the upper tributary, and those that isolate quality fish habitat. The best restoration sites also are far from other existing fish barriers.

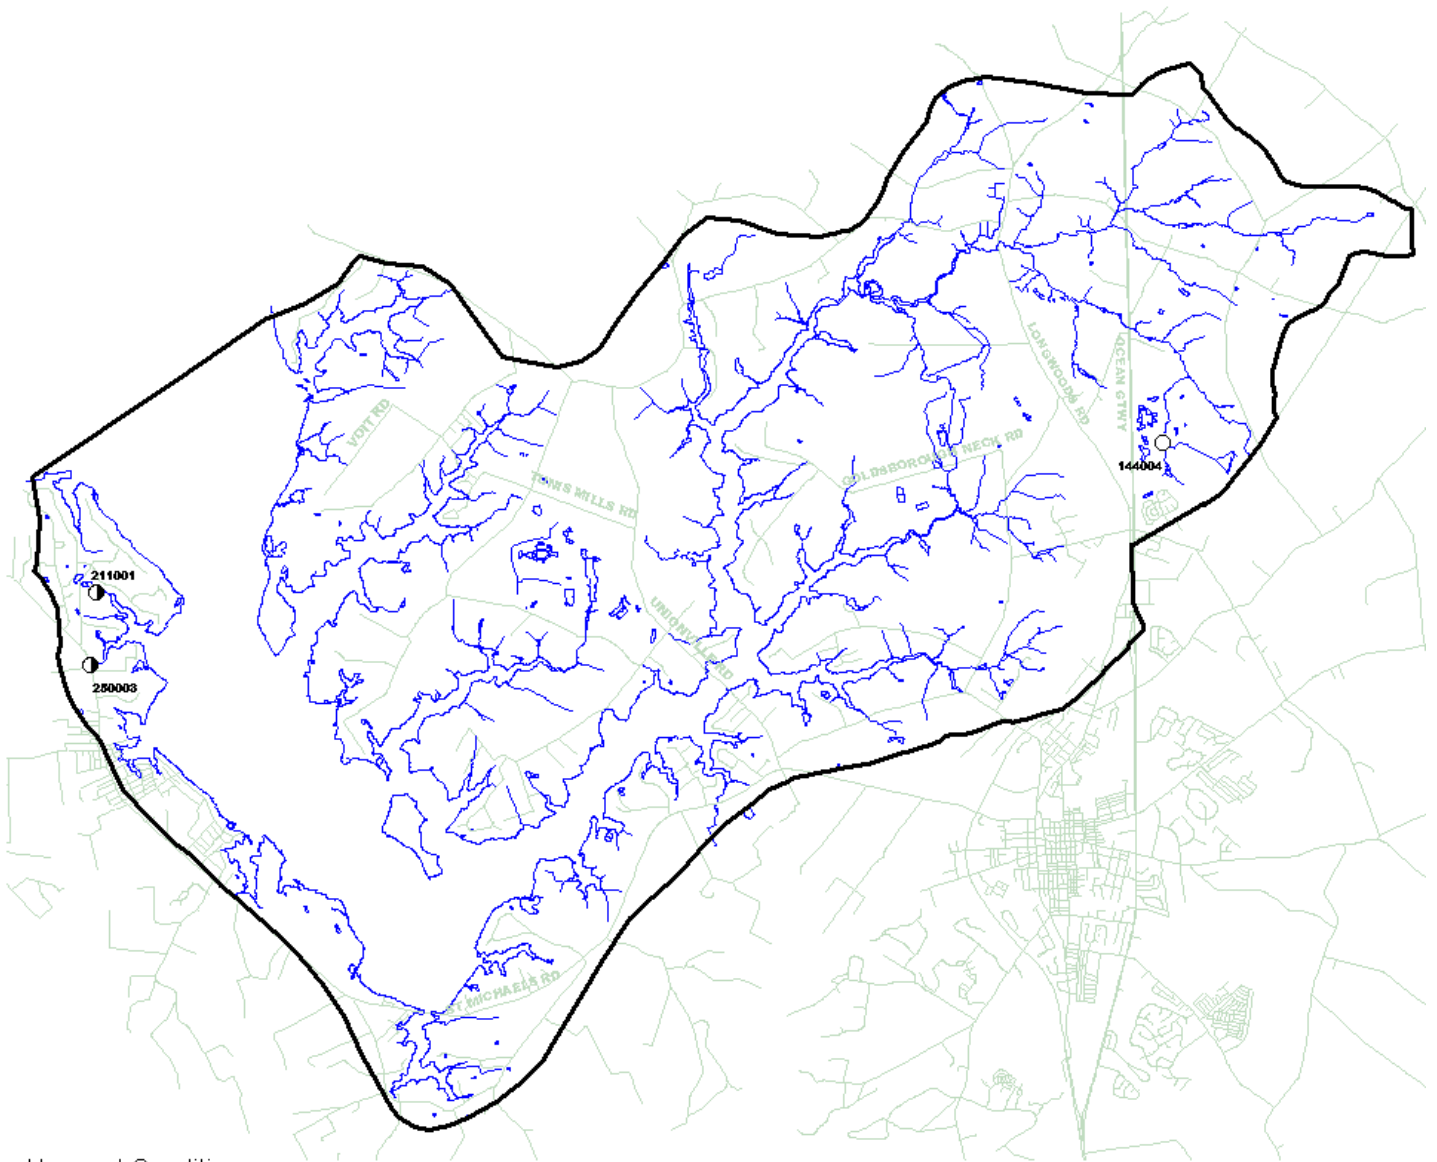
Figure 10: Map showing the locations of the Unusual Condition sites in the Miles River Watershed

The survey crew identified 3 unusual conditions throughout the Miles River watershed. The severity and location of unusual condition sites is shown in Figure 10. The three unusual conditions sites were excessive grass clippings in the stream, a pond covered in algae, and where rubber tubing was laid along side of the road.

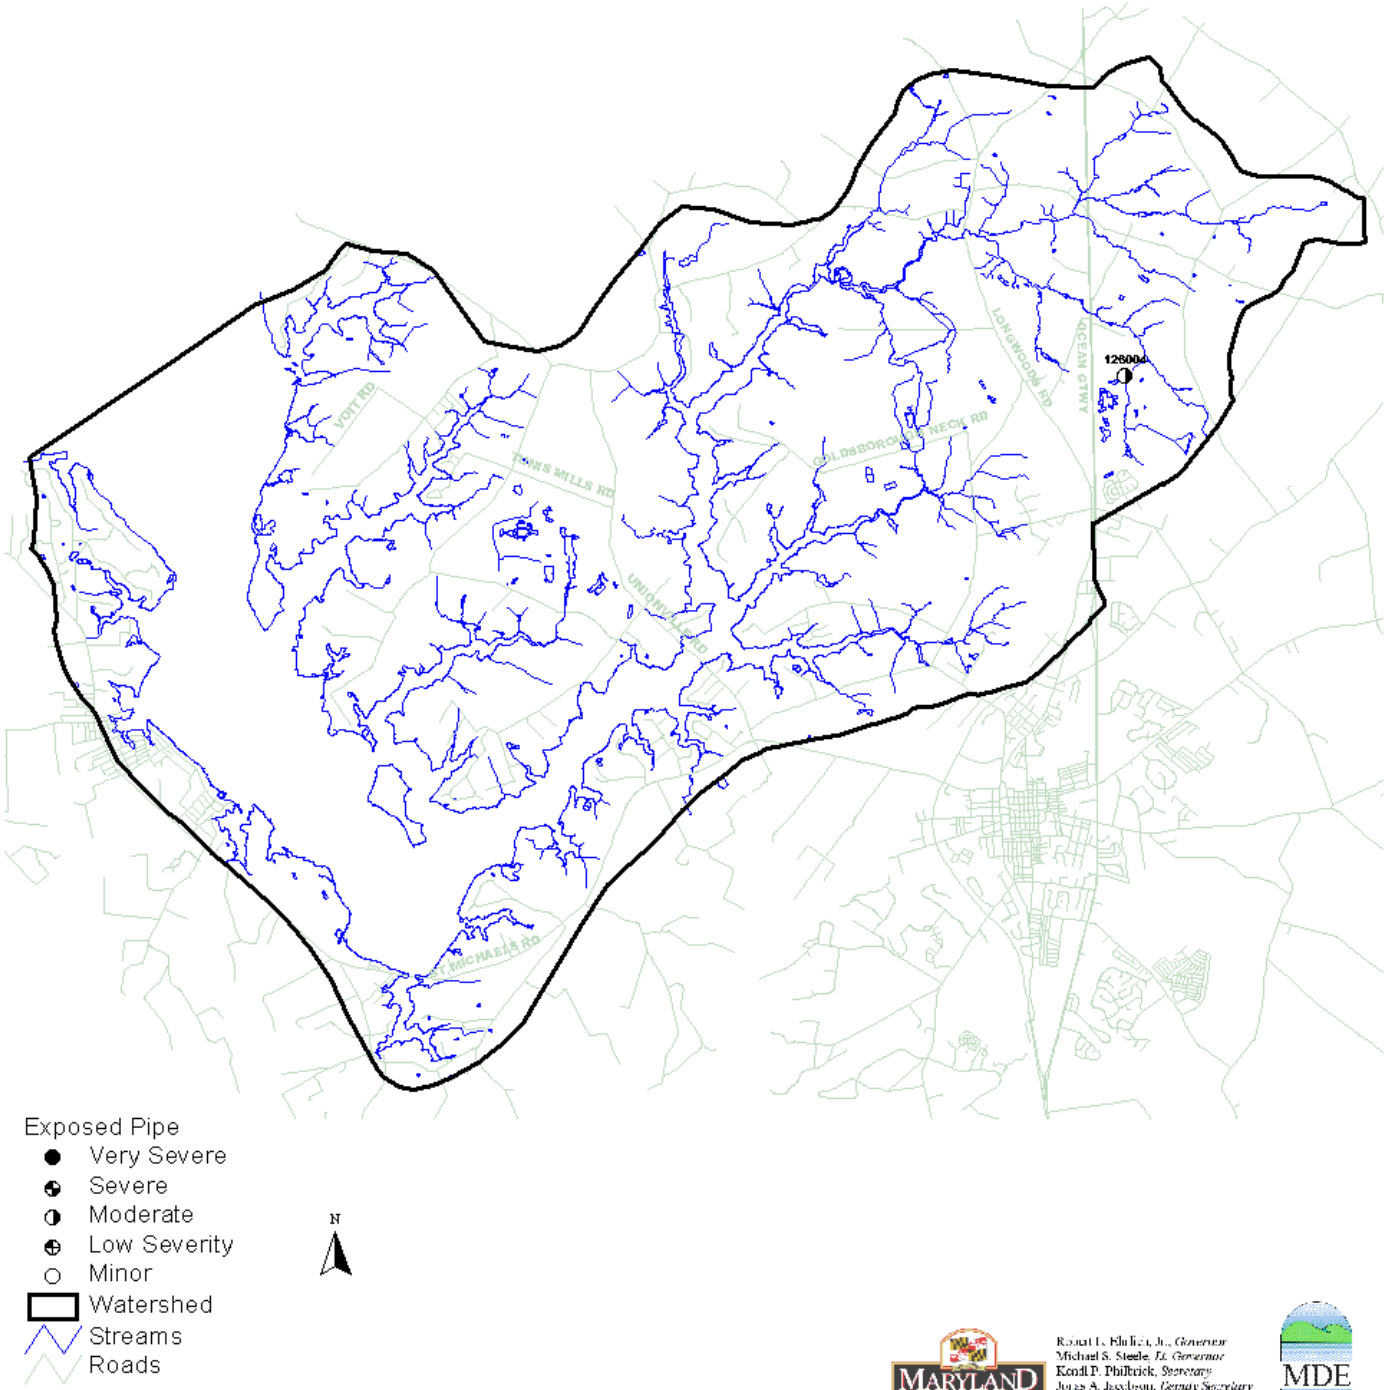
Figure 11: Map showing the location of the Exposed Pipe site in the Miles River Watershed

Field crews observed 1 exposed pipe during the survey. It was rated moderate. The pipe was rated as moderate because it is located along the stream bottom where it may be damaged by debris. It was reported not to have any discharge at the time of the survey. Location of the site is shown in Figure 11.
