**Stream Corridor Assessment Survey for the Prettyboy Reservoir Watershed,
Baltimore County, Maryland**

April 2006

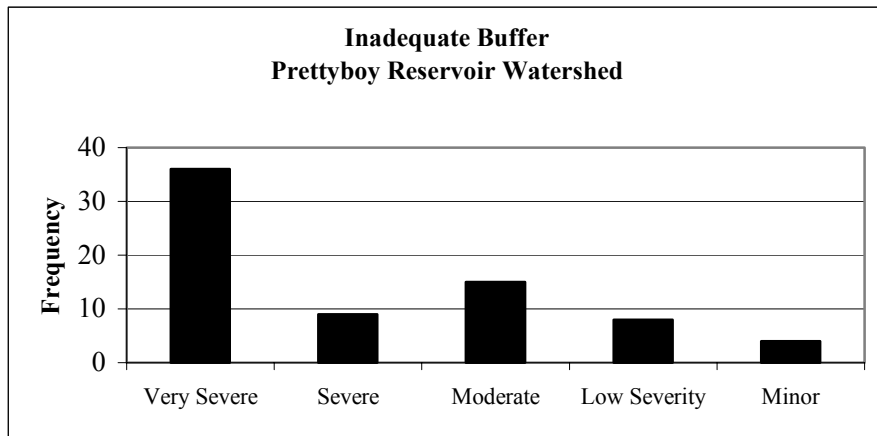
Survey crews identified 71 inadequate buffer sites with a total length of 144,500 feet (27.3 miles), or approximately 32 percent of the 85 miles streams surveyed. The severity and location of inadequate buffer sites is shown in Figure 4b. Forty-five of these sites are ranked as very severe or severe, while the other twenty-six sites are moderate, of low severity, or minor (Figure 4a). Land use along the stream at inadequate buffer sites, was found to be nearly equally distributed between cropfields, lawns, and pasture.

Figure 4a. Histogram showing the frequency of severity ratings given to inadequate buffer sites during the Prettyboy Reservoir SCA survey.

Any inadequate buffer site would benefit from the restoration of trees along both stream banks. For sites on agricultural land, farmers also may qualify for federal and state government financial incentives for allowing 50-foot forest buffers to grow on their farmland. Those sites that may have particular natural resource value are headwater streams, or those that form gaps in existing forested buffer areas.

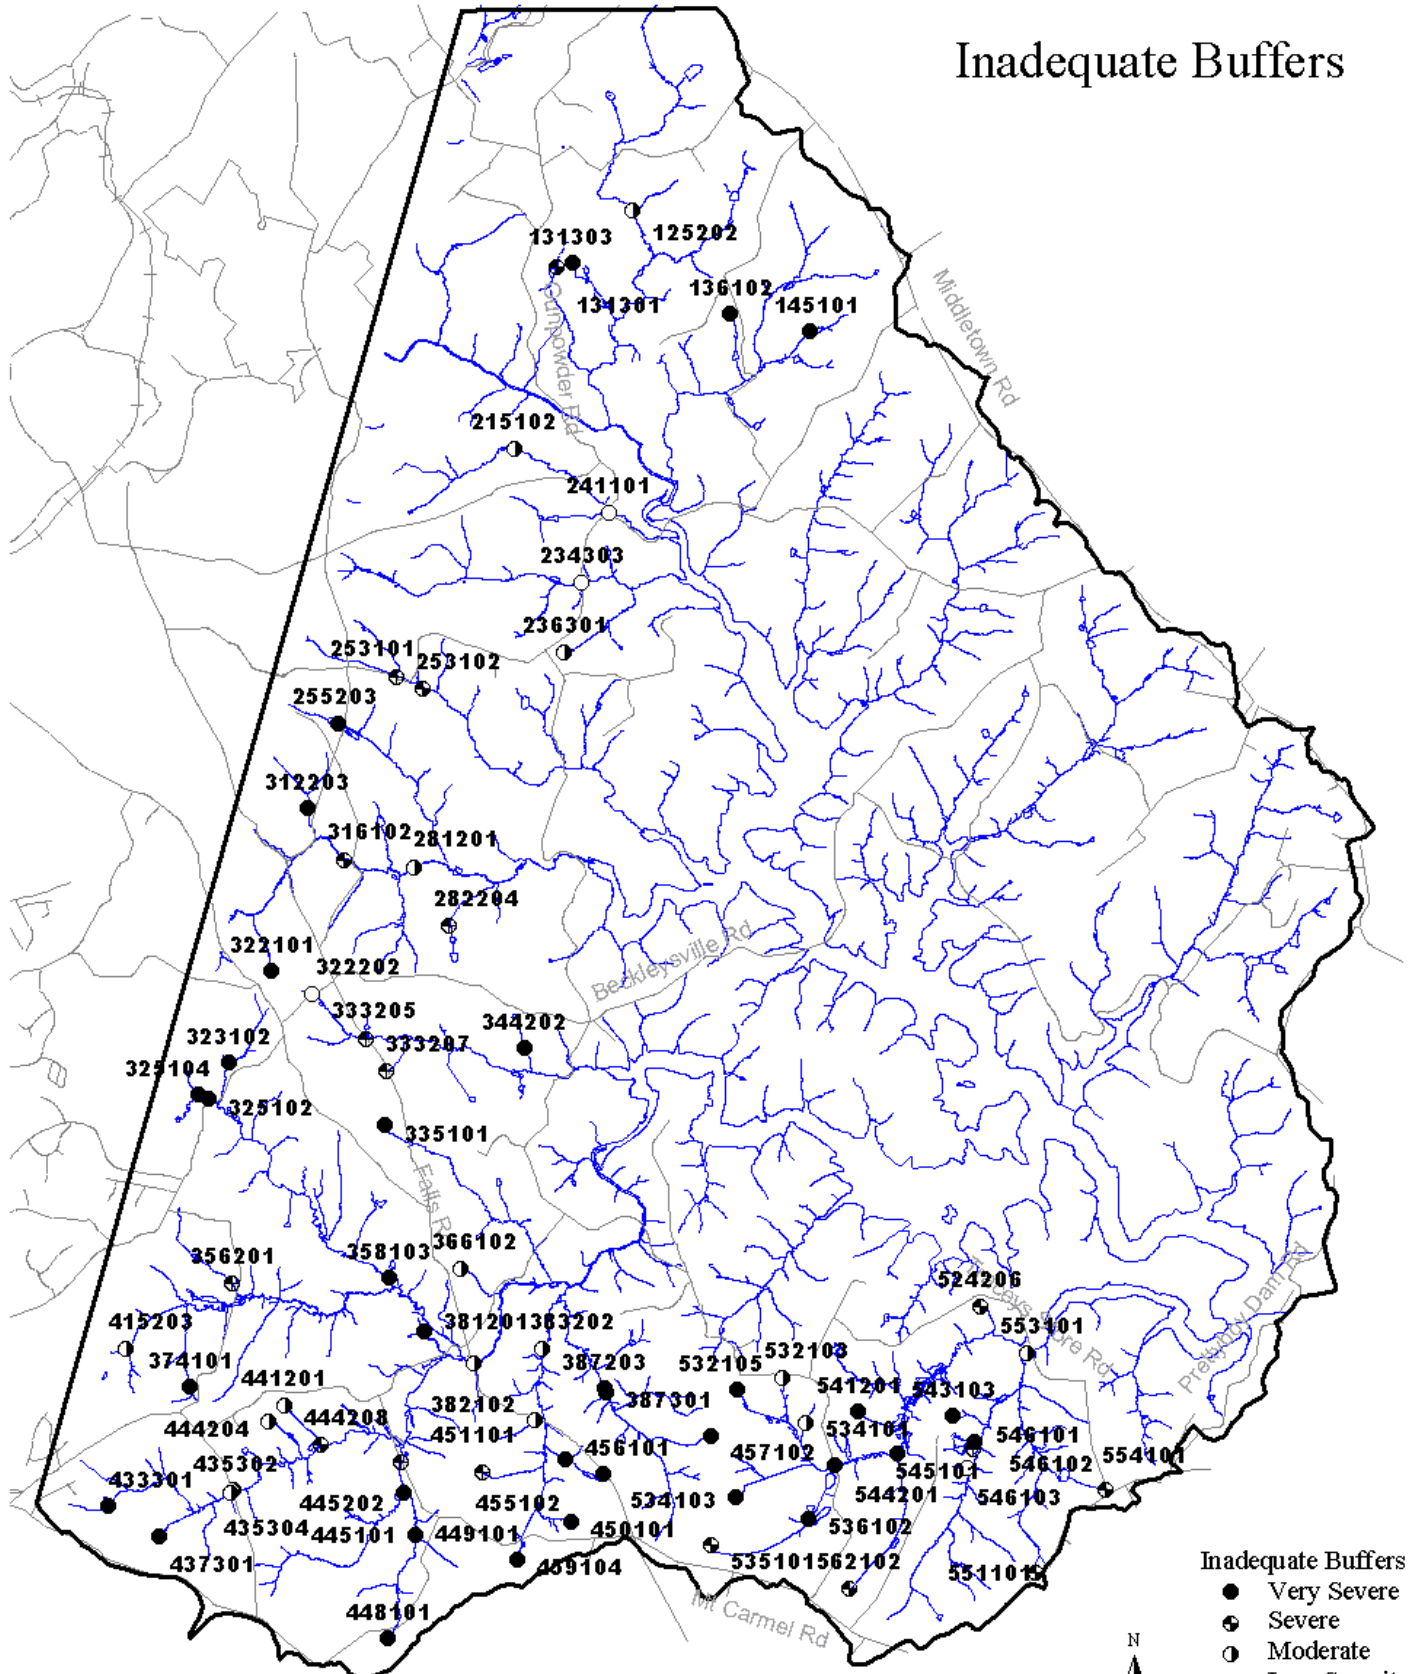
Figure 4b: Map showing the locations of the Inadequate Buffers in the Prettyboy Reservoir

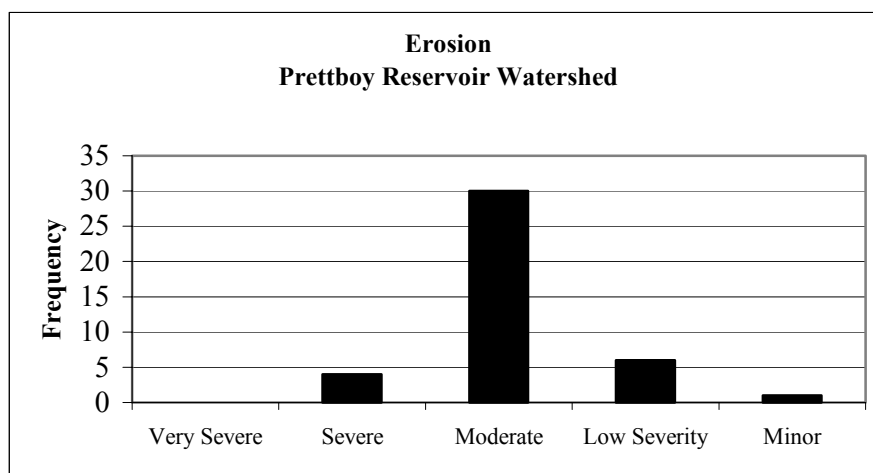
The SCA survey found 41 eroding stream banks over the length of 61,900 feet (11.7 miles) of stream, or about 14 percent of the 85 miles streams surveyed. The severity and location of erosion sites is shown in Figure 5b. Four of the sites are ranked as severe (Figure 5a). (Appendix B).

Figure 5a. Histogram showing the frequency of severity ratings given to erosion sites during the Prettyboy Reservoir SCA survey.

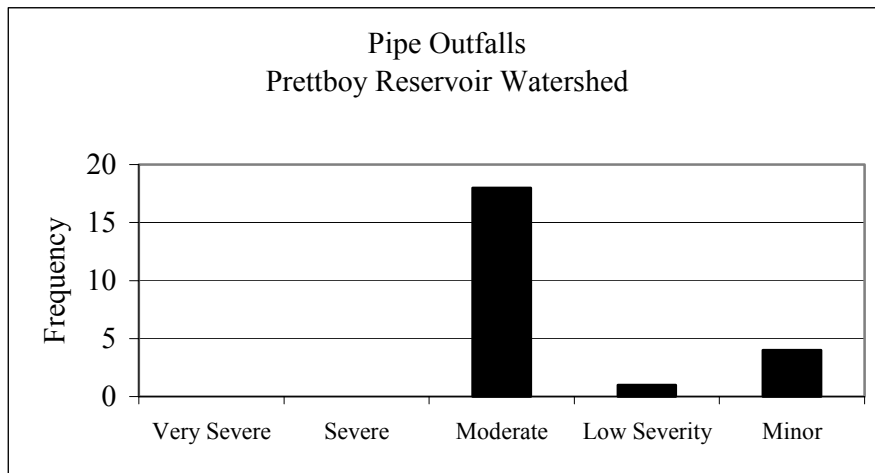
The survey crew identified a total of 23 pipe outfalls. The severity and location of pipe outfall sites is shown in Figure 6b. Eighteen of the pipes had a discharge. All except one pipe was reported to have a discharge of clear with no odor. The pipes were rated as moderate. The remaining pipes did not have any discharge. (Appendix B)

Figure 6a. Histogram showing the frequency of severity ratings given to pipe outfalls sites during the Prettboy Reservoir SCA survey.

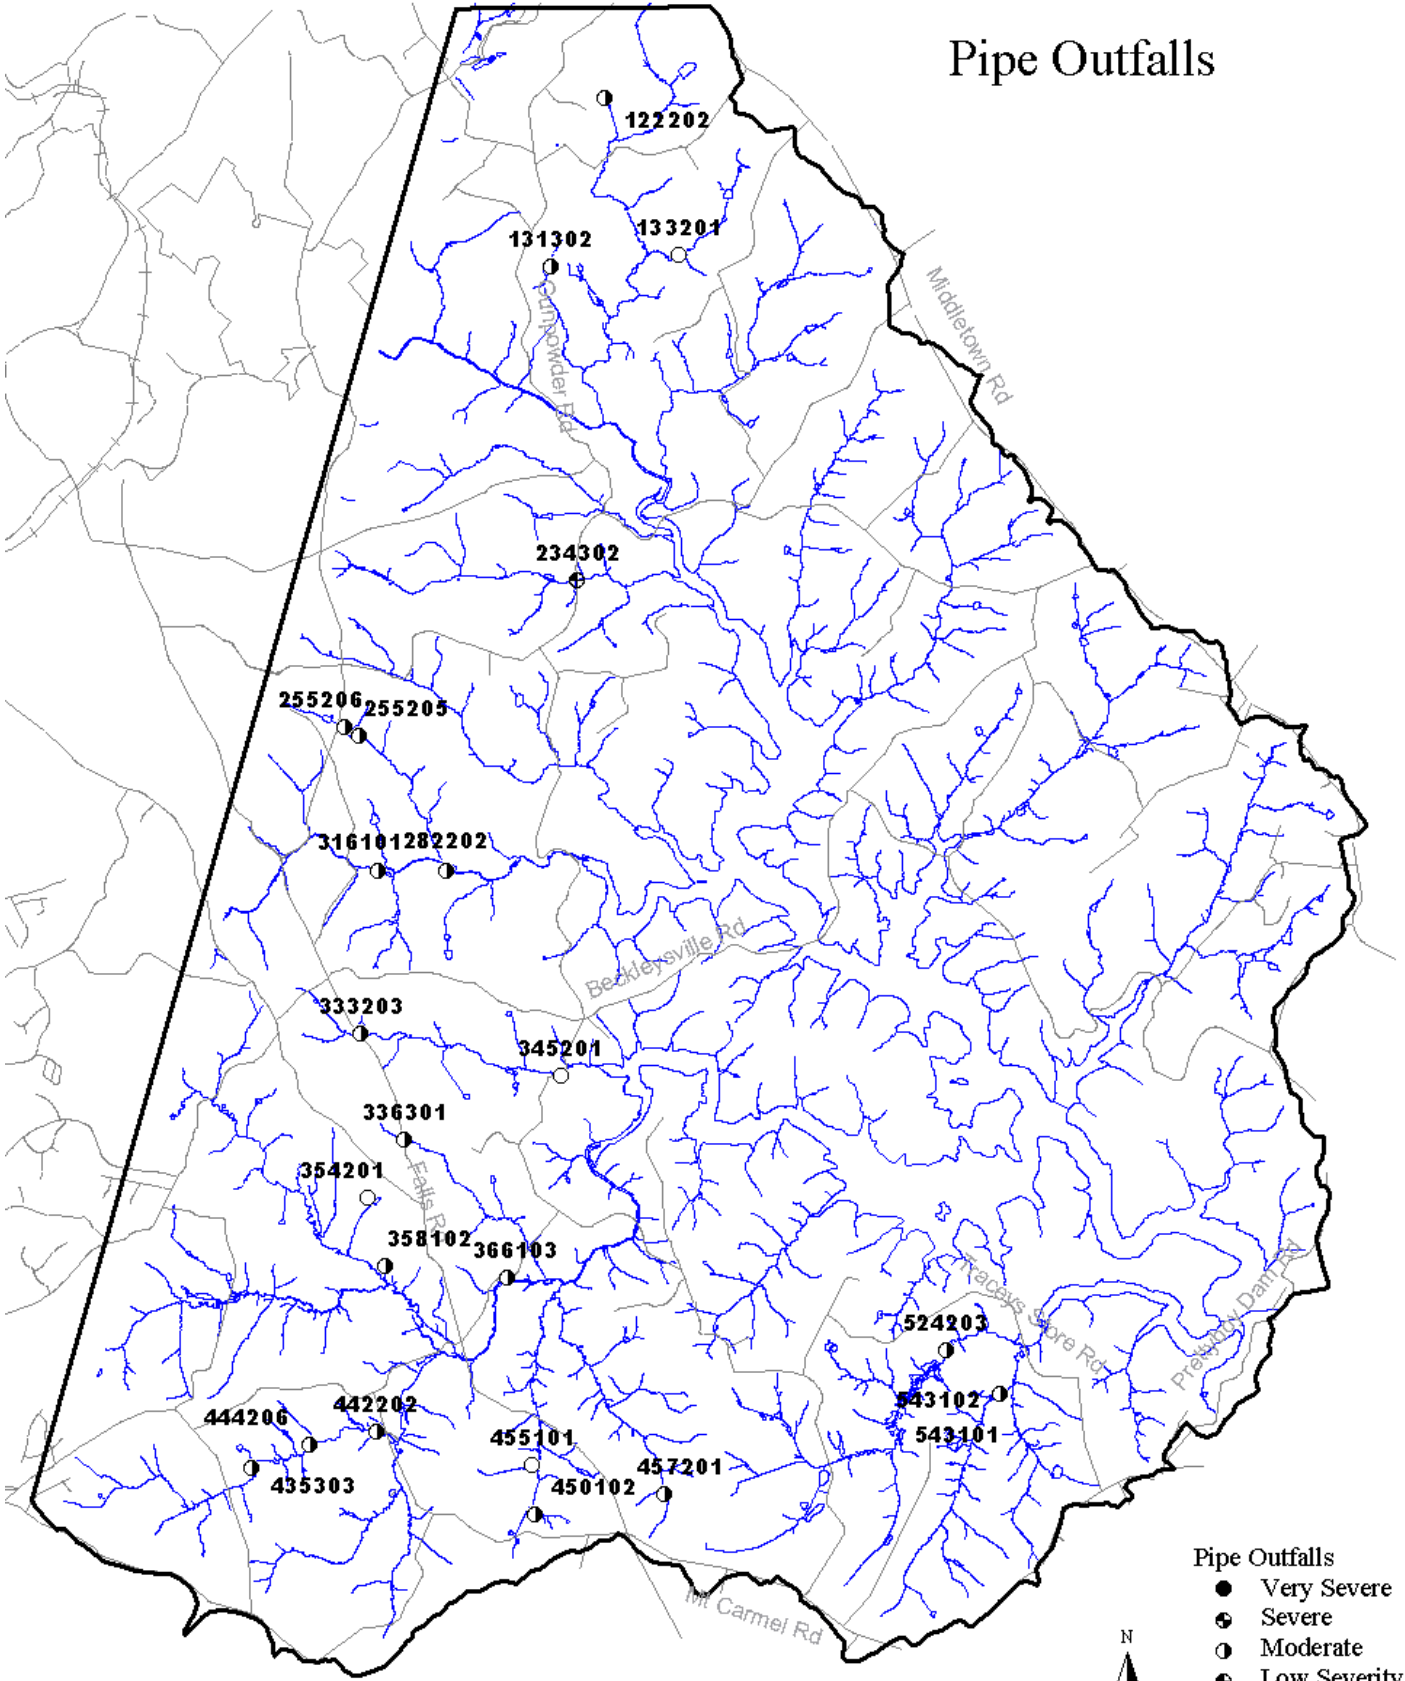
Figure 6b: Map showing the locations of the Pipe Outfalls in the Prettyboy Reservoir

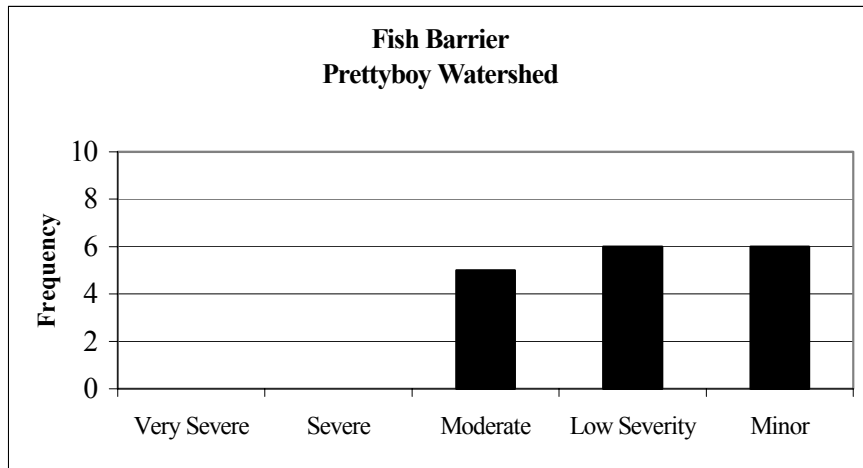
The Prettyboy Reservoir SCA survey found 17 fish migration barriers. The locations of fish blockages are shown in Figure 7b. Fish barriers in this watershed are due natural falls (2), road crossings (10), dams (2), and debris dams (2). Five of these sites received a moderate rating. They were all at road crossings.

Figure 7a. Histogram showing the frequency of severity ratings given to fish barrier sites during the Prettyboy Reservoir SCA survey.

In restoration work, priority is given to removing fish barriers that will yield access to the greatest quality and quantity of upstream habitat per dollar spent. The mainstem is ideally kept as barrier-free as possible, allowing anadromous fish to migrate to spawn and a source of fish species for tributaries in the event of a disturbance. Restoration planning includes targeting barriers for removal that isolate entire tributaries, those that isolate significant portions of the upper tributary, and those that isolate quality fish habitat. The best restoration sites also are far from other existing fish barriers.

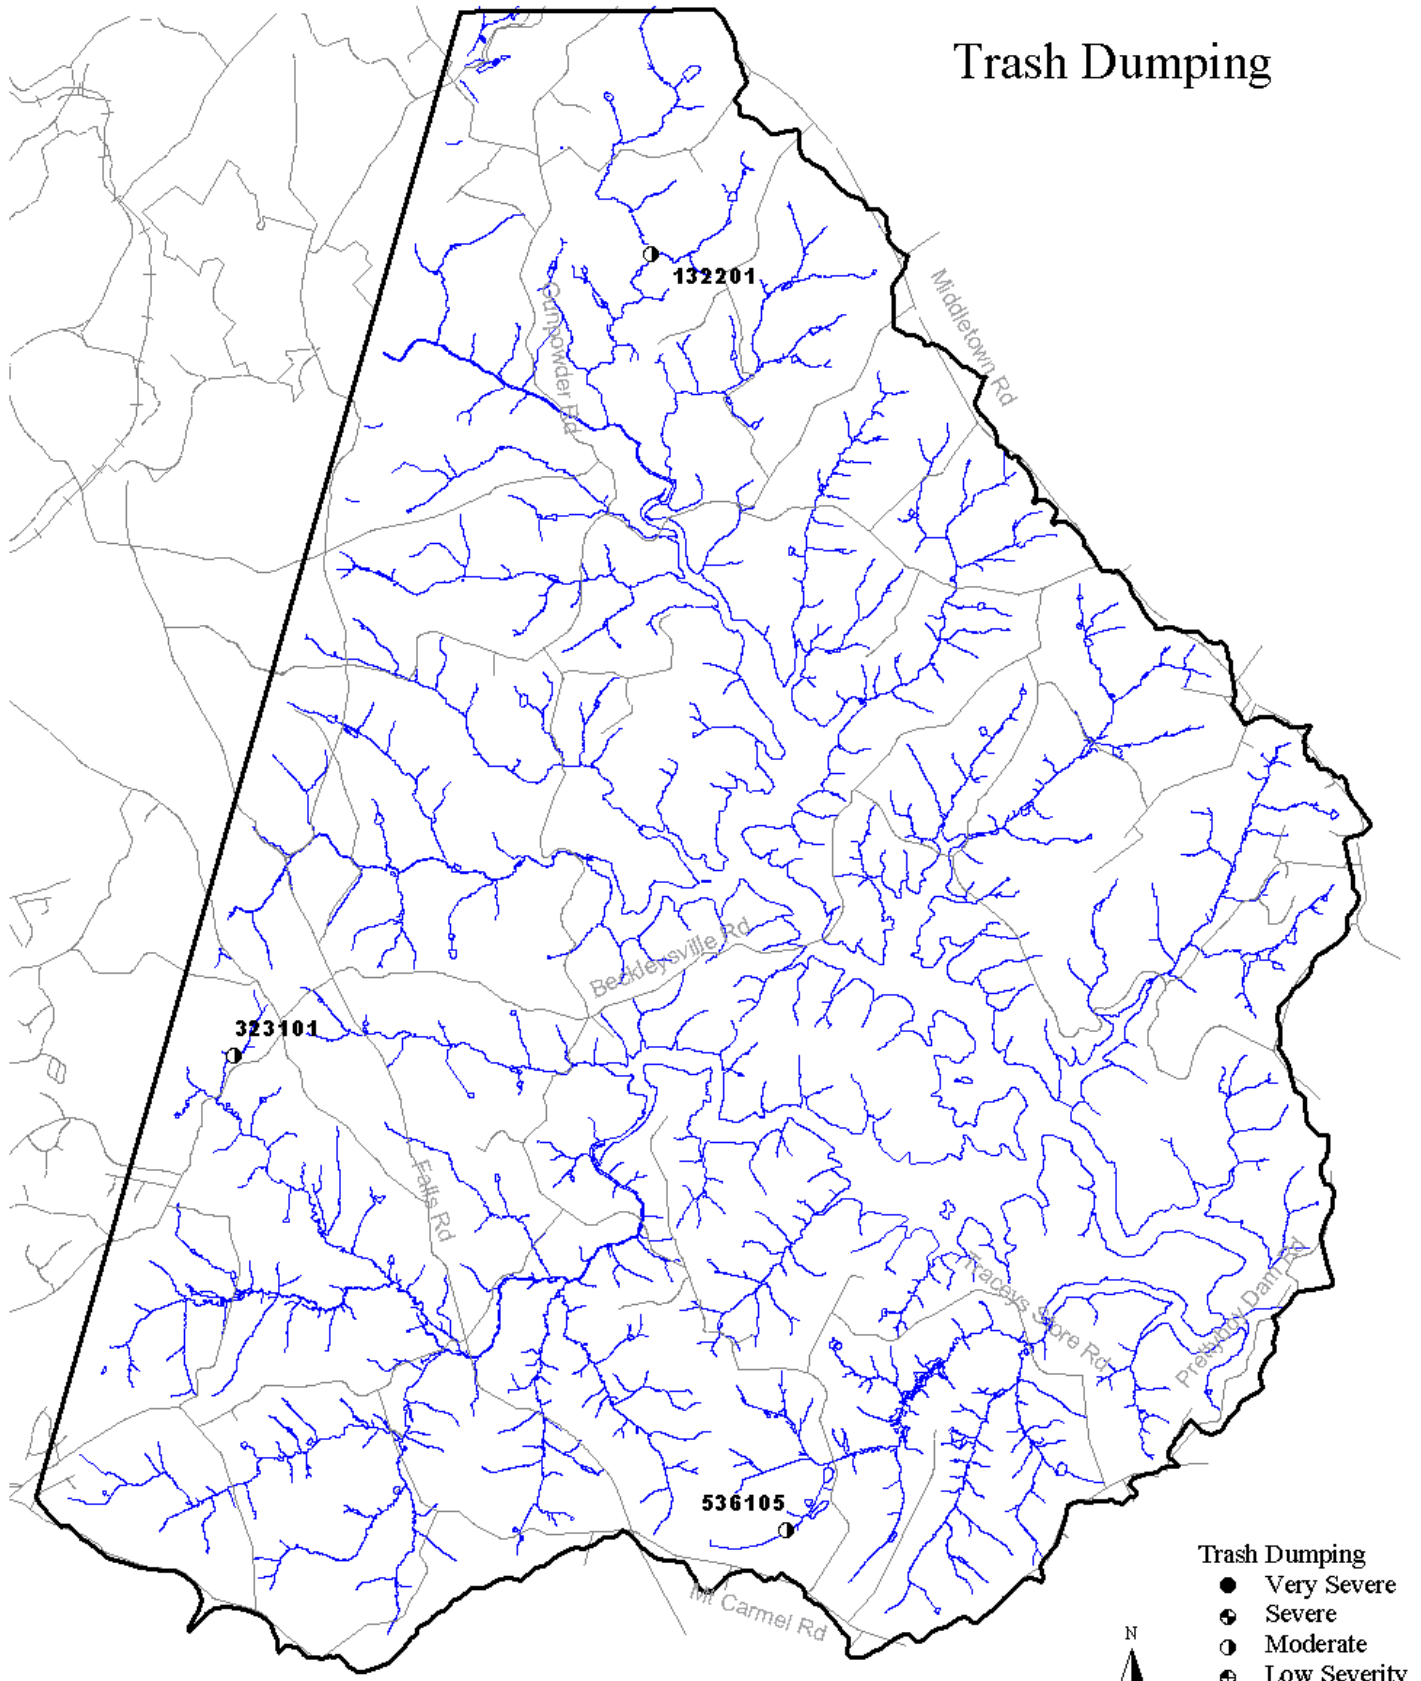
Survey crews found three trash dumping sites (Figure 9). Site 132201 was an area where vehicles and other trash had been dumped. Sites 323101 and 536105 were areas where residential trash had been dumped. All were given moderate severity ratings.

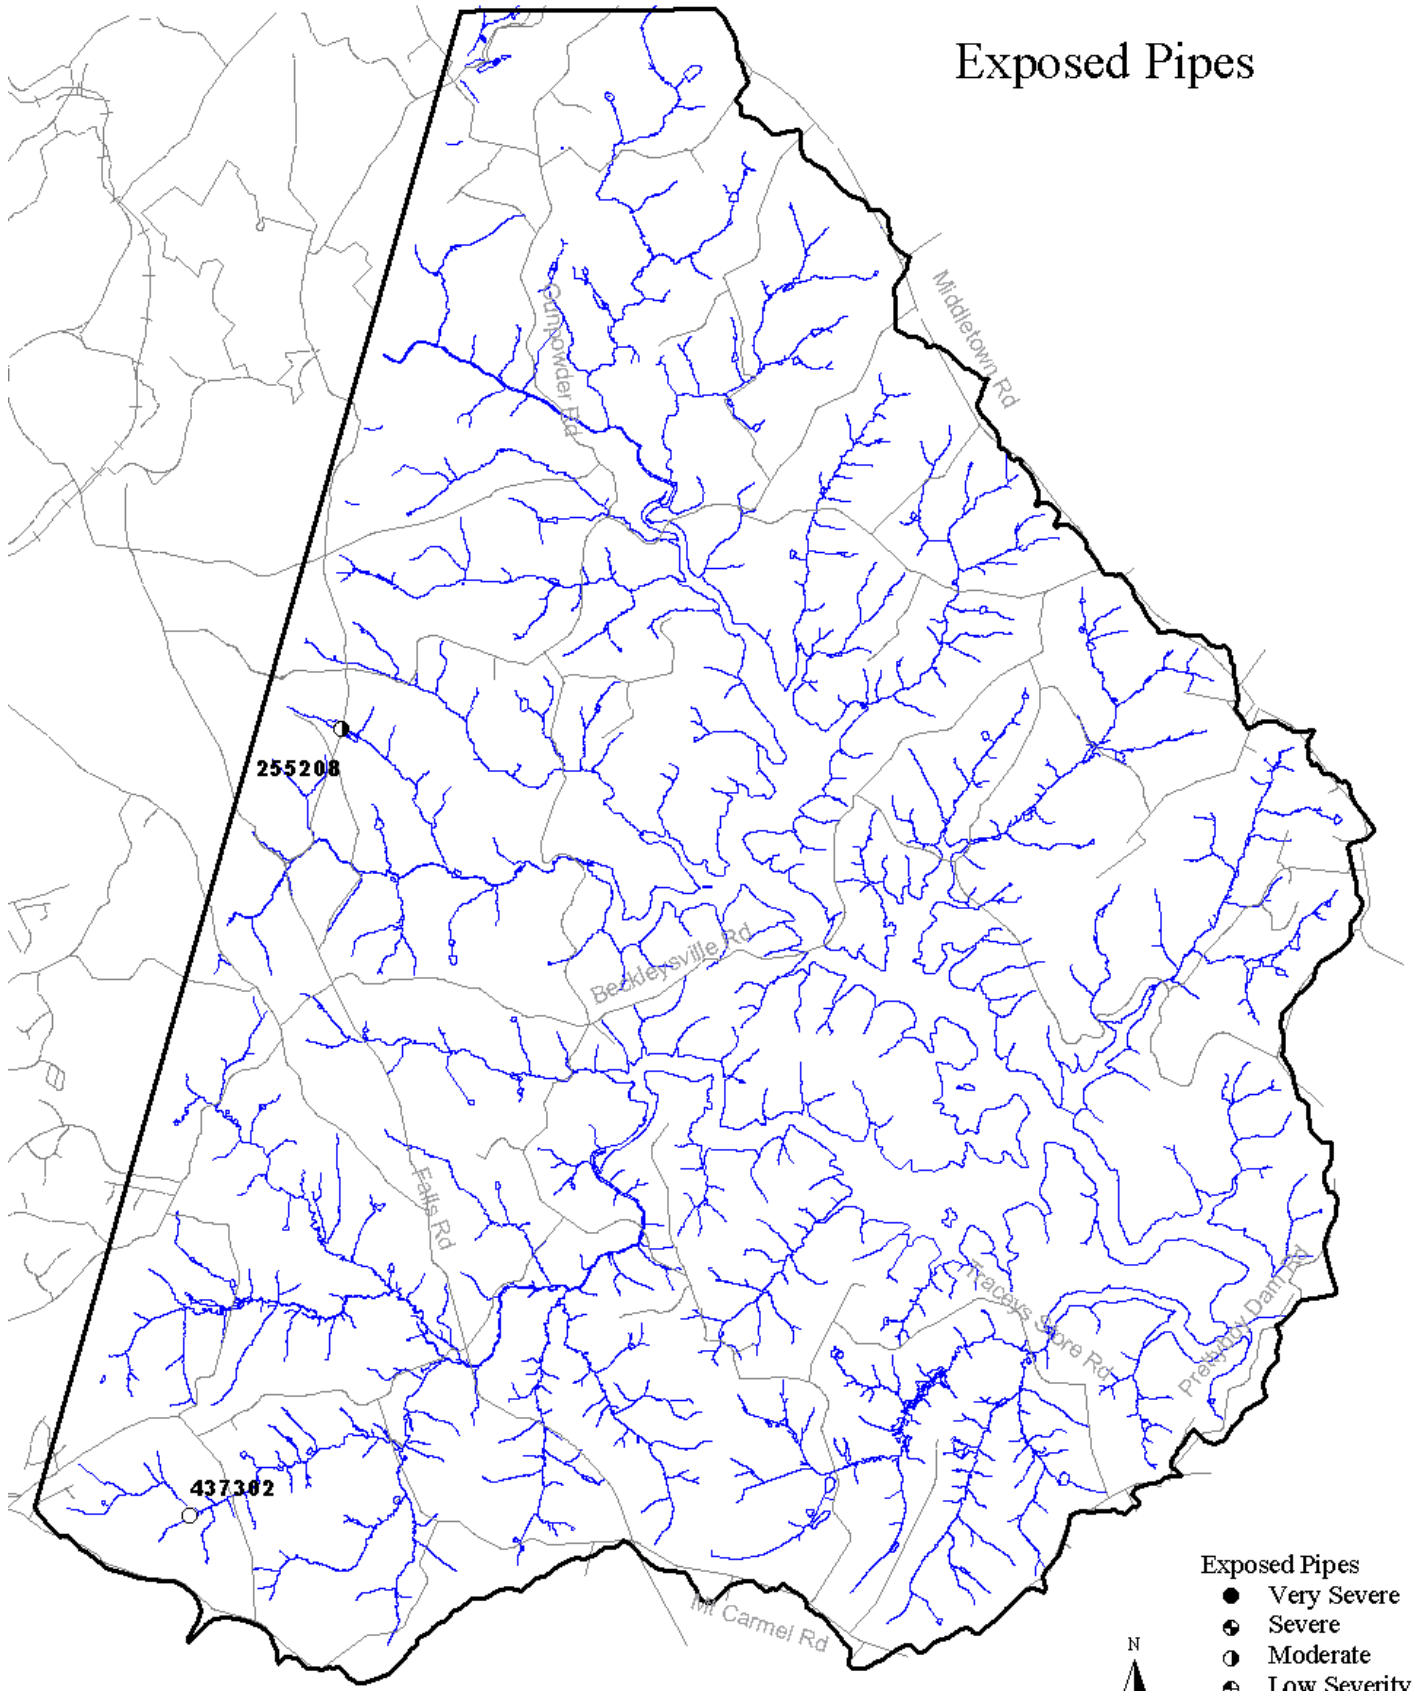
Field crews observed 2 exposed pipes during the survey. Site 255208 was rated moderate and site 437302 was rated minor in severity. A pipe will generally be rated as moderate because it is located along the stream or along the bottom where it may be damaged by debris. None of the pipes were reported to have any discharge at the time of the survey. Locations of these sites are shown in Figure 10.

Figure 10: Map showing the locations of the Exposed Pipes in the Prettyboy Reservoir

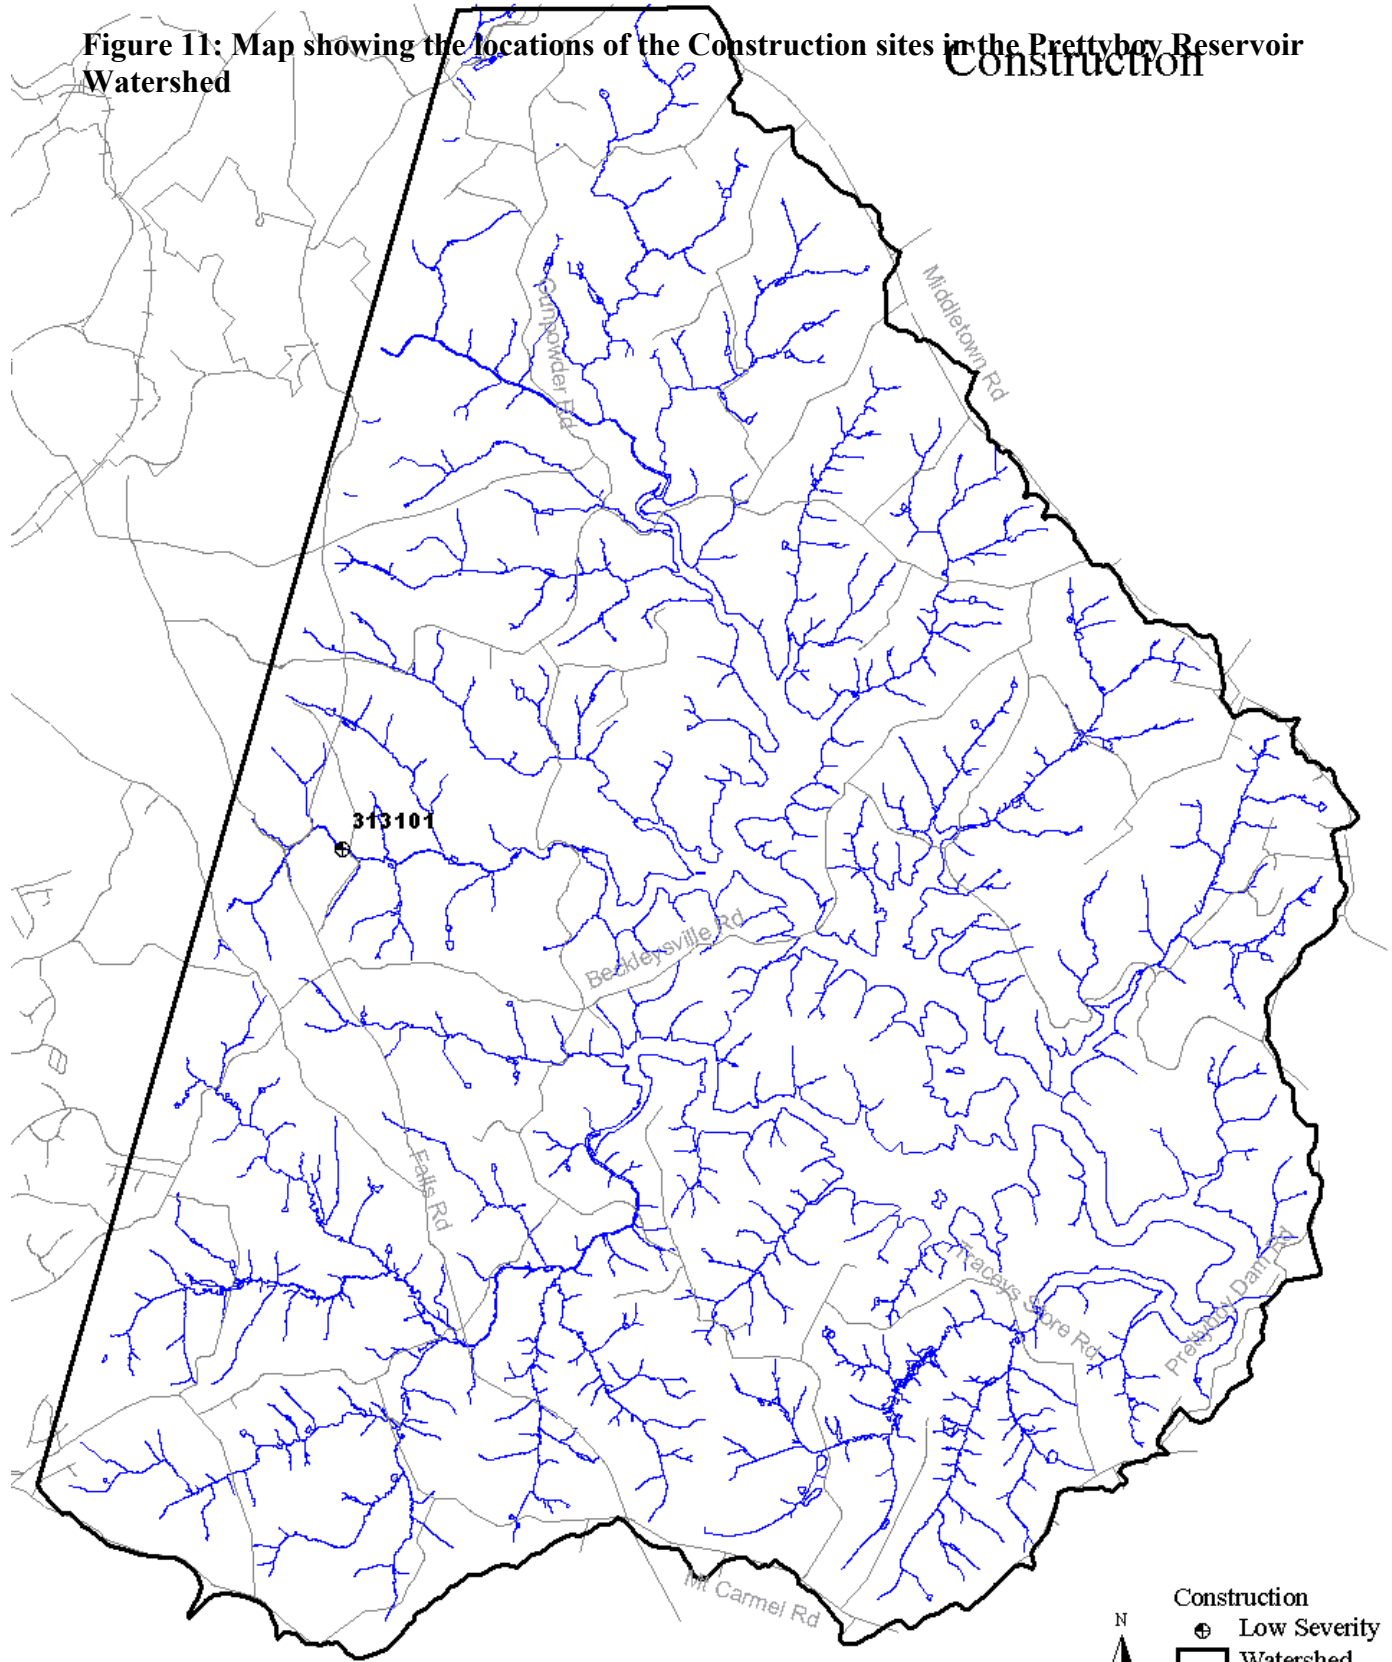
One construction site affected a nearby stream during the time of the survey. It appeared the site was part of road construction. (Appendix B). Location of in- or near-stream construction site is shown in Figure 11.

Figure 11: Map showing the location of the Construction site in the Prettyboy Reservoir

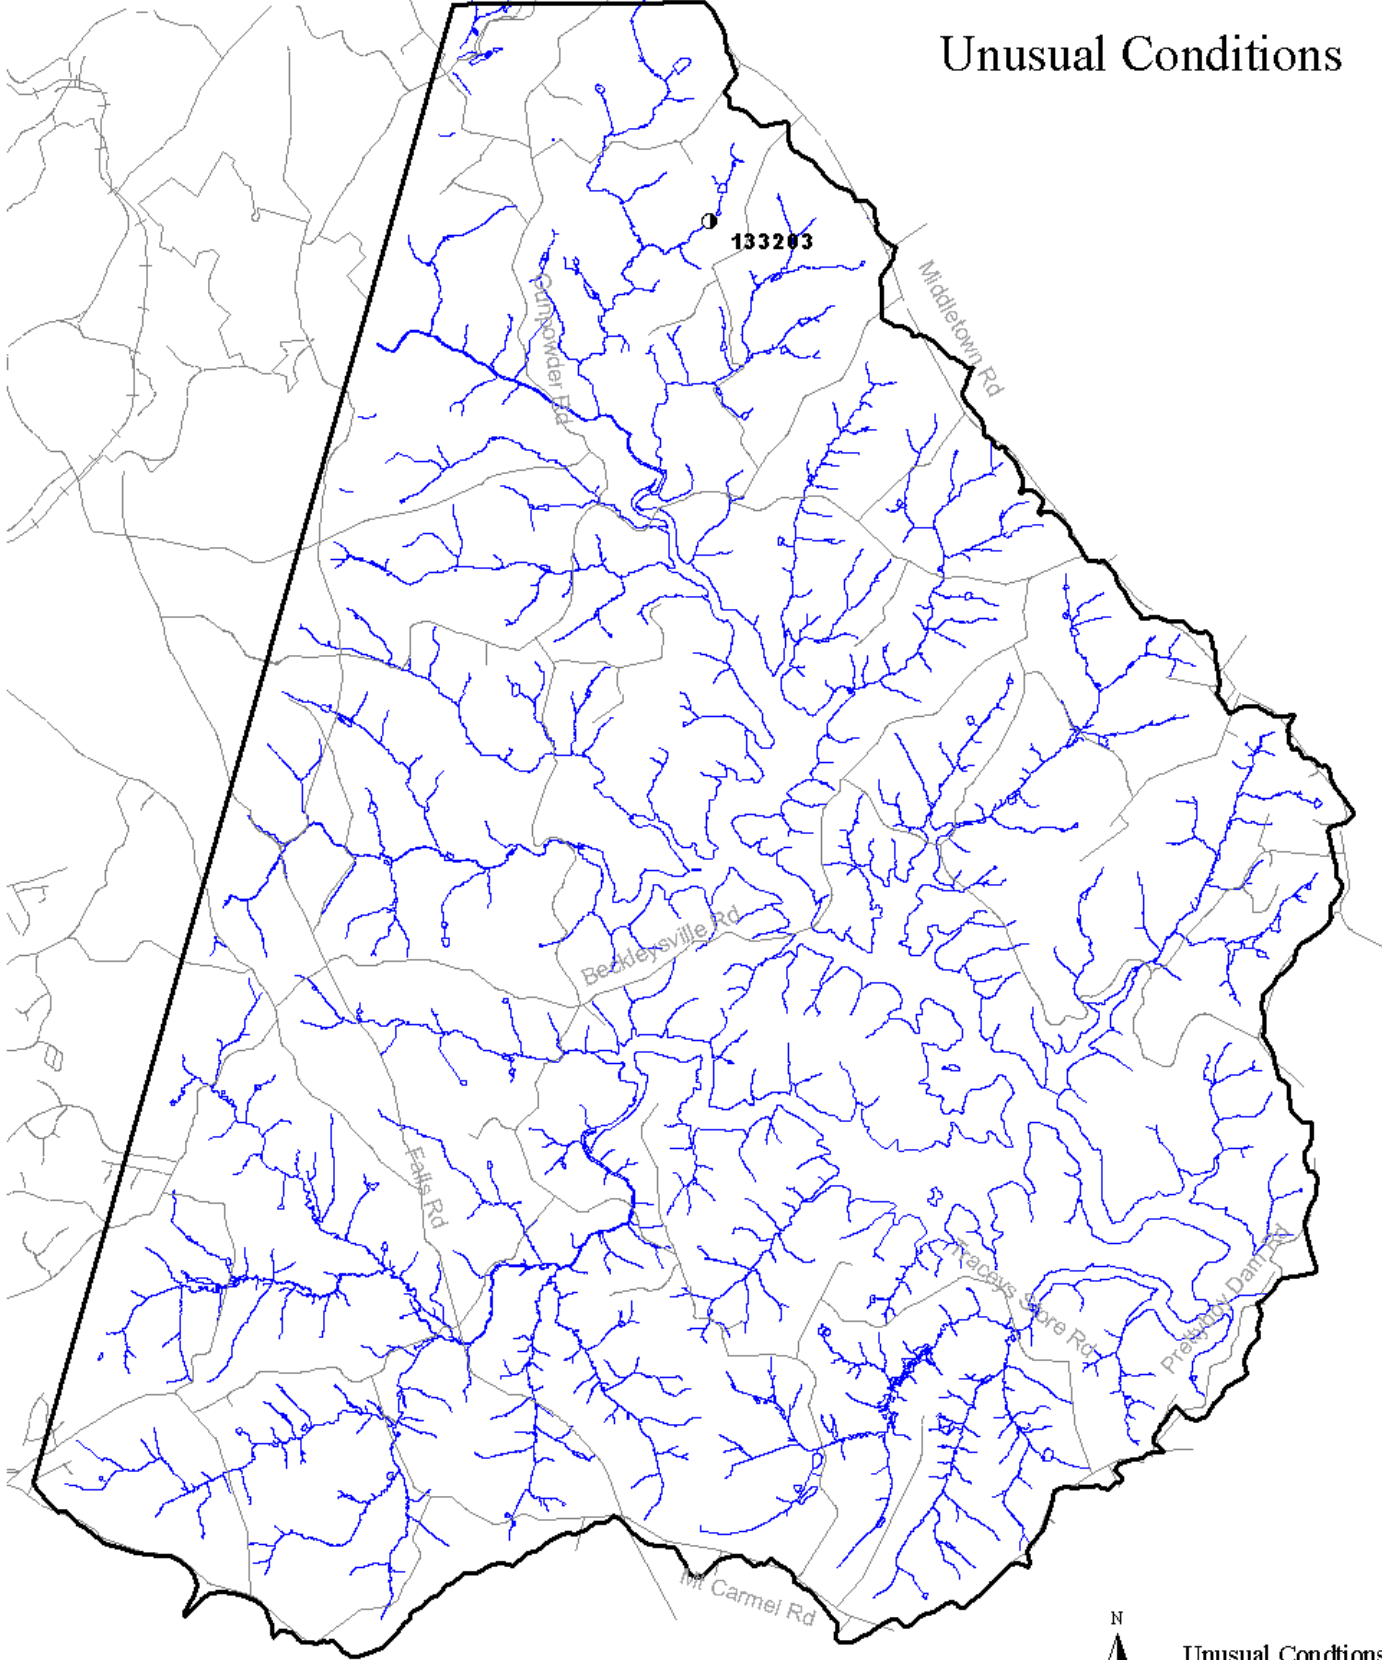
The survey crew identified 1 unusual condition and 3 comments throughout the Prettyboy Reservoir watershed. The severity and location of the unusual condition site is shown in Figure 12. Site 133203 was where livestock were found in the stream. This site was given a moderate severity rating.

Figure 12: Map showing the location of the Unusual Condition in the Prettyboy Reservoir
 5000 0 5000 Feet

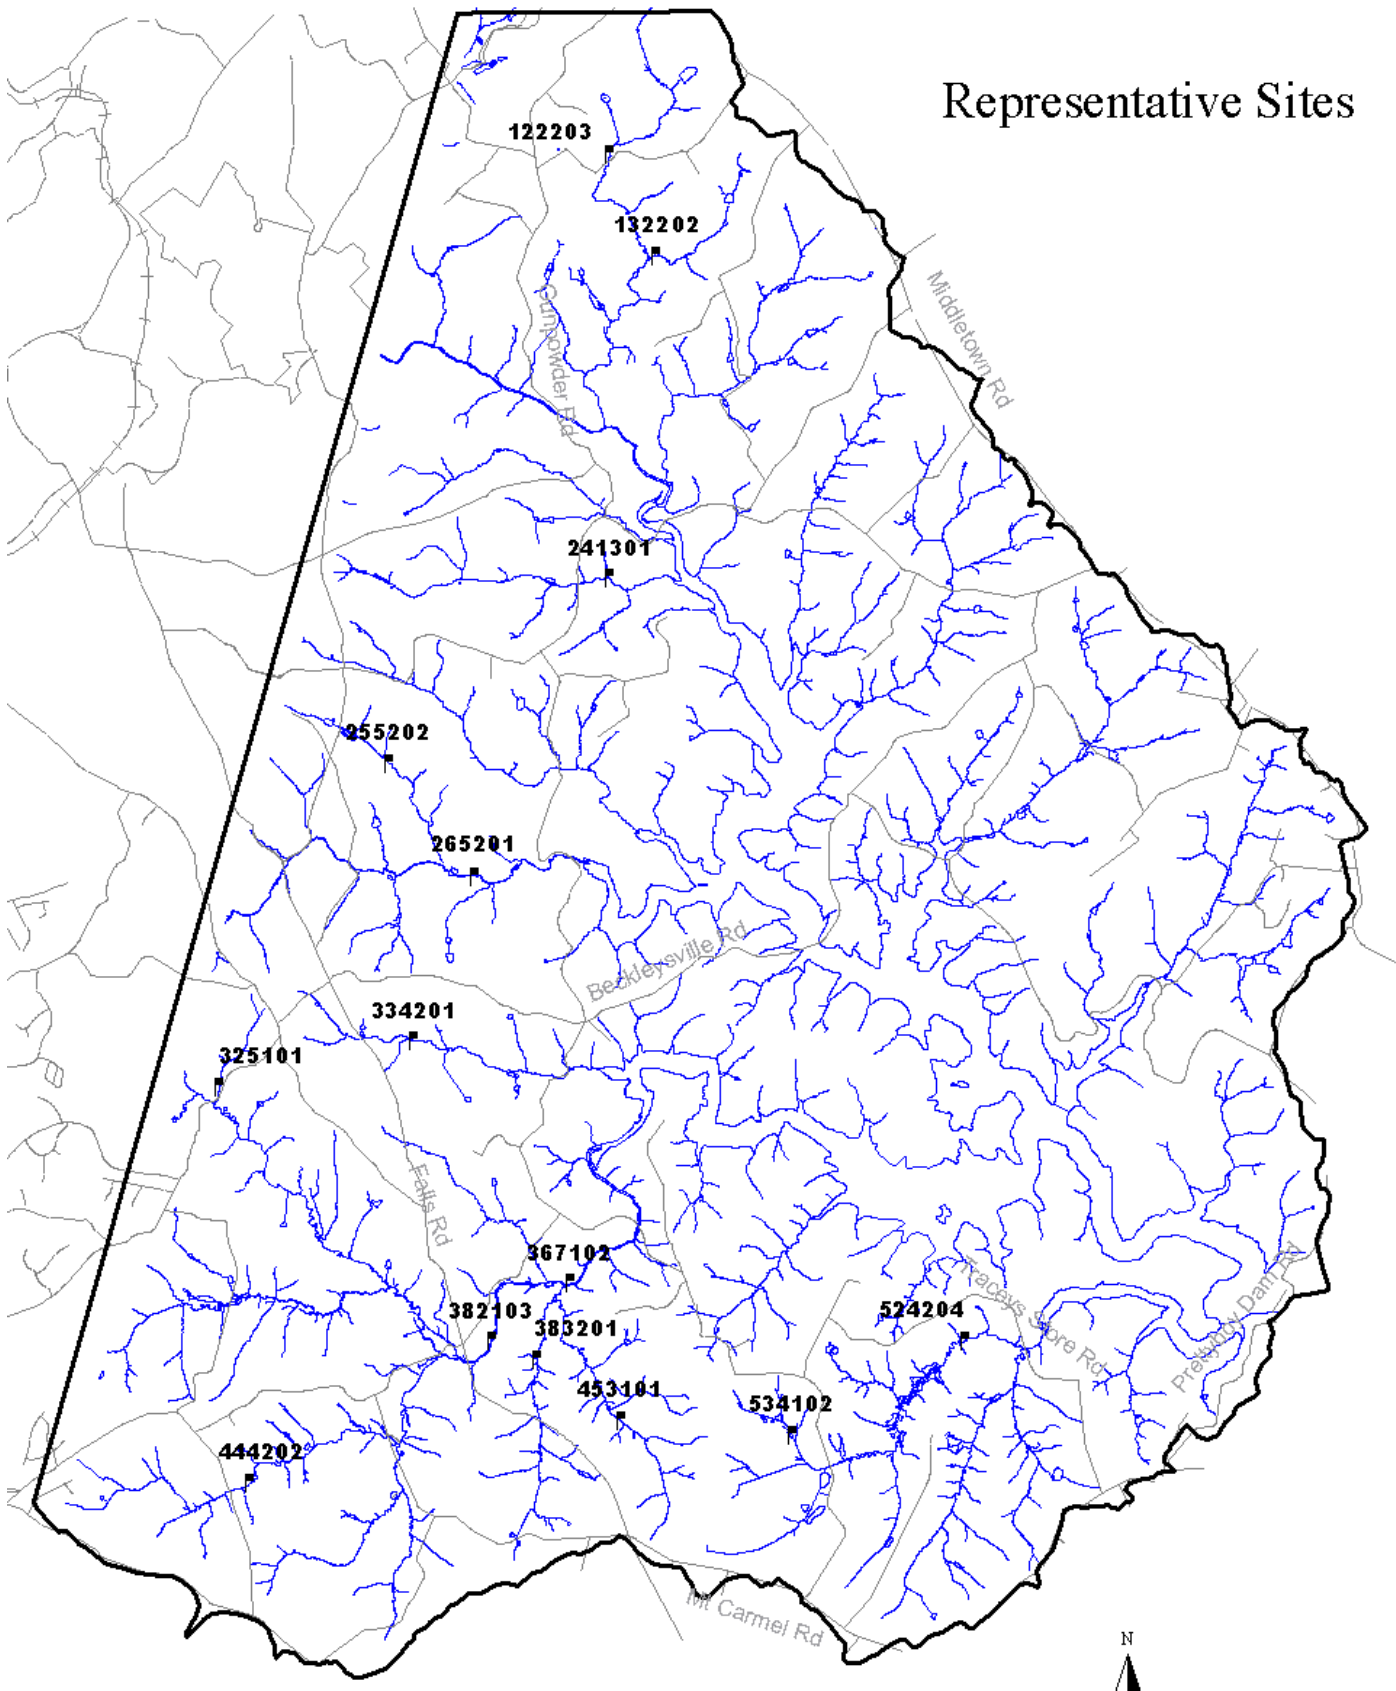
Attachment sites for macroinvertebrates rated mostly optimal or suboptimal. There were some gravel riffles for the macroinvertebrates. Embeddedness was averaged to be suboptimal. The bottom of the streams were mostly gravel with some silt. Shelter for fish varied from stream to stream. Channel Alteration rates the amount of man-made changes to the stream channel. A few of the representative sites indicate that there was some alteration to the channel. The channel had been altered at some point in the past and seems to be no longer maintained. There was some sediment deposition at the some of the representative sites but most were found to be optimal or suboptimal. The condition of the banks were rated to be mostly optimal or suboptimal. There were a few areas of erosion but these were small. For riparian vegetative zone width the sites were rated to be mostly optimal or suboptimal. This indicates in the spots where the representative sites were, the areas were forested. There was one area where the rating was poor. (Appendix B)

Figure 13: Map showing the locations of the Representative Sites in the Prettyboy Reservoir
