**UPS4—Unnamed Tributary to the Patuxent River.**

**UPS6—Unnamed Tributary to the Patuxent River.**

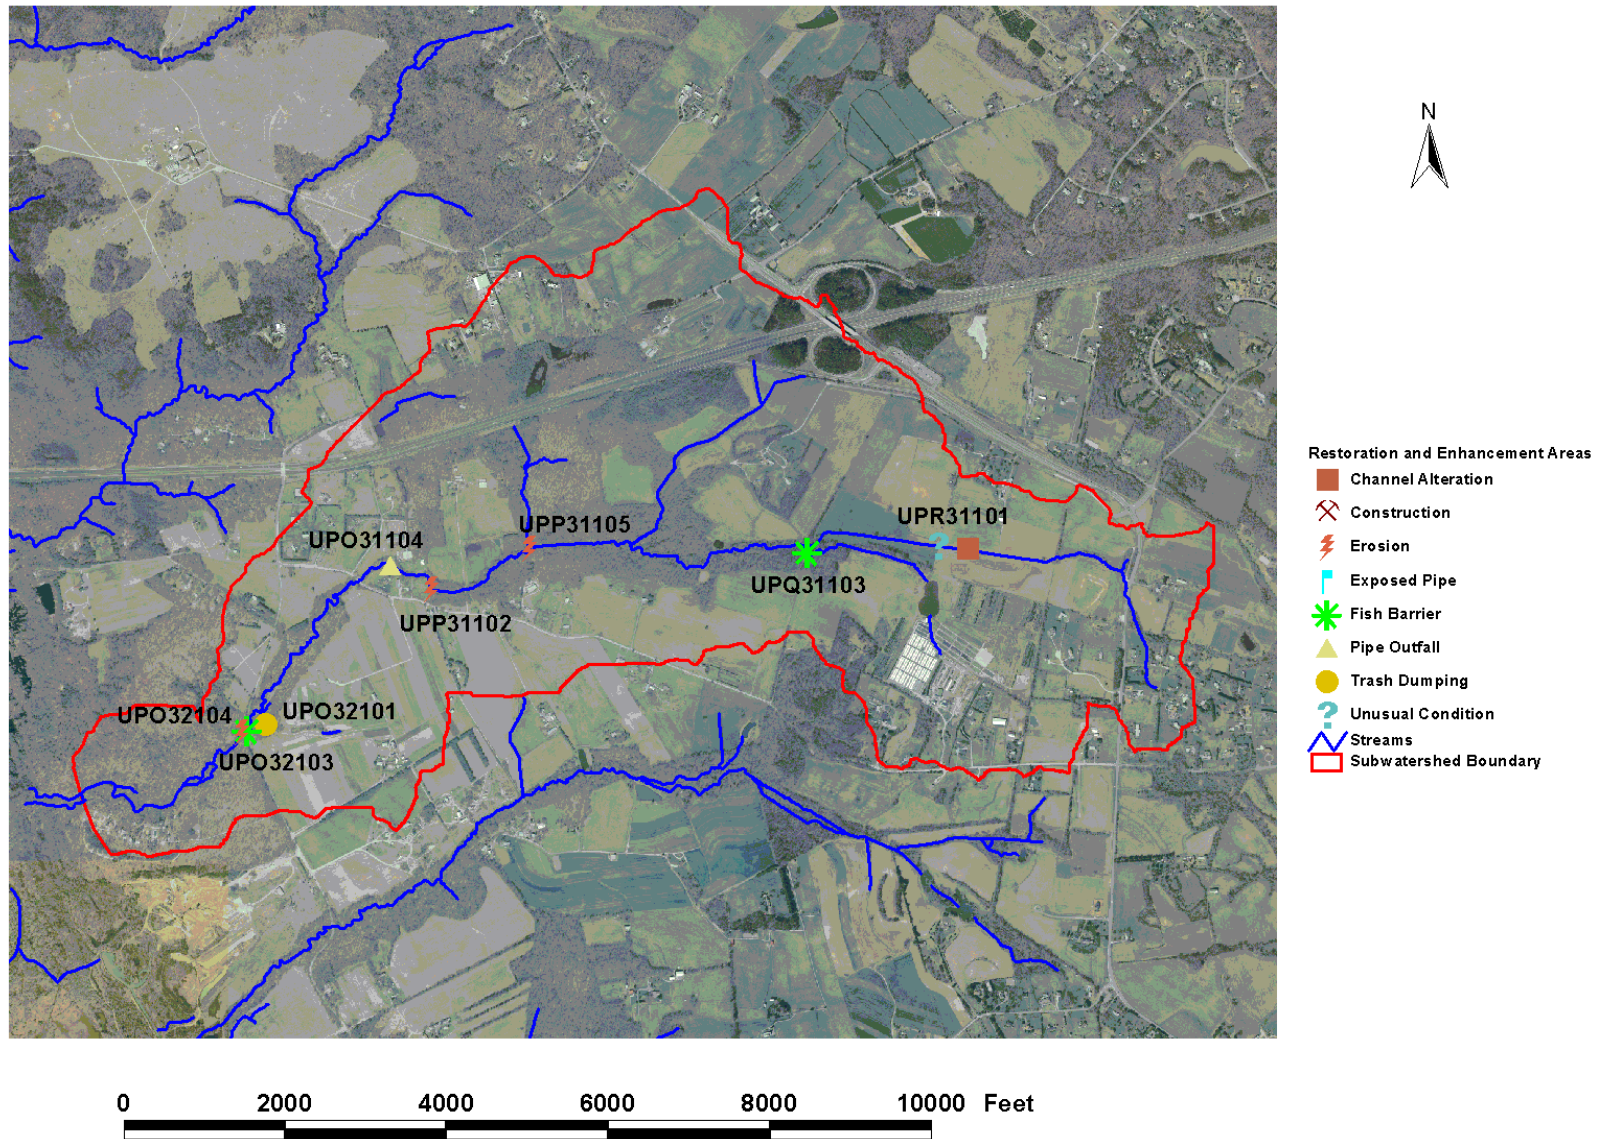
Figure 18. Potential restoration sites in UPS4.

SCA Site Number	Project Type	Project Description	Subwatershed Priority Ranking	Notes
UPQ31103	FB	Perched road crossing	1	The blockage is downstream of 2200' of highly altered reach. Appears to be headwaters converted to agricultural drainage. These projects should be done in tandem. Further investigation needed to determine project feasibility
UPR31101	CA/UC	In-stream pond removal/retrofit, riparian area restoration	1	
UPO31104	PO	18-inch pipe from agricultural area.	3	Rotten egg smell observed in discharge. Water quality investigation should be performed.
UPO32103	FB	Severely perched culvert road crossing	3	Crossing under Patuxent River Road. Erosion downstream of culvert. Projects should be done concurrently. Additional diagnostic study needed for design.
UPO32104	ES	10 feet high, 300 feet long eroding bank	3	
UPO32101	TD	Extensive dump comprised of residential and industrial trash	6	Professional clean-up suggested due to nature, extent of trash.

UPP31102	ES	4 feet high, 2200 feet long eroding bank	7	These projects are in close proximity to each other and downstream of UPR31101. Additional study necessary to determine cause of instability.
UPP31105	ES	4 feet high, 2500 feet long eroding bank	7

Figure 18 and Table 26 denote specific restoration or enhancement projects for this subwatershed. For projects UPO32103 and UPO32104, UPQ31103 and UPR31101, and UPP31102 and UPP31105, there are likely linkages between erosion and other channel disturbances. Consequently, these projects should be combined for future diagnostic work necessary to support restoration designs for these problem reaches.
