UPS9—Stocketts Run.

UPS10—Unnamed Tributary to Patuxent River.

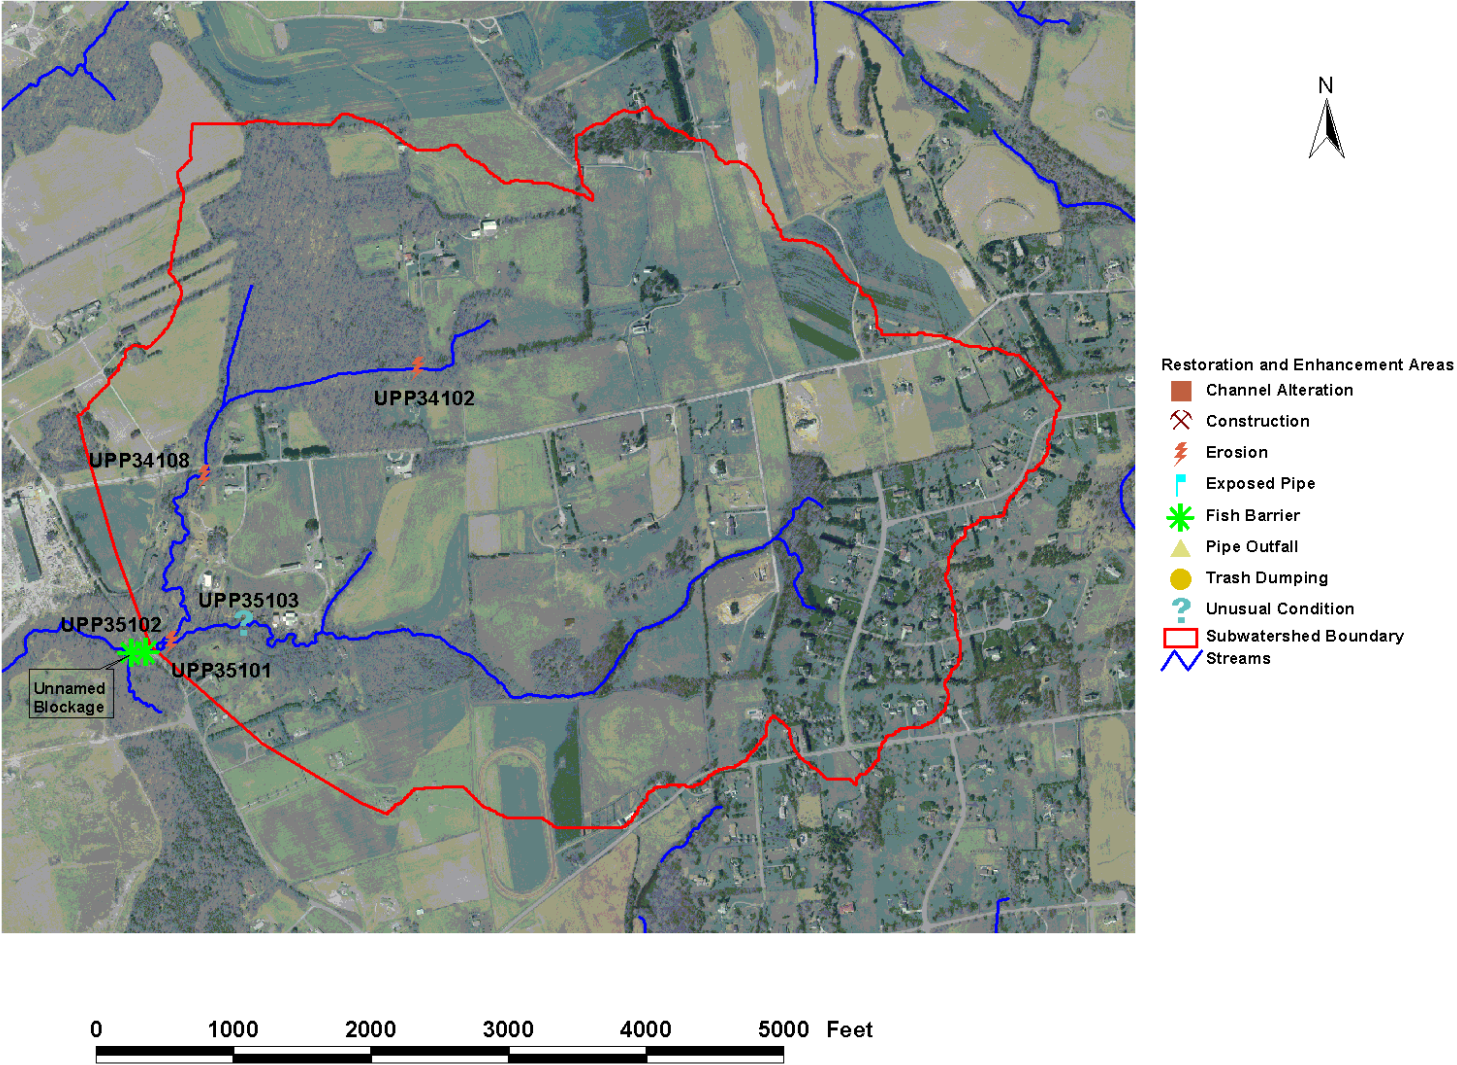
Figure 20. Location of potential priority restoration sites in UPS6.

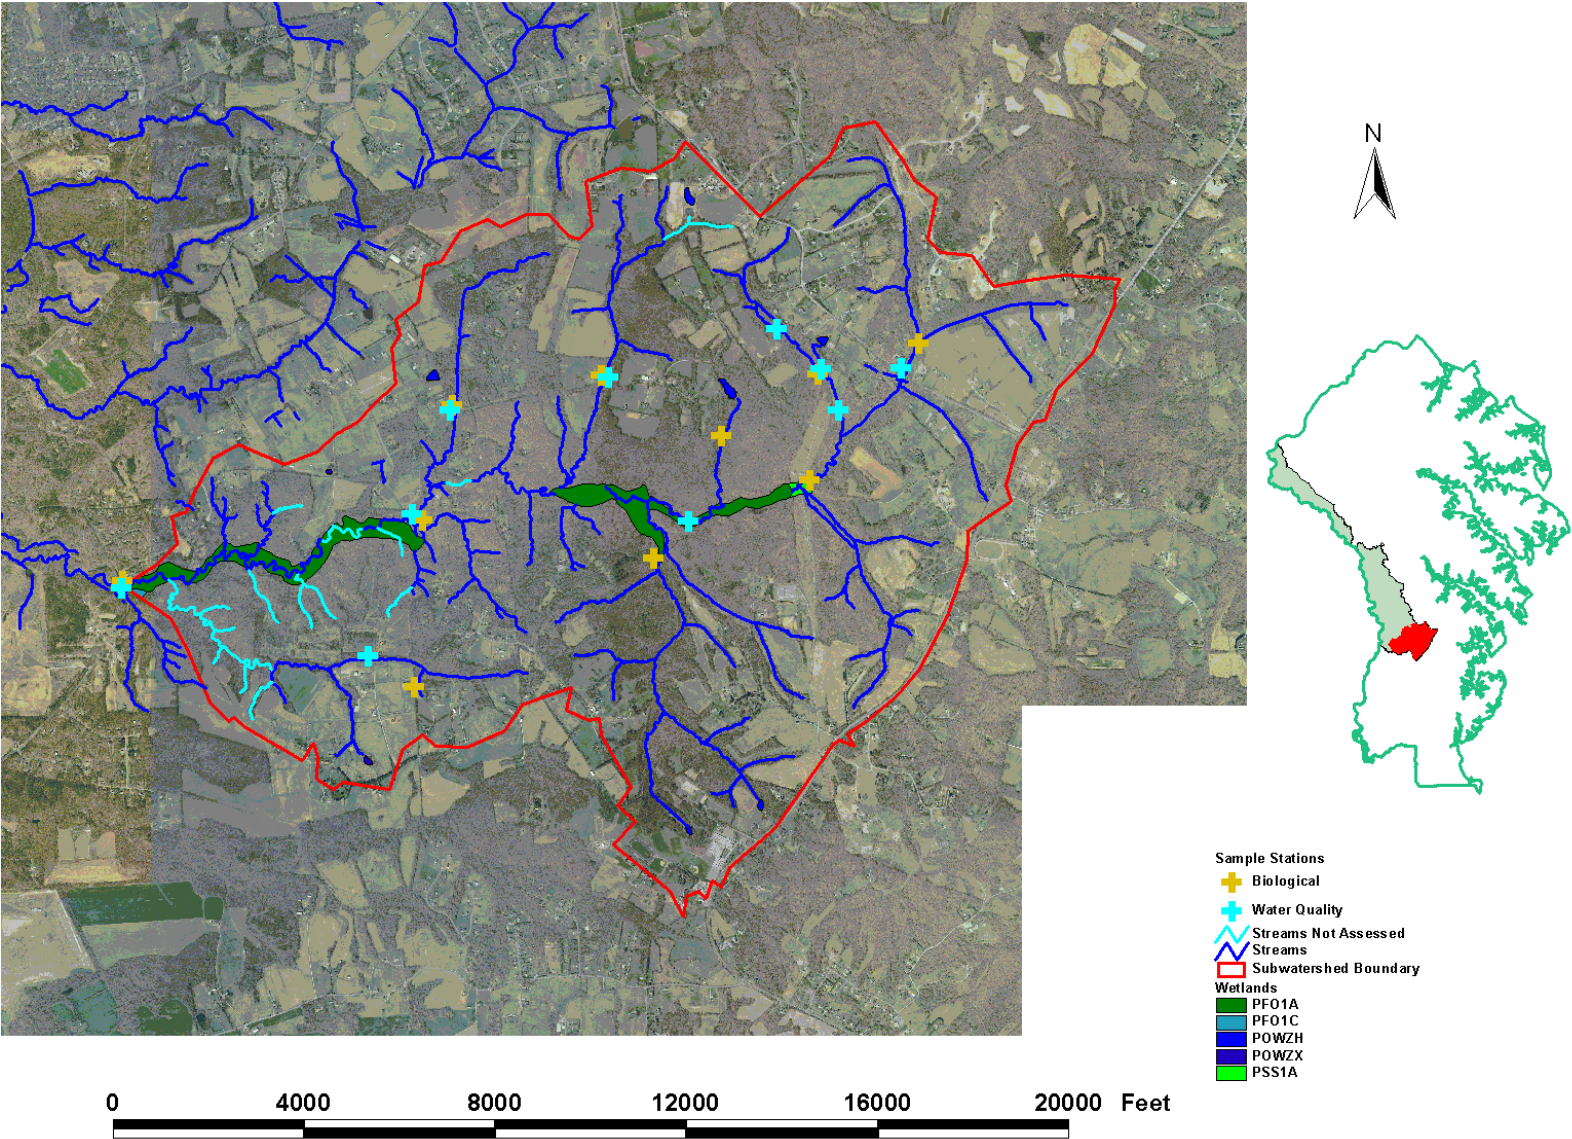
As illustrated in Figure 21, this subwatershed has about equal amounts of agricultural land and vacant land. Most of the vacant land is currently in forest cover. The remainder of the subwatershed is comprised of single family residential along with lesser amounts of open space and other categories. The current level of watershed impervious surface is approximately

Natural Resources. Thirty-one miles of stream channel drain UPS9 (Stocketts Run) of which approximately 28 miles were assessed. As mapped by the National Wetlands Inventory, there are 100 acres of wetlands in Stocketts Run (see Figure 21). Most of the wetlands are concentrated in a 53-acre complex spanning the lower quarter of the mainstem riparian area and in a 38-acre complex in the middle portion of the subwatershed. The balance consists of scattered ponds on agricultural land and stormwater management facilities in larger developed areas. According to the most recent soil survey, there are no hydric soils mapped in the Stocketts Run watershed.

Figure 21. Overview of Stocketts Run (UPS9).

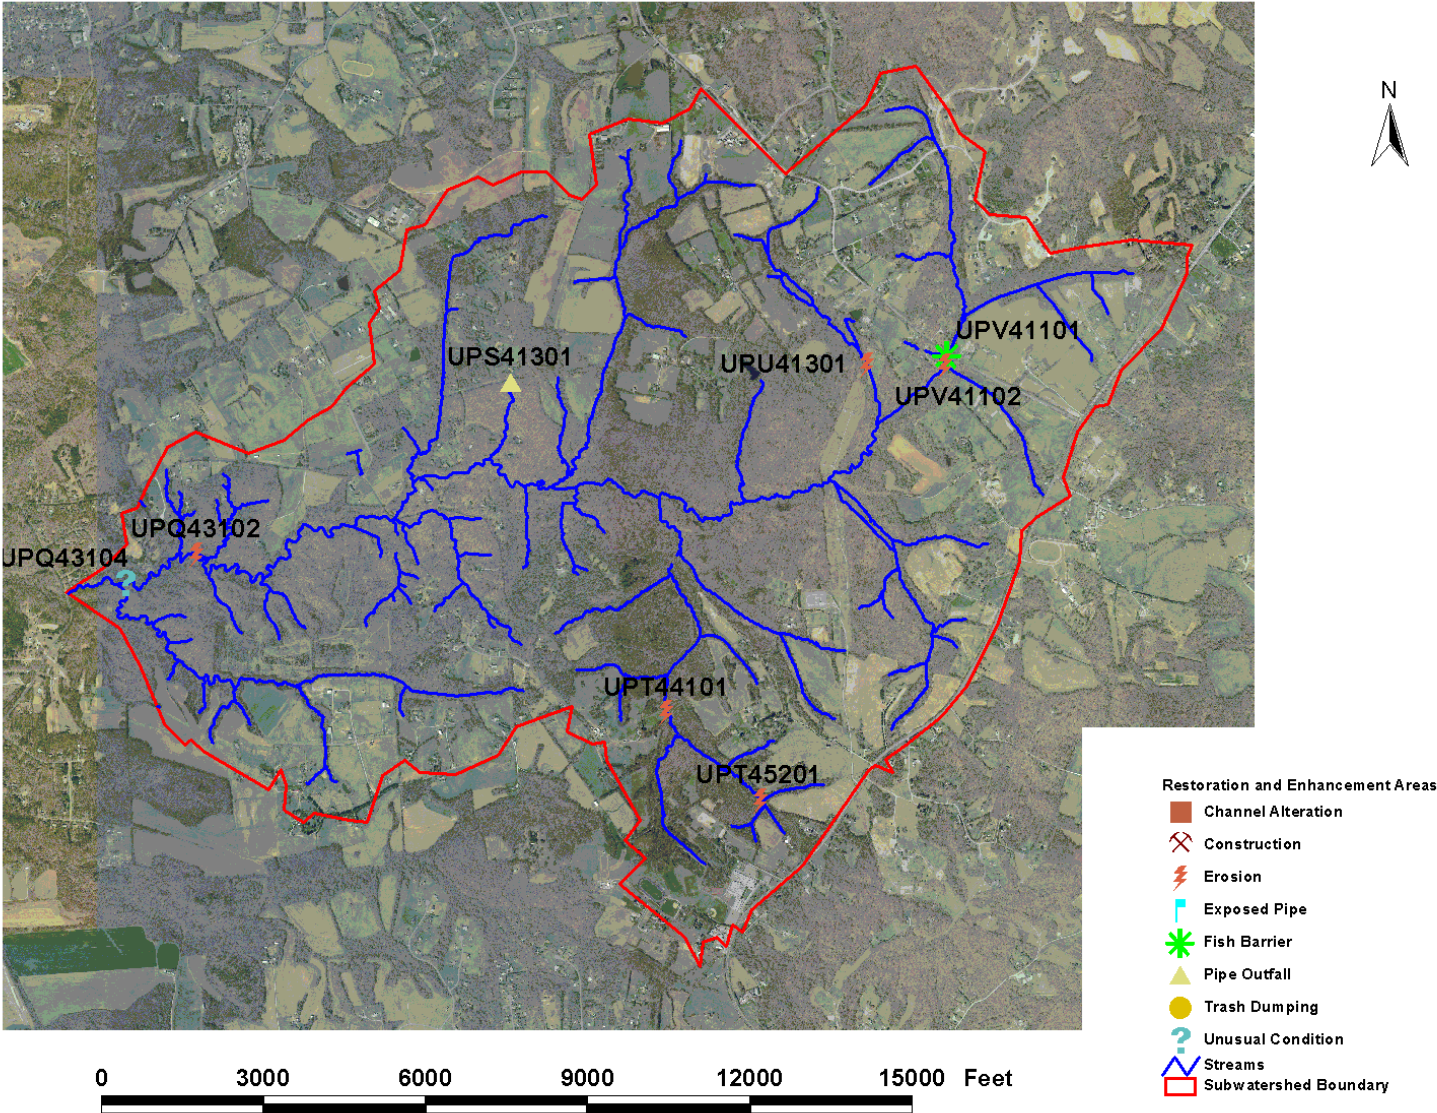
SCA Site Number	Project Type	Project Description	Subwatershed Priority Ranking	Notes
UPQ43104	UC	Stream flow being diverted into pool and garden	1	Easy correctability score put this at top of list.
UPV41101	FB	Shallow box culvert prevent fish movement	2	Successful project opens up 2.7 miles of headwater stream habitat.
UPS41301	PO	Stormwater outfall discharging into stream	3	Source of discharge unknown. Requires additional investigation.
UPQ43102	ES	Eroding bank 8 feet high, 3600 feet long	3	. Requires additional investigation
UPT44101	ES	Eroding bank 5 feet high, 400 feet long	5	Easier access and moderate difficulty in correction result in higher rating than others.
UPU41301	ES	Eroding bank 4 feet high, 2000 feet long	6	Access judged difficult.
UPV41102	ES	Eroding bank 5 feet high, 2400 feet long	6	. Requires additional investigation
UPT45201	ES	Eroding bank 5 feet high, 1000 feet long	8	Project judged difficult to correct.

Figure 22. Location of potential restoration sites in Stocketts Run (UPS9).
