Prepared for
**Dorchester County
Department of
Planning and Zoning**

Hoopersville Coastal Resiliency Study

May 2022

EXECUTIVE SUMMARY

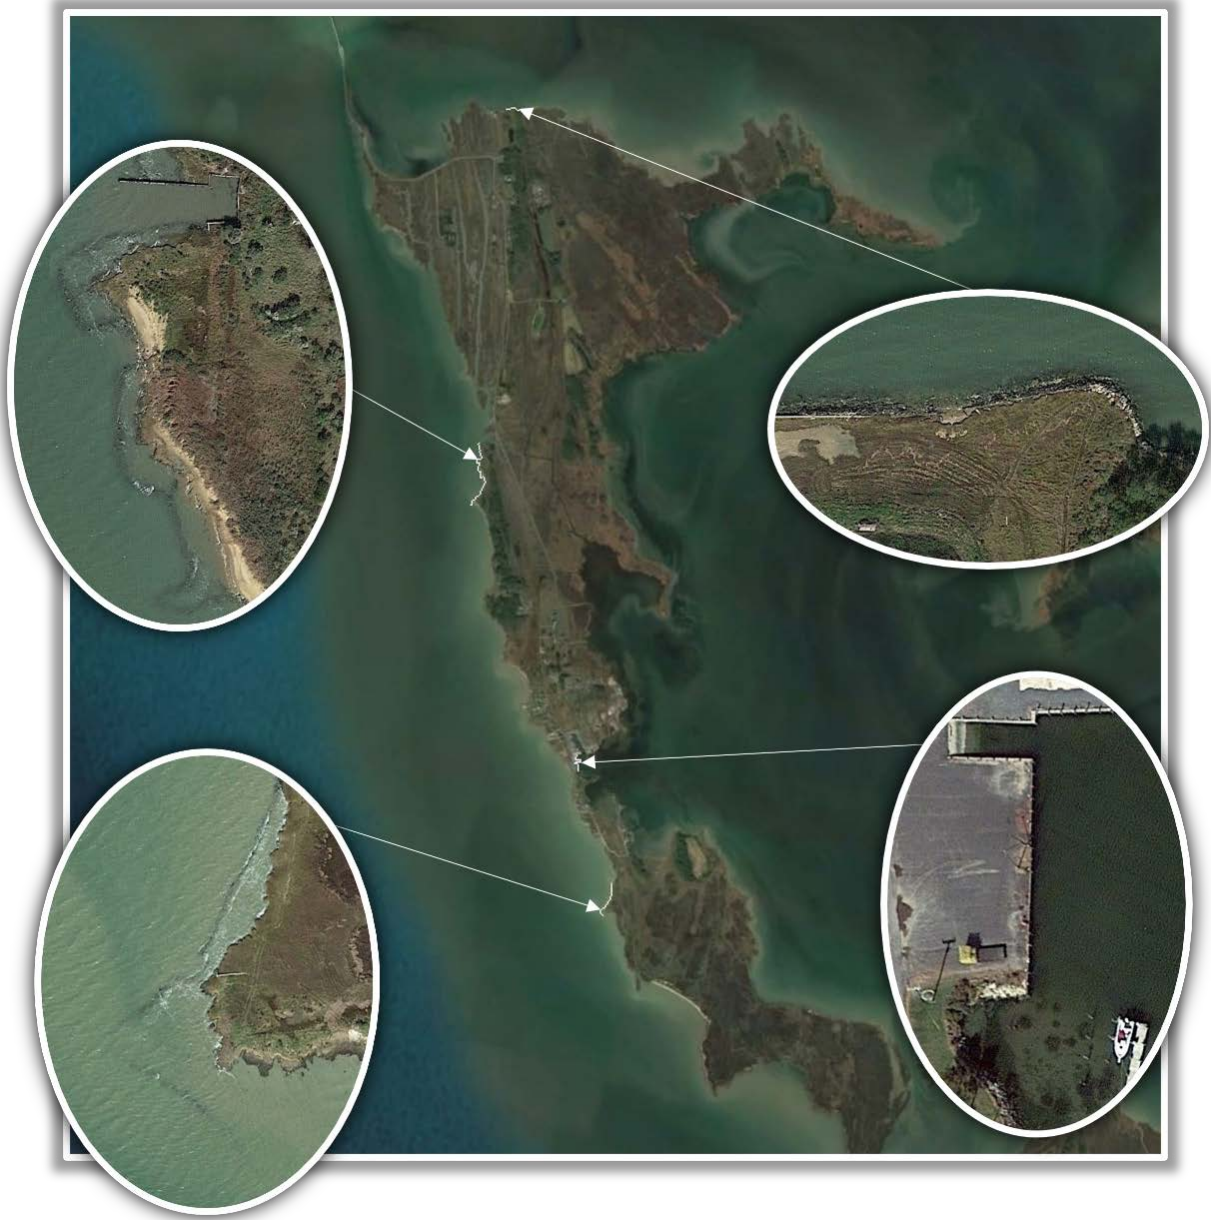
Figure 2 - Shoreline Stabilization Measures

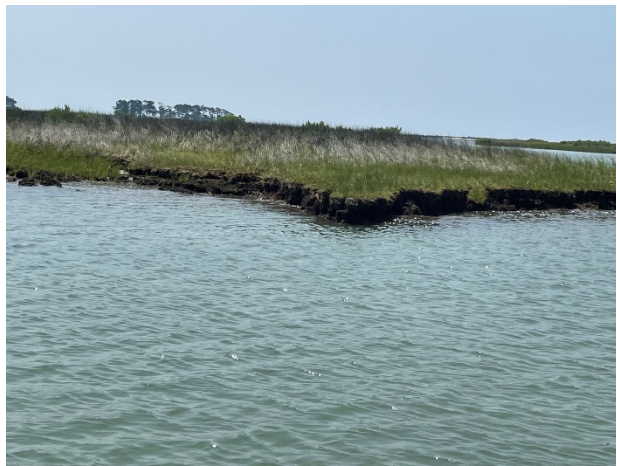
Photo 4 - Erosion of Coastal Marshes

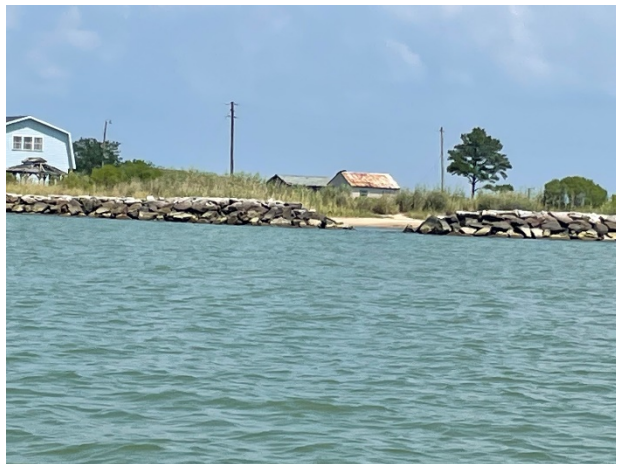
Photo 6 - Stone Breakwaters Protecting against Coastal Erosion

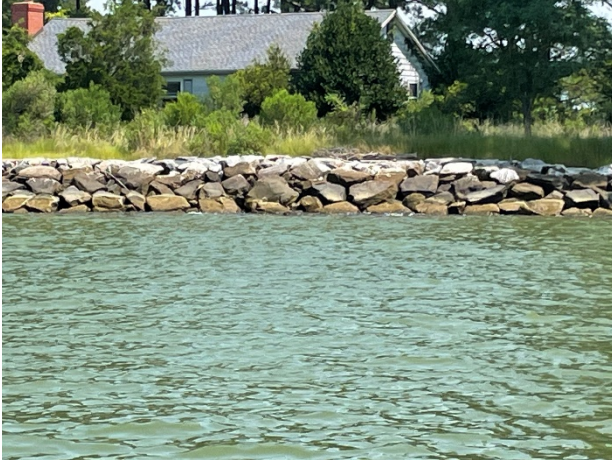
Photo 7 - Shoreline Protected with Revetment

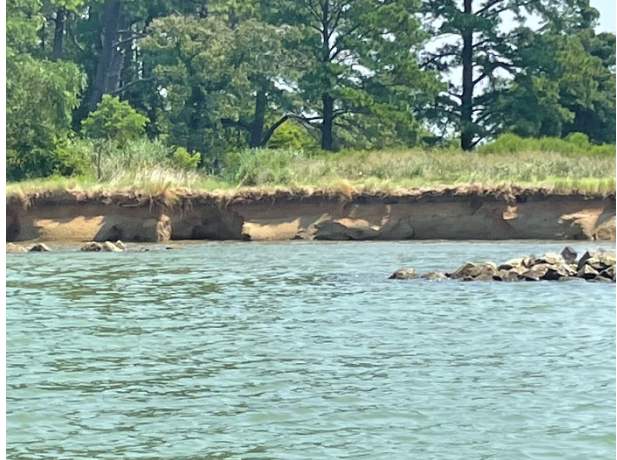
Photo 8 - Unprotected Eroded Bluff

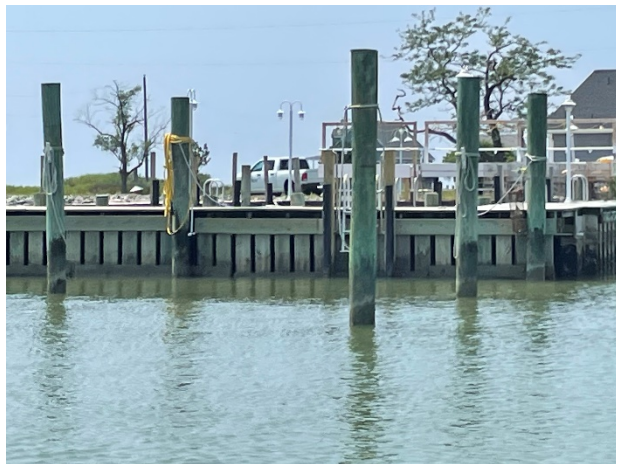
Photo 10 - Bulkhead

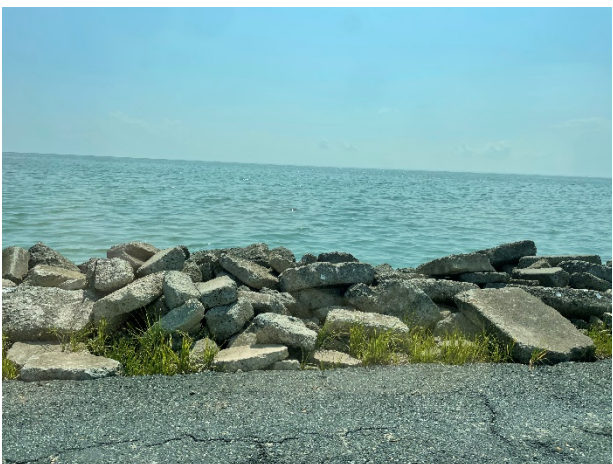
Photo 11 - Rubble Protection along Road

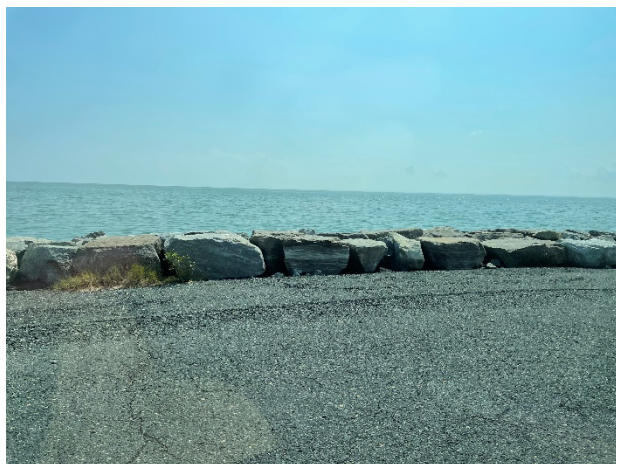
Photo 12 - Stone Revetment Protection along Road

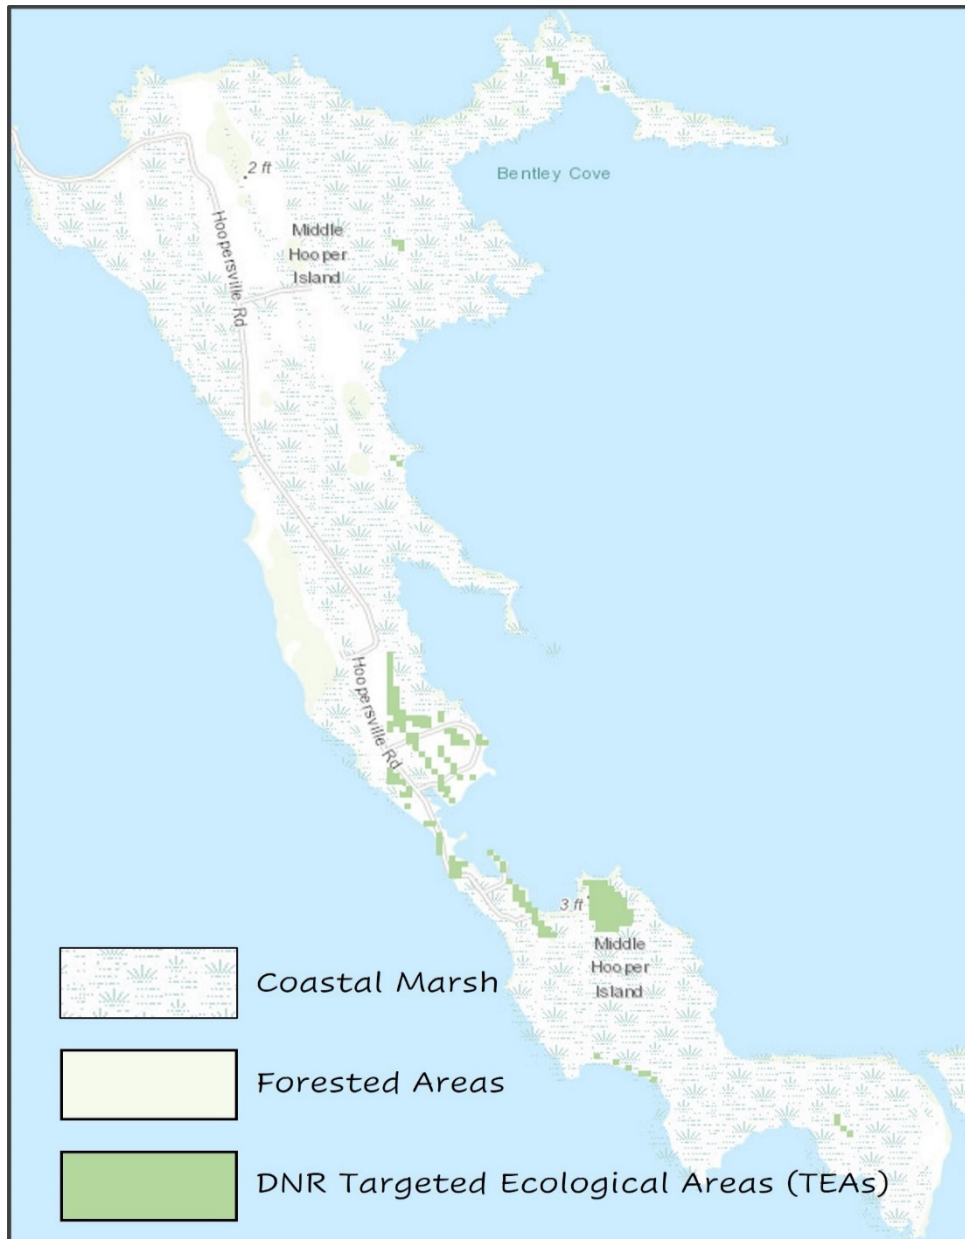
Figure 4 - Habitat Along Hoopersville (Source: MERLIN)

approximately 1,120 acres. The marsh consists of multiple natural runnels and man-made ditches that were cut through the marsh in order to improve tidal flushing and prevent standing water in the inland areas of the island. This area has high ecological value for many native waterfowl and wading birds, plants, mammals, invertebrates, and reptiles such as the Diamondback Terrapin. Many areas throughout Hoopersville have been identified by the Maryland DNR as Targeted Ecological Areas (TEAs) which are of high priority for conservation and natural resource protection. These areas are shown in Figure 4.

Forested areas consist of areas with dense tree canopy coverage. Forests play a significant role in helping to trap pollutants and nutrients from runoff. Streamside forests, also known as riparian buffers, line many of the coastal marshes and ditches within Hoopersville. These forested areas have the added benefit of providing habitat, nesting sites and safe migration paths for multiple land and water species. Based on 2019 aerial imagery, approximately 60 acres, or 5% of the island's natural habitat consists of forested areas.

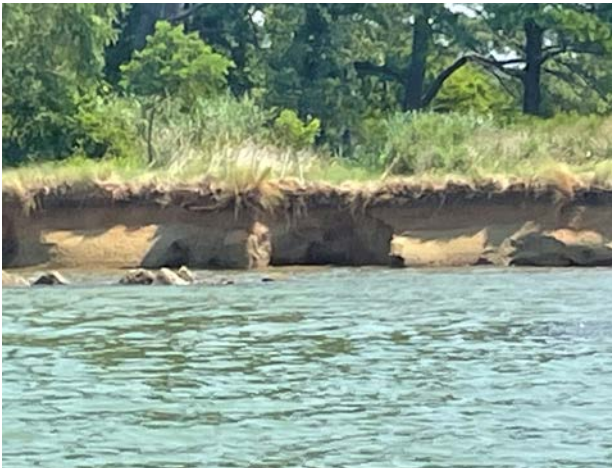
Coastal erosion is the process of waves and/or high flows destabilizing the sediments along the natural shoreline. The sediments are then moved offshore or to another location. Along the Hoopersville shoreline, wind-waves are the predominant drivers of coastal erosion. While some portions of the shoreline are protected by shoreline stabilization measures, the majority of the island is exposed and susceptible to erosion.

Photo 13 - Eroded Bank

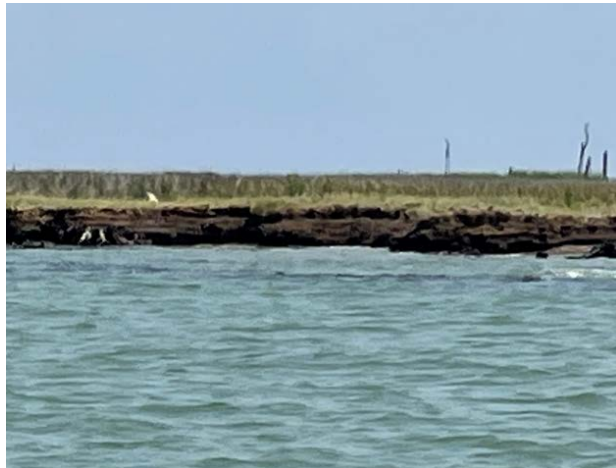
Photo 14 - Eroded Marsh Bank

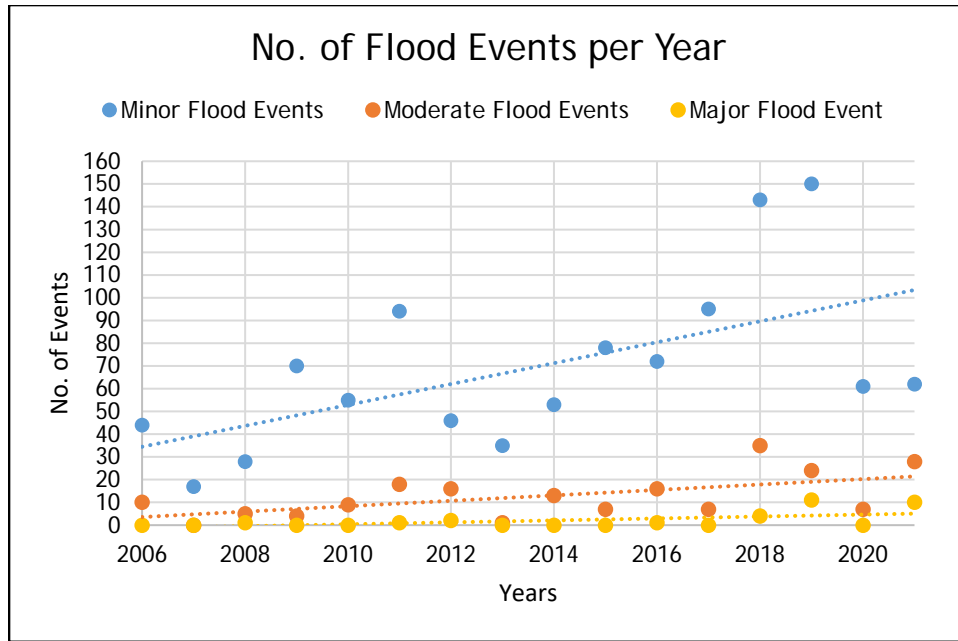
SLR will result in these flood elevations occurring more frequently in the future. In fact, Table 1 shows the number of flood events per year has nearly doubled from an average of 57 flood events per year between 2006 – 2013 to an average of 110 flood events between 2014 – 2021. The plot of the number of flood events per year shown in Figure 7 shows a clear indication that the frequency of the flood events, especially nuisance flooding events, has increased over the last fifteen years.

Figure 7 - No. of Flood Events at Bishops Head between 2006 - 2021

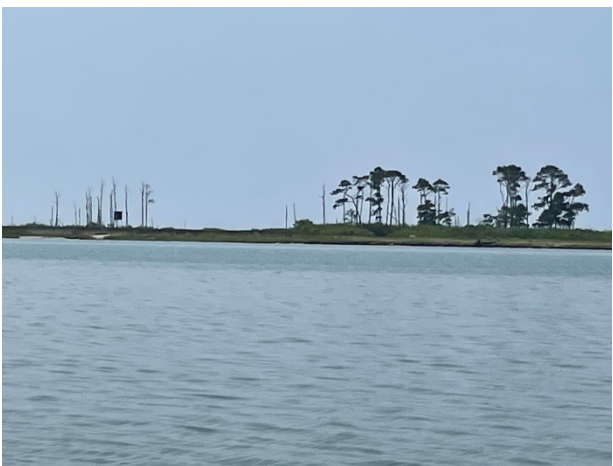
Saltwater intrusion refers to water with a higher salinity encroaching on areas with lower salinities. Salinity of the water plays a significant role in determining the habitat and species that can survive and prosper. Increasing the salinity can have detrimental impacts on freshwater species of plants and animals. This can already be seen by the loss of forested areas along the shoreline, as shown in Photo 15 and Photo 16.

Photo 15 - Decline of Tree Clusters around Island

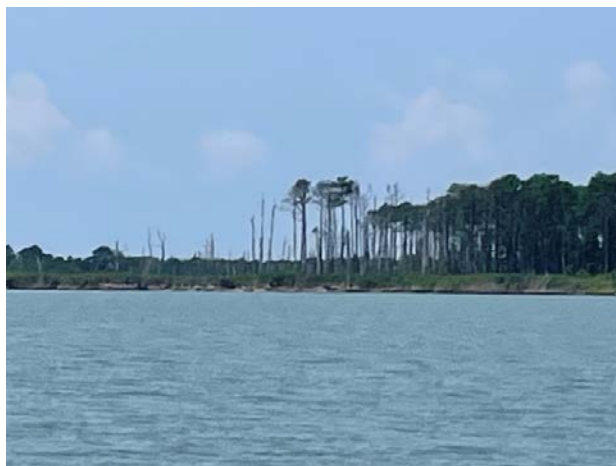
Photo 16 - Dead Trees along Shoreline

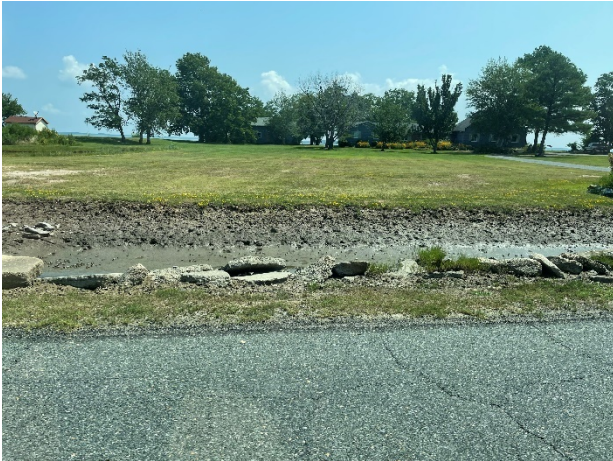
Low-lying, flat areas such as Hoopersville can often experience issues when draining stormwater from rainfall events. Stormwater runoff will often pond in flat areas and remain in place long after the rainfall has ceased. Additionally, drainage ditches or swales can offer an inlet for coastal waters to reach inland areas during significant high-water levels. These factors can often lead to habitat degradation due to saltwater intrusion or flooding. It can also result in flooding of low-lying areas inland of the shoreline. Photo 17 shows an example of a drainage ditch between the road and an adjacent property.

Photo 17 - Drainage Ditch along Hoopersville Road

These ditches require maintenance to removed sedimentation. Sedimentation along the bottom of the ditch can also cause flooding by decreasing the discharge capacity within the ditch. Erosion of the side slopes during high flows could also results in land encroachment and deposition of the material along the bottom of the bank.

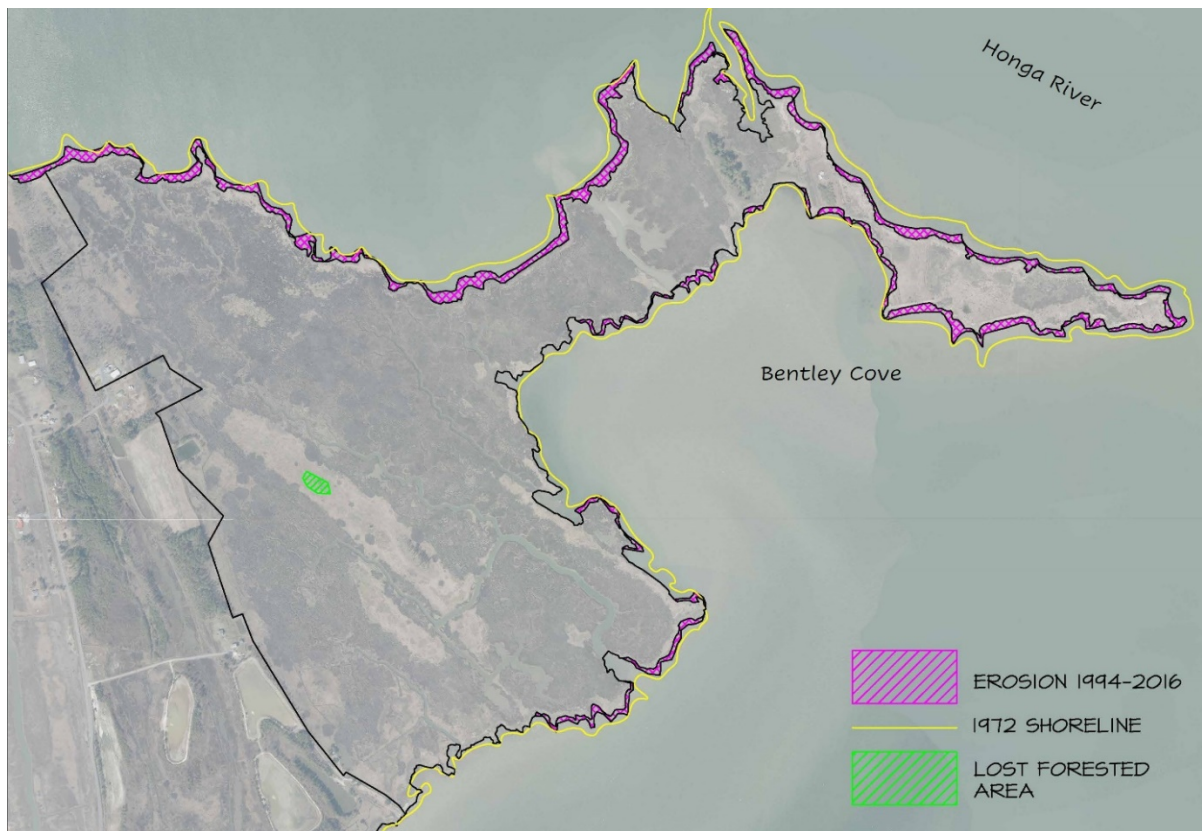
Figure 11 - Erosion and Lost Habitat along the Northeast Marsh Area

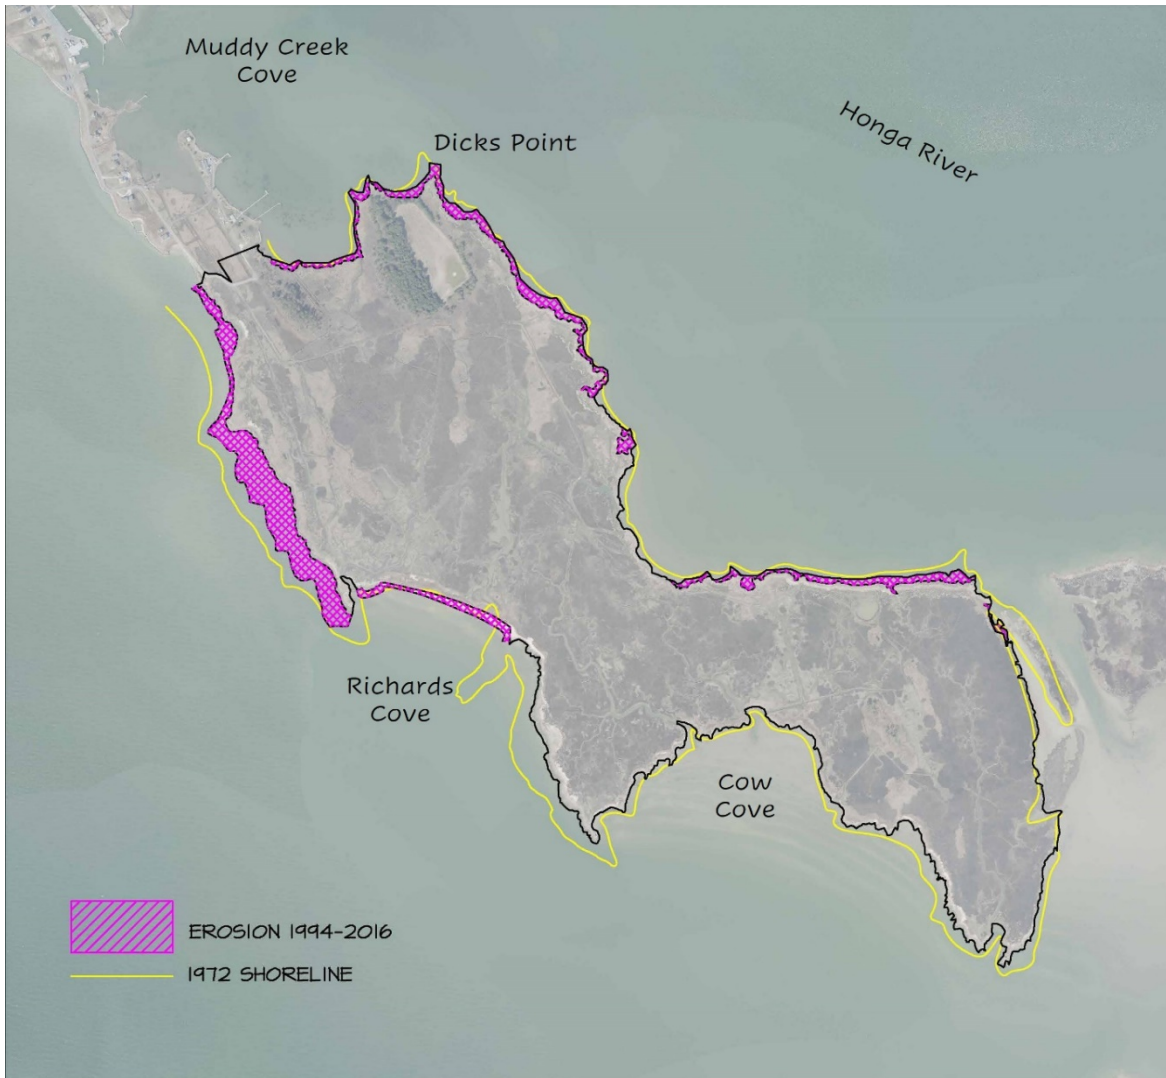
According to the ESRGC analysis, erosion of the marsh has occurred on both the Chesapeake Bay side and the Honga River side of this area. The average rate of erosion is approximately 3.3 feet/year for an average shoreline recession of approximately 75 feet between 1994 and 2016. Erosion along the Chesapeake Bay has reached as high as over 12 feet/year. Over 275 feet of shoreline recession has occurred in some areas of the Southern Marsh. The erosion as well as the approximate location of the 1972 shoreline is shown in Figure 19.

Figure 19 - Erosion along the South Marsh Shoreline

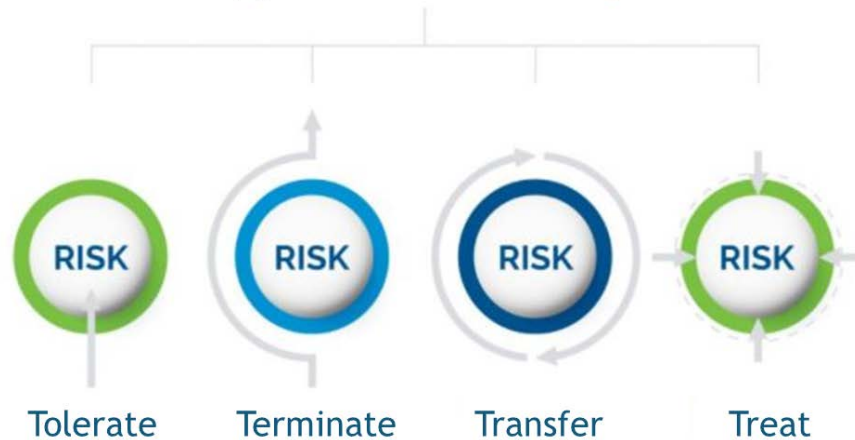
Figure 29 - The 4 T's of Risk Management

Risk management strategies refer to concepts or ideas for handling the risk determined during the vulnerability assessment. Options should follow the four T’s of risk management, shown in Figure 29.

The four types of Risk Management Strategies (RMS) are defined as follows:

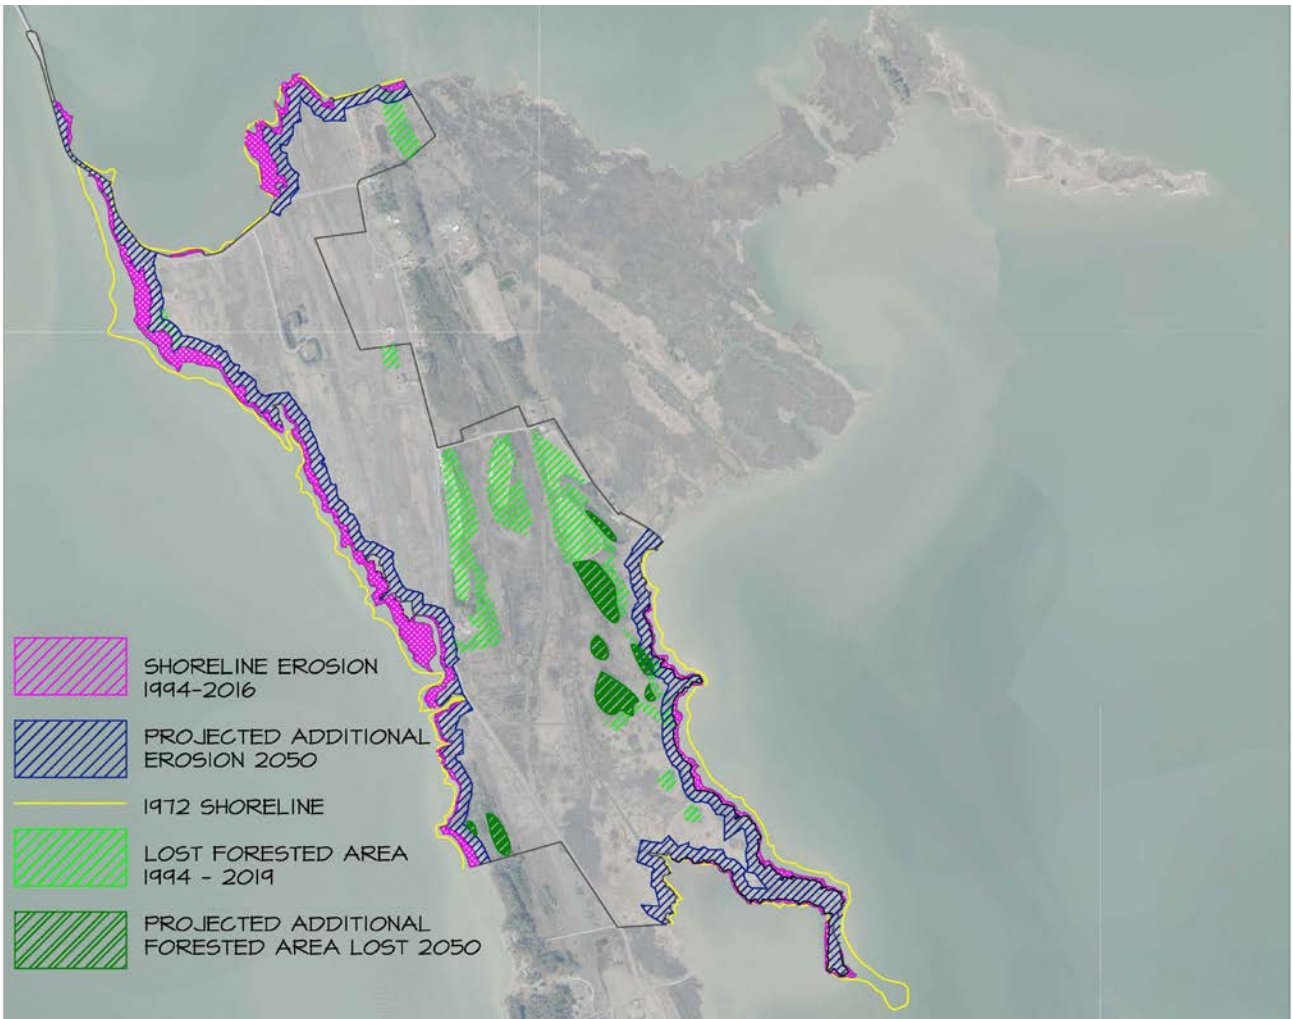
Using the same threshold value of necessary forest elevations between 1 – 1.5 feet above MHW, it is anticipated that approximately 13 acres of remaining forested area will be lost due to saltwater intrusion by 2050. This additional lost forested area is shown in Figure 32.

Figure 32 - Northwest Marsh Projected Erosion and Forest Lost by 2050

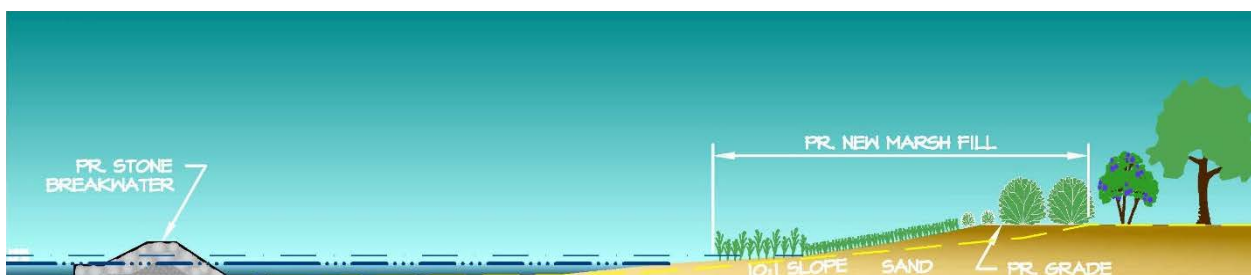
Figure 48 - Stone Breakwaters and Marsh against Coastal Erosion
