Abstract: Once nitrogen from wastewater treatment plants and septic systems enters aquatic ecosystems, it is difficult to distinguish it from other sources contributing to degradation. The Monie Bay sub-estuary of Chesapeake Bay, just south of Wicomico River, is situated within the Chesapeake Bay (Maryland) National Estuarine Research Reserve and provides a 'natural laboratory' useful to test whether or not waste nitrogen sources can be identified by analyzing $\delta^{15}\text{N}$ in oyster (*Crassostrea virginica*) tissues. Monie Bay receives freshwater inputs from three creeks varying in watershed size and land use: residential septic systems (Monie Creek), crop fertilizer (Little Monie Creek), and wetlands/forest (Little Creek). Differences in oyster $\delta^{15}\text{N}$ suggested oysters were suitable to identify waste nitrogen sources. Furthermore, in conjunction with a Water Quality Index score (0.36 ± 0.04), waste nitrogen was interpreted to be derived from septic and manure sources which entered Monie Bay from both within (35 poultry houses) and outside its watershed (sewage/septic). Sewage/septic/manure sources likely arrived from the adjacent Wicomico River, with a wate

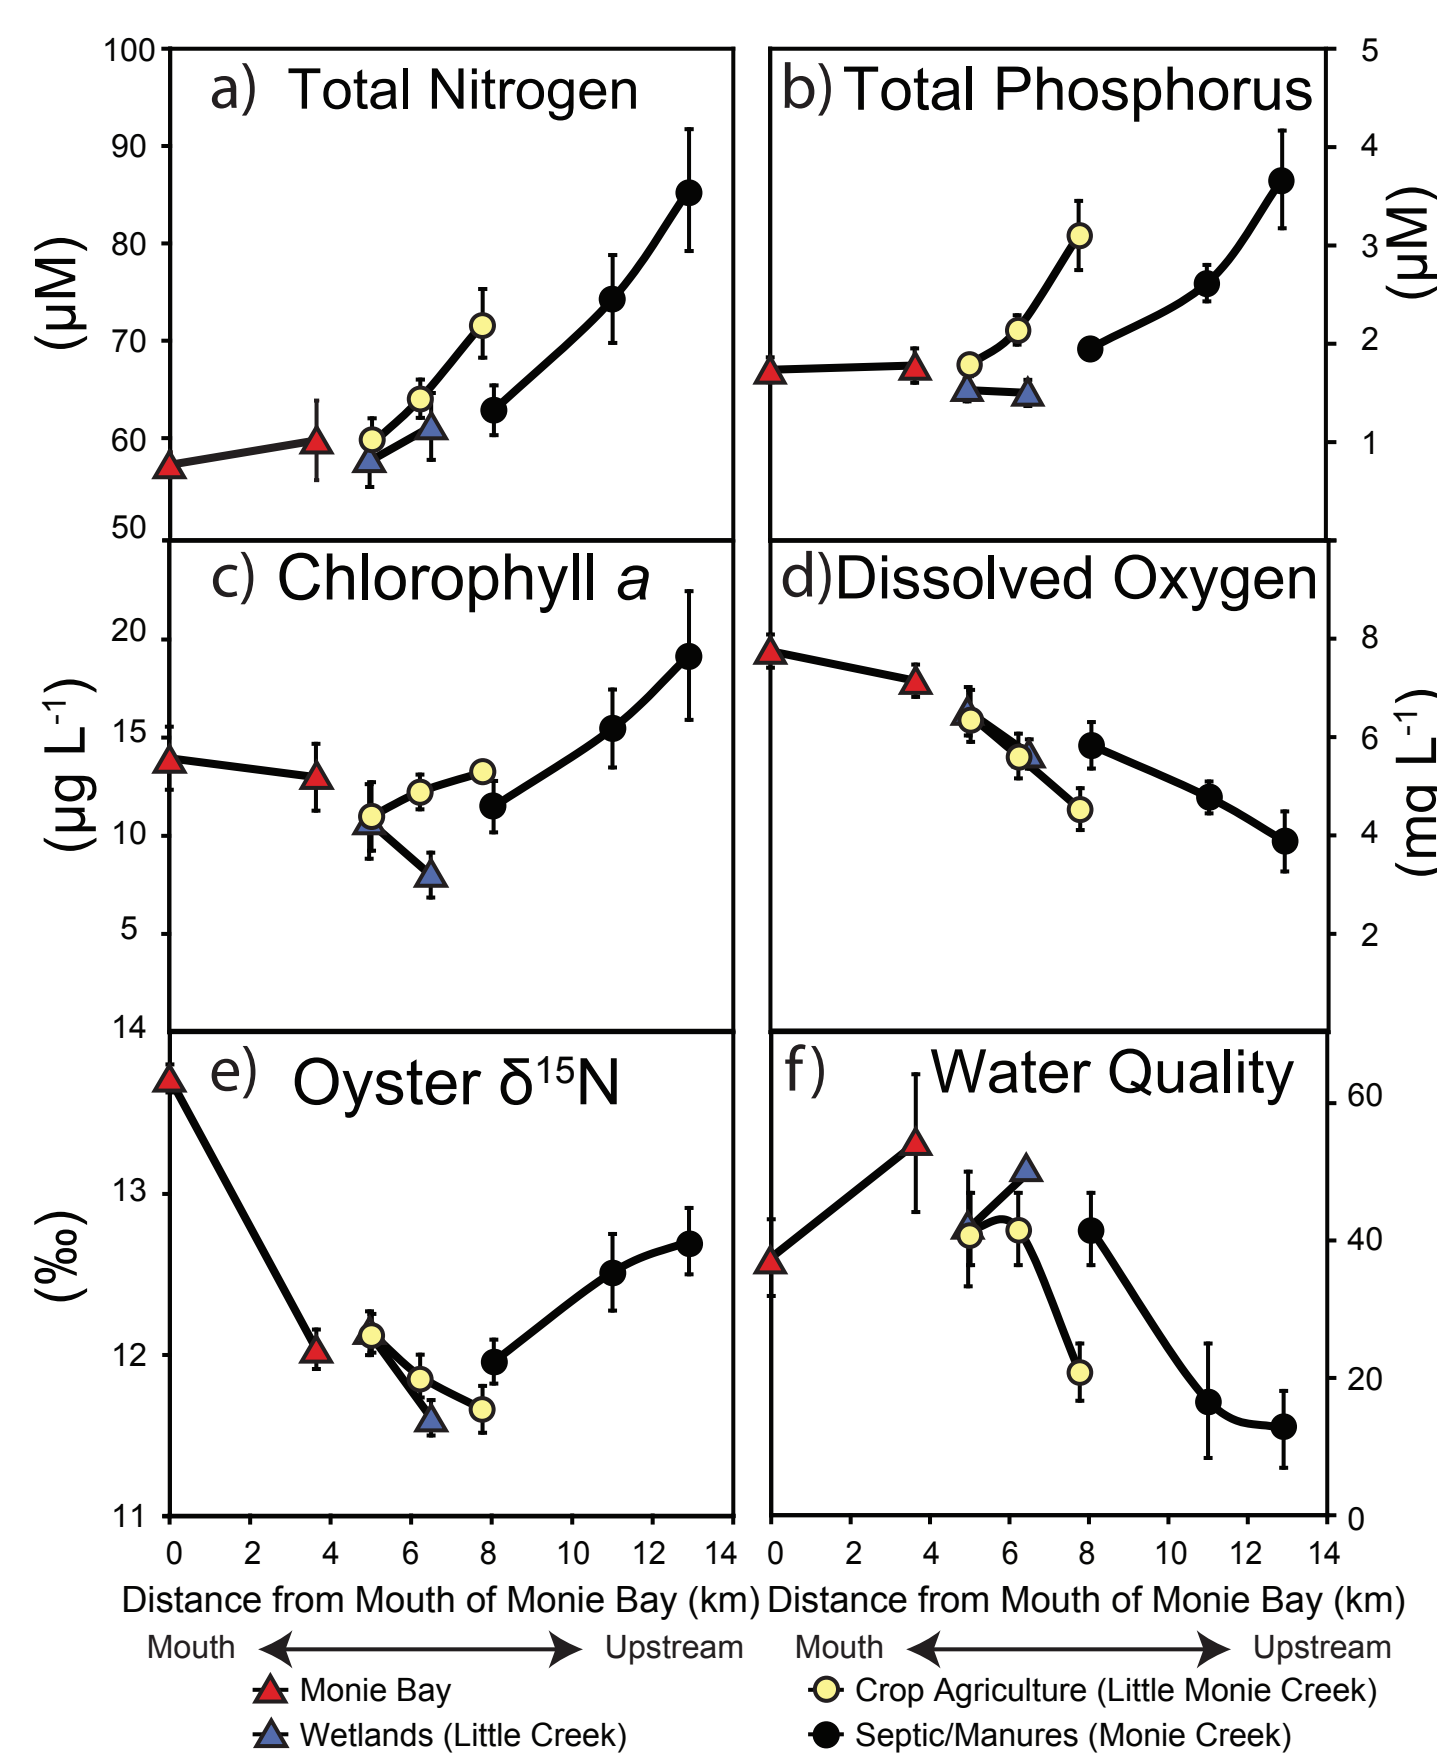
Monitoring data showed terrestrial inputs of nutrients increased chlorophyll *a* and decreased dissolved oxygen. Enriched oyster $\delta^{15}\text{N}$ at the mouth (red triangles) and in Monie Creek (black circles) suggested human/animal wastes. Water Quality Index was poor at the aquatic margins, which suggested multiple sources led to degradation.

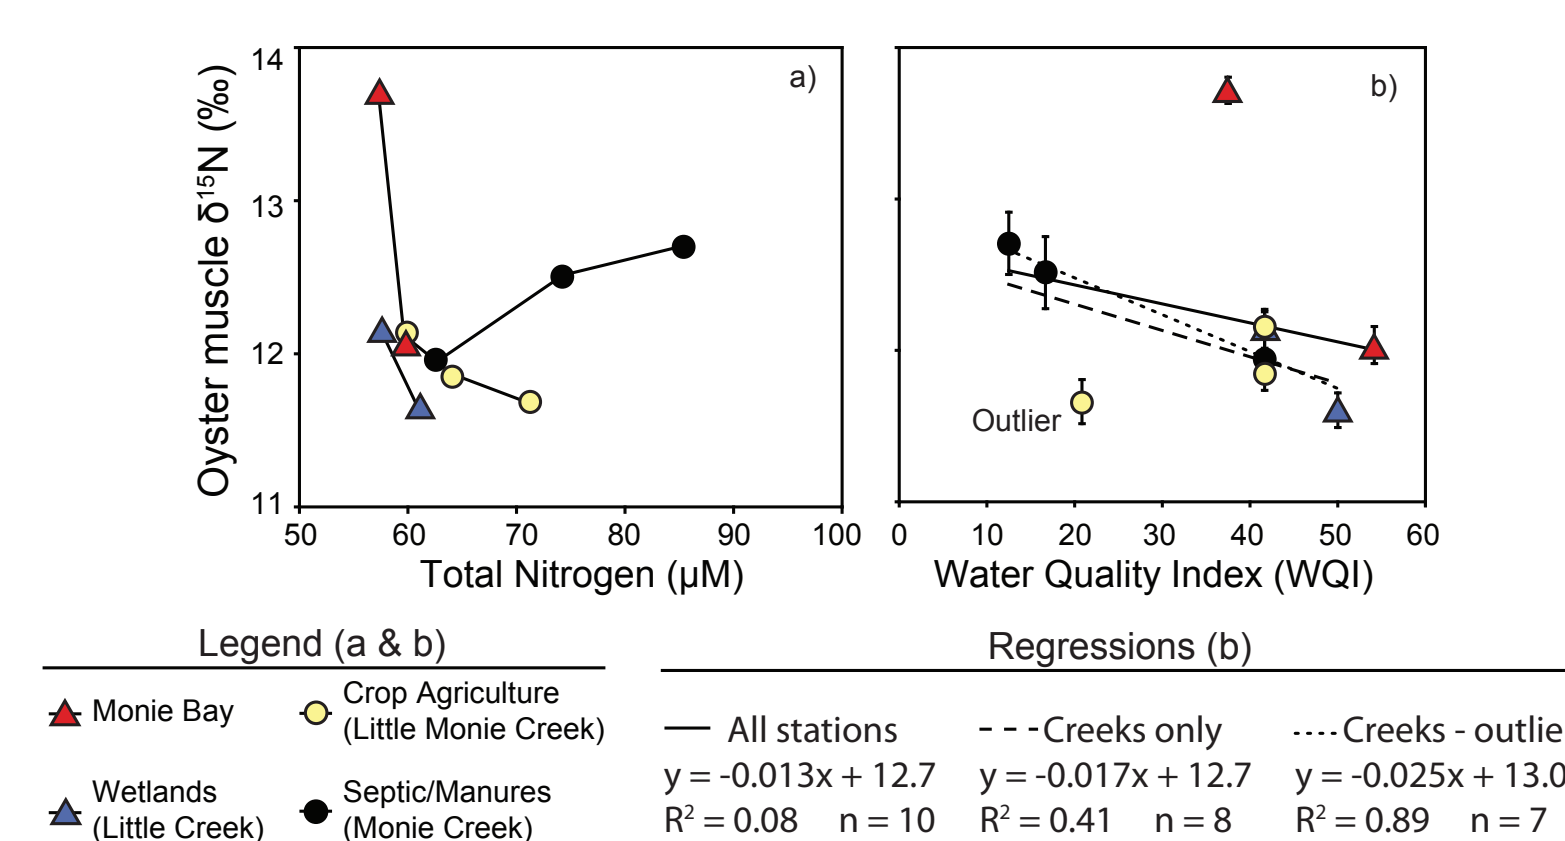
Oyster $\delta^{15}\text{N}$ was not directly related to TN, which meant they provided different information. Oyster $\delta^{15}\text{N}$ was inversely related to the Water Quality Index. Therefore, poor water quality was related to human/animal wastes. Low $\delta^{15}\text{N}$ and poor water quality in Little Monie Creek suggested fertilizer sources contributed to poor water quality at that site.

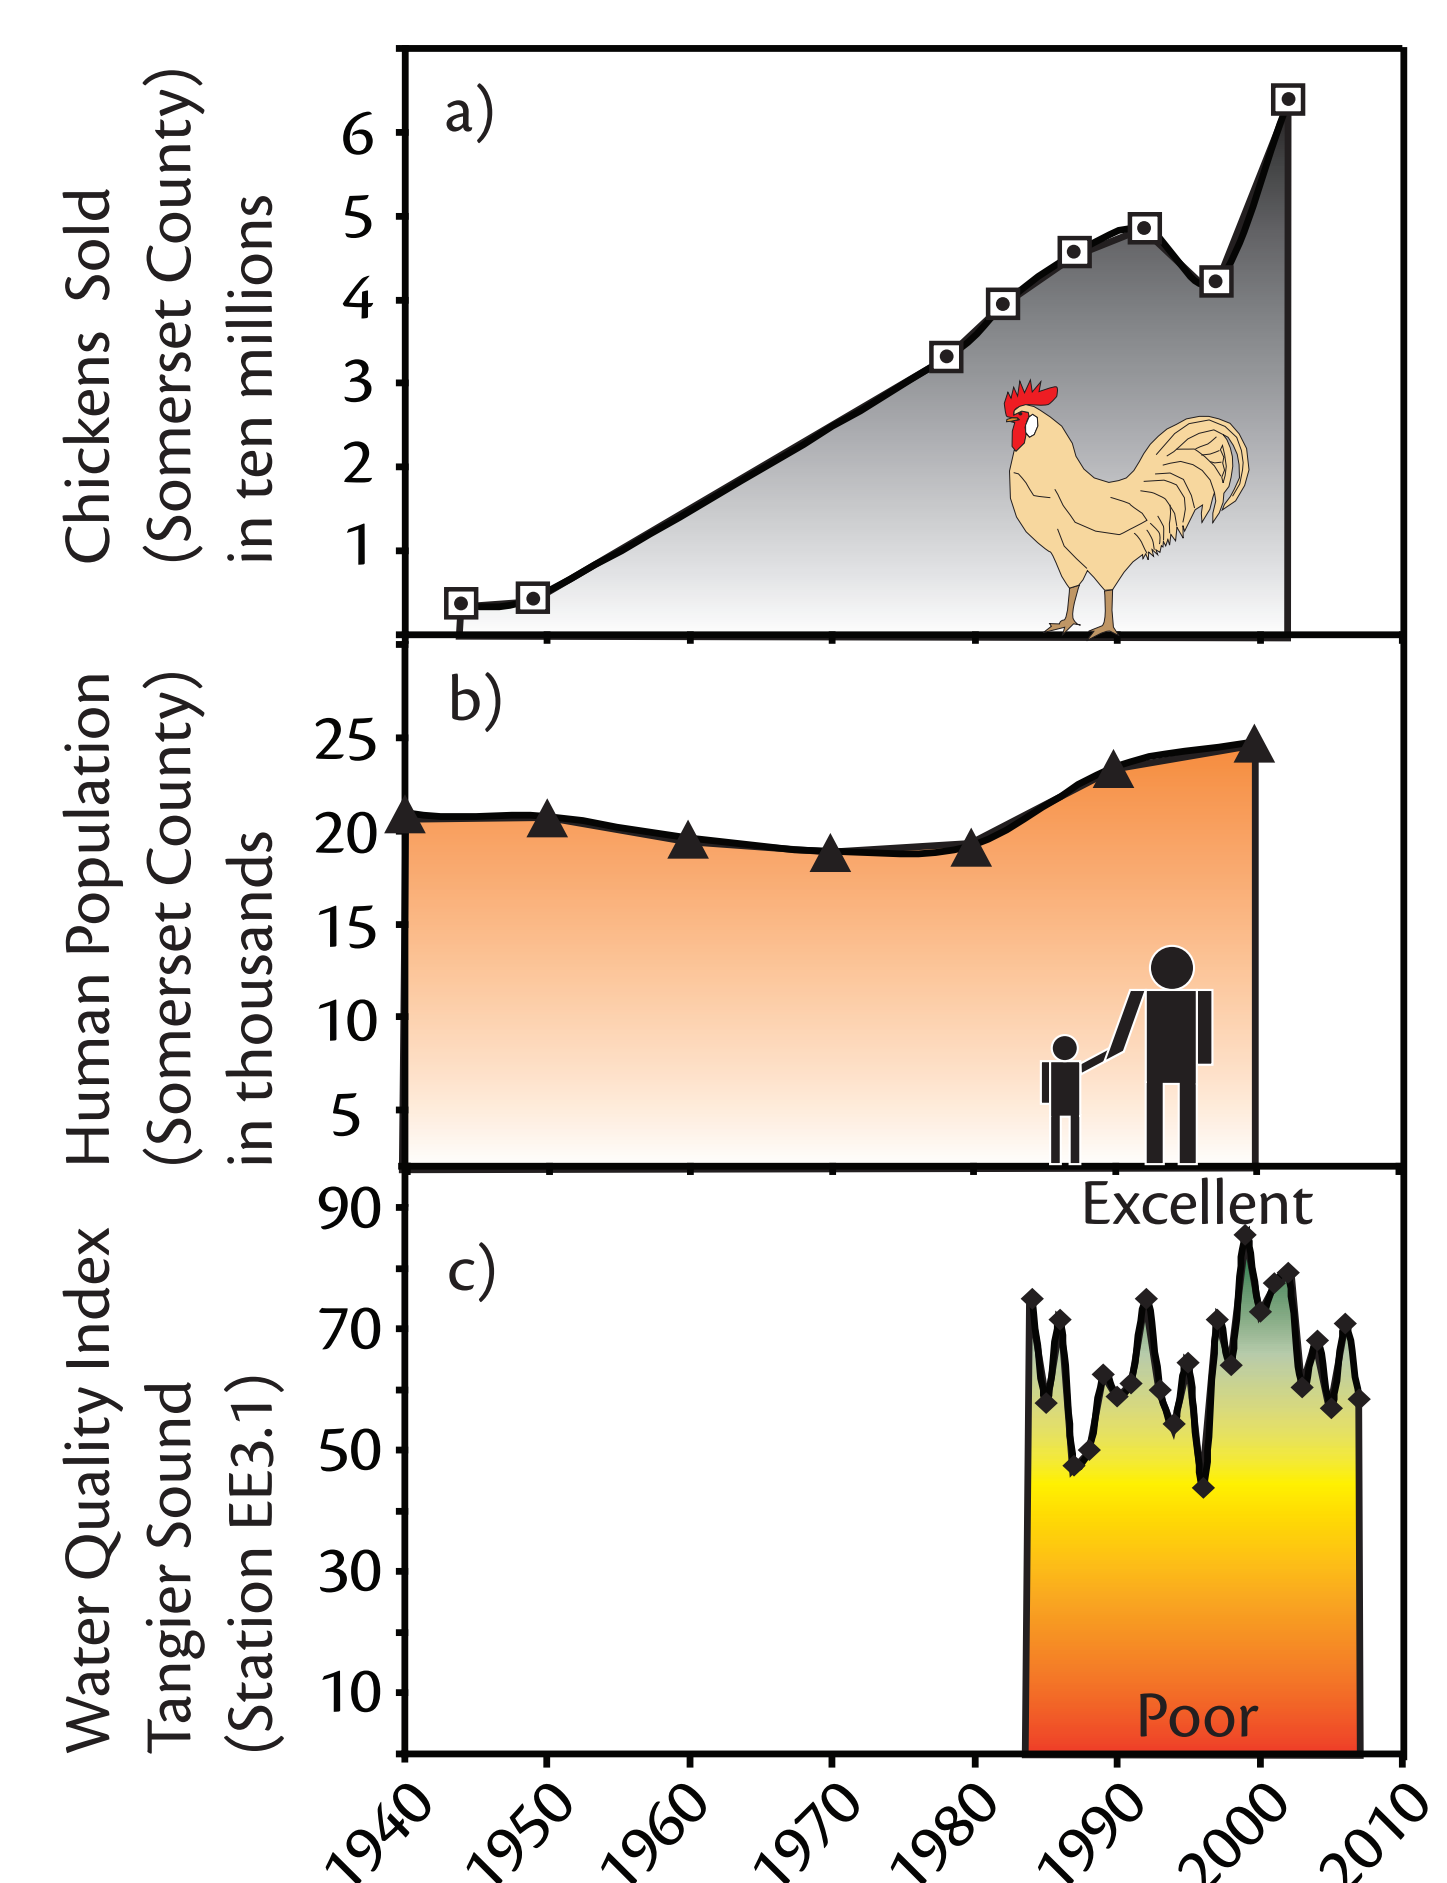
Historically, water quality in Tangier Sound declined after periods of poultry production increase and improved after decreases in production (USDA 2002, US Census 2000, CBP 2008).
