2009 Bush River Shallow Water Monitoring Data Report

DNR publication #12-8112010-468

Brian Smith, Diana Domotor, Mark Trice, and Tom Parham
Resource Assessment Service/Tidewater Ecosystem Assessment
Maryland Department of Natural Resources
Tawes Building, D-2
580 Taylor Avenue
Annapolis, MD 21401

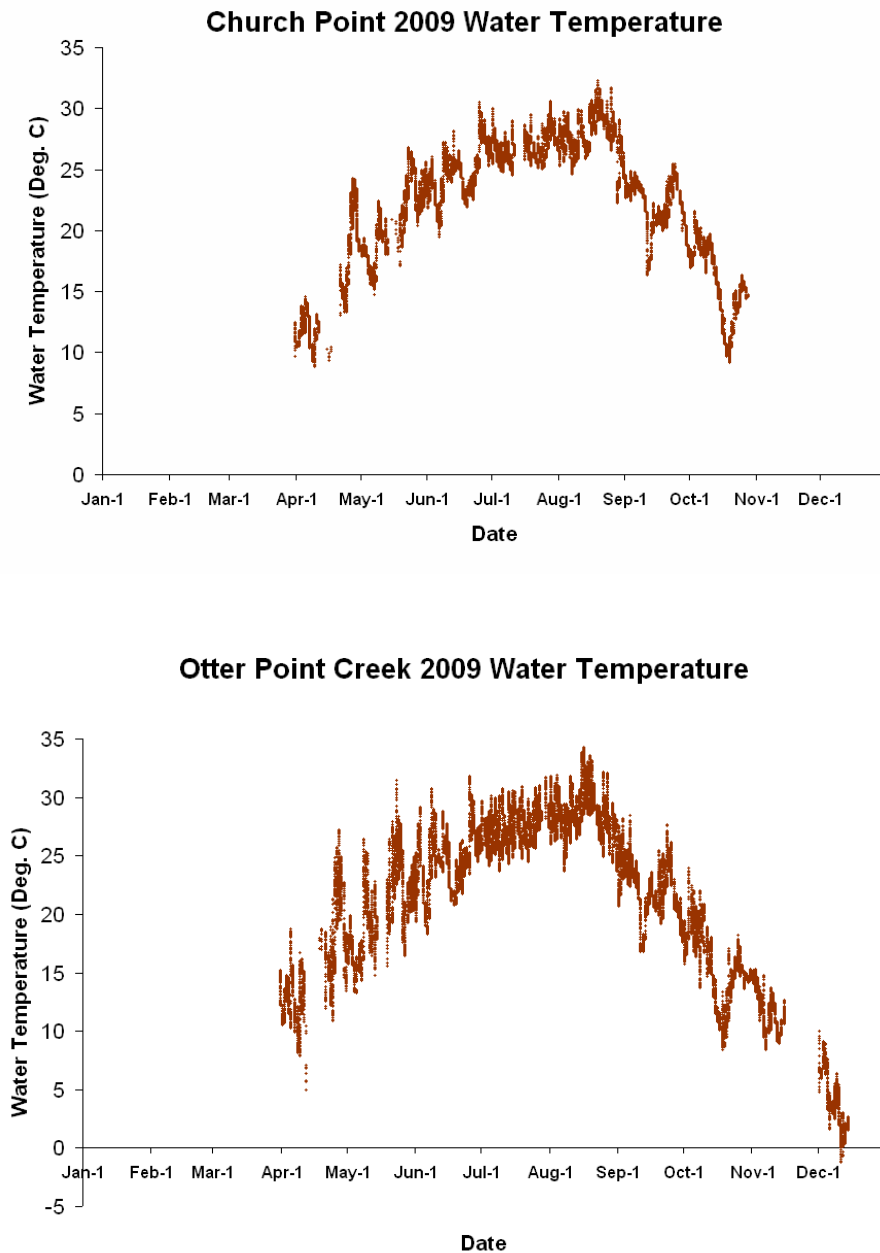
Figure 4. Water temperature at Bush River Continuous Monitoring sites during 2009.

Water temperature at both Bush River Continuous Monitoring sites rose predictably as air temperatures increased during the summer months and peaked in August (Figure 4). Church Point reached a peak of approximately 32°C, while Otter Point Creek peaked at 34°C.

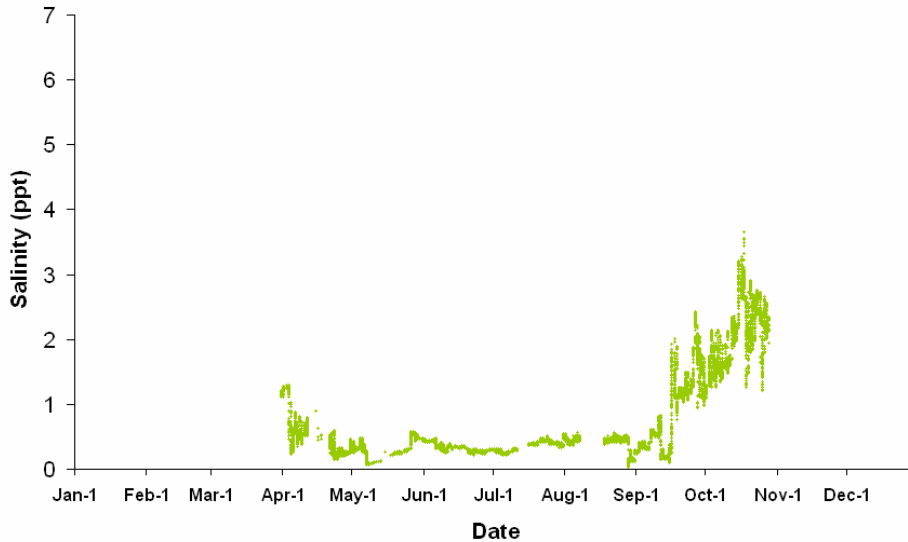
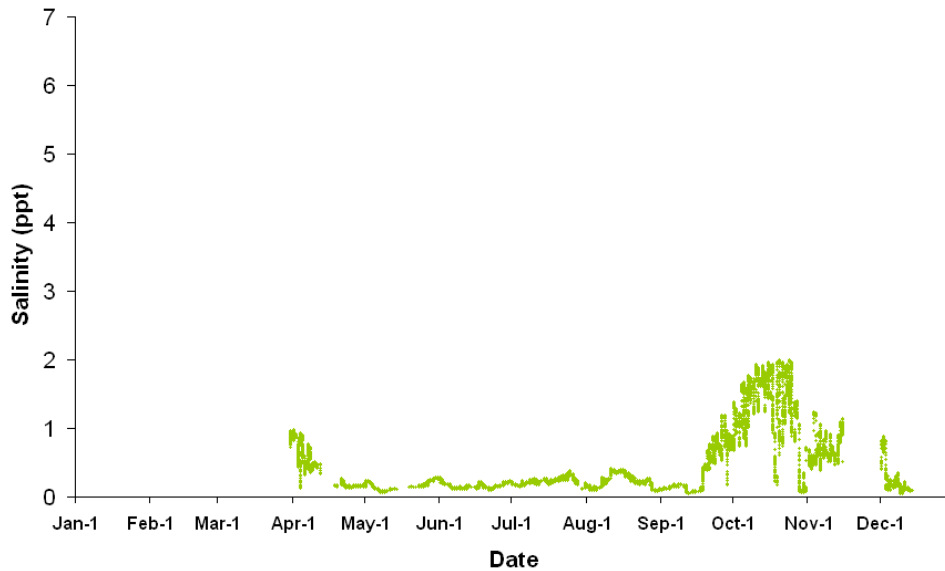
Figure 5. Salinity levels at Bush River Continuous Monitoring sites during 2009.

Salinity levels for both the Church Point and Otter Point Creek Continuous Monitoring sites remained low for most of the spring and summer (Figure 5). Levels then increased during the late summer and early fall, but not to the extent that was seen during the drier years of 2007 and 2008. Church Point salinity levels peaked at 3.7 parts per thousand (ppt) on October 17th and Otter Point Creek levels peaked at 2.0ppt on October 24th.

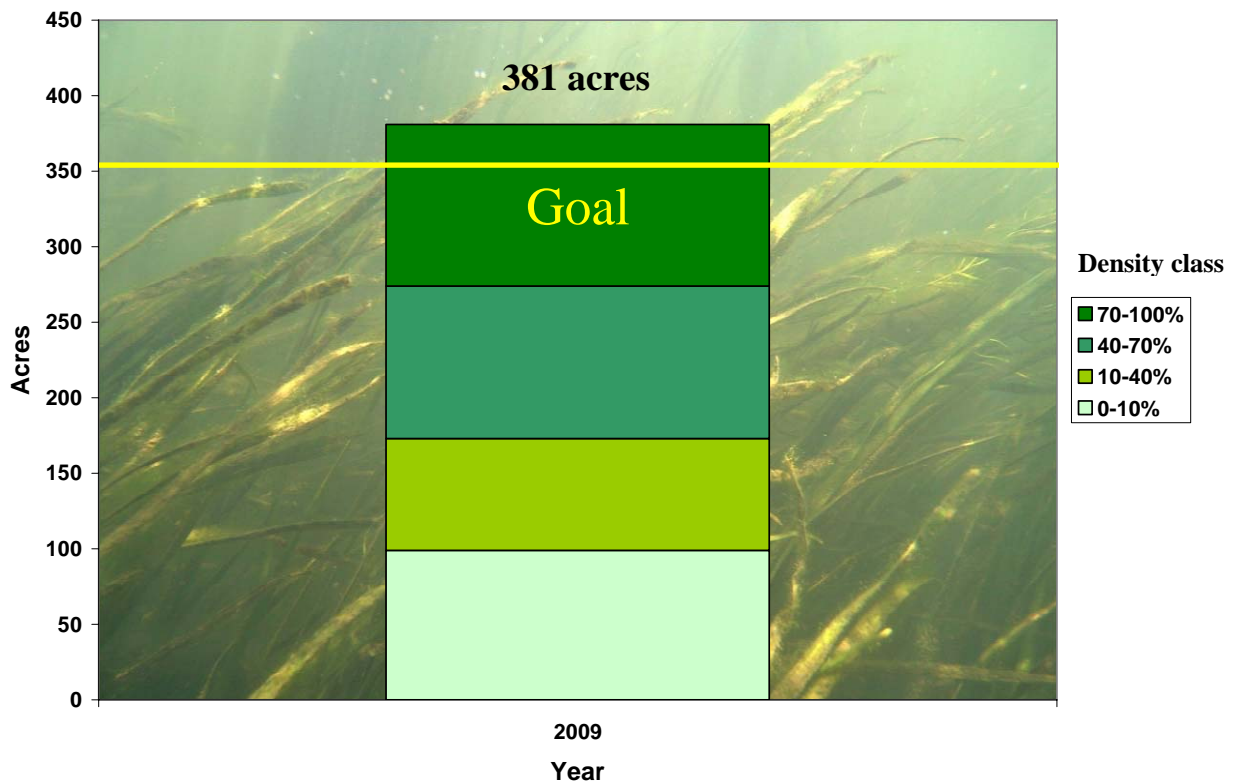
Figure 10. Total area and density of SAV in the Bush River in 2009.

SAV acreage continued a two year decline in the Bush River in 2009. Total area of SAV in 2009 was 381 acres, which is approximately 9% higher than the restoration goal for the Bush River (Figure 10). Total area, however, has decreased by 41% in the Bush River since 2007 and the amount of high density beds has decreased from 66% of total acreage in 2007 to 28% of total acreage in 2009. VIMS did not conduct ground survey observations on the Bush River in 2009 so SAV species diversity could not be determined.

The decrease in SAV acreage in the Bush River follows the patterns seen in precipitation and discharge events and water clarity. 2009 was a wetter than average year (Figure 2) which led to numerous spikes in daily discharge and runoff events into waterways (Figure 3). Water clarity was also poor in 2009 (Figure 9) and K_d values (Table 4) indicate that light conditions within the water column were not optimal to facilitate SAV growth.
