2006 Water Quality Newsletter

Bush River, Maryland

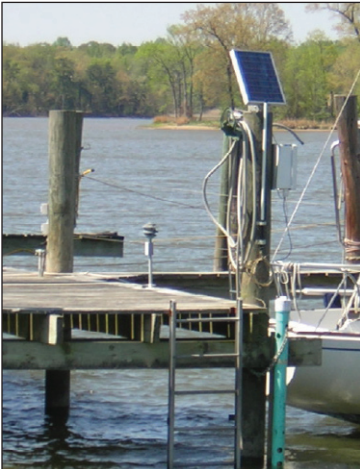
Real-time Continuous Monitoring instrumentation at Lauderick Creek.

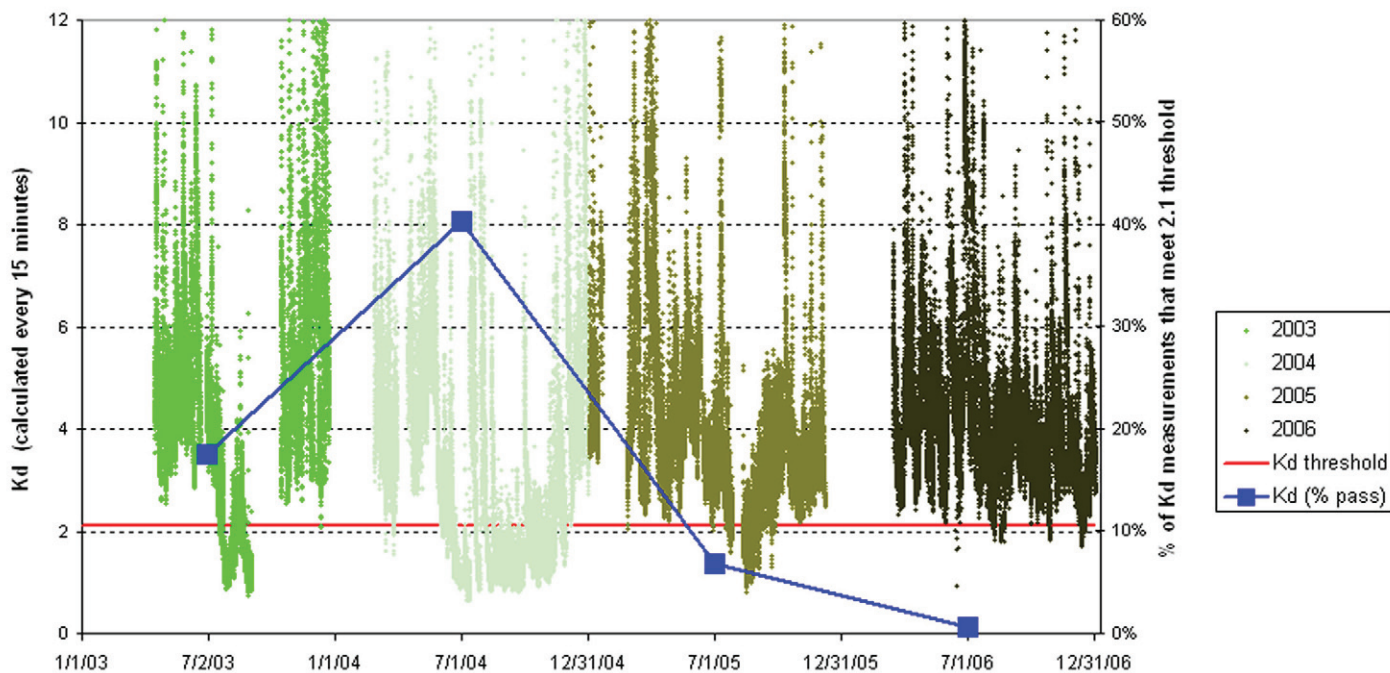
Otter Point Creek Continuous Monitoring Station

Using turbidity, chlorophyll and salinity data from the Continuous Monitoring stations, DNR scientists can calculate the coefficient of light attenuation (Kd). Light attenuation measures how far light travels through the water column. Clear water has a low Kd, while cloudy water has a high Kd. Underwater grasses (SAV) depend on light penetrating the water column, so abundance of grasses can be related to the Kd values. For the Bush River, Kd values at or below 2.1 are considered optimal for SAV growth in depths of one meter or less. Graphing the Kd data for the 4 year period 2003 – 2006 (above) shows that 2004 was the best year for Kd, with a steady decline in the two following years. The graph on page three shows a similar declining trend in SAV acreage.

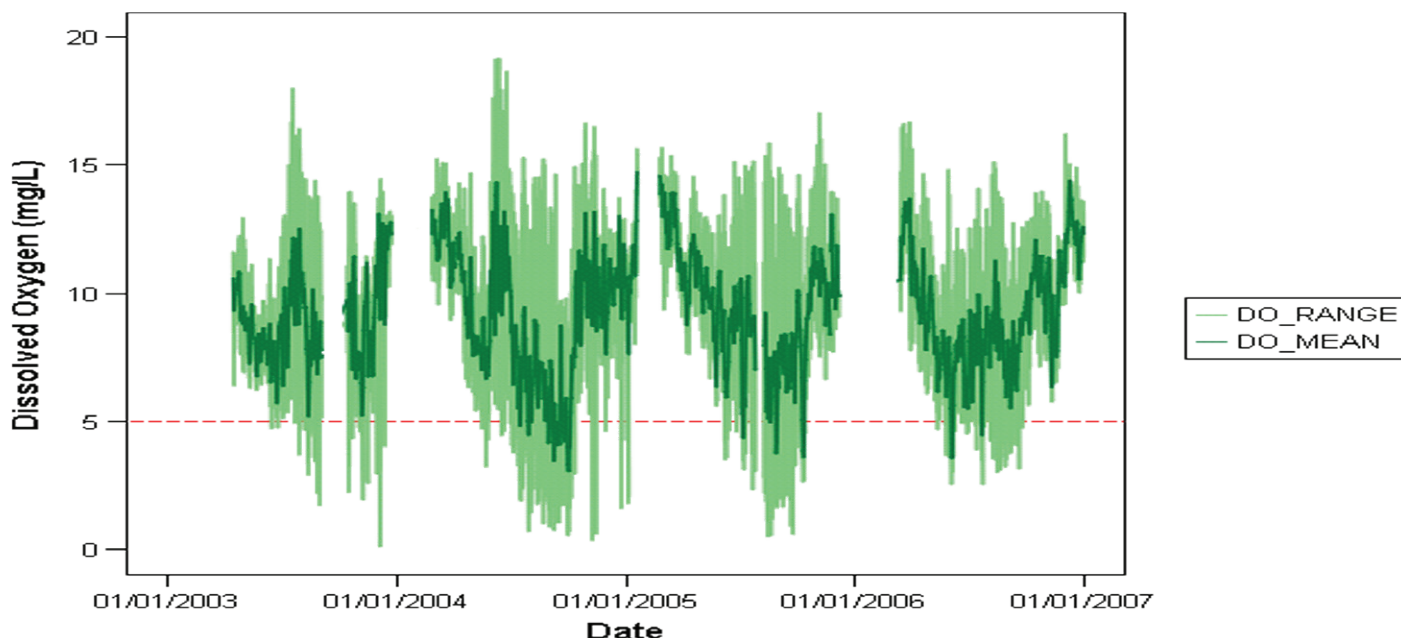
Continuous Monitoring data also shows a highly variable dissolved oxygen range in Otter Point Creek (below). High oxygen levels are observed when a large algal community produces oxygen during daylight hours. At night, when the algae respire, the oxygen is consumed, resulting in very low oxygen levels. The wide variability in the oxygen levels observed at Otter Point Creek suggests a substantial algal community, and many algae blooms have been observed over the last several years.
