Stream Corridor Assessment Survey for the Deer Creek Watershed, Harford County, Maryland

Department of the Environment
1800 Washington Boulevard, Suite 540
Baltimore MD 21230-1718

April 2006

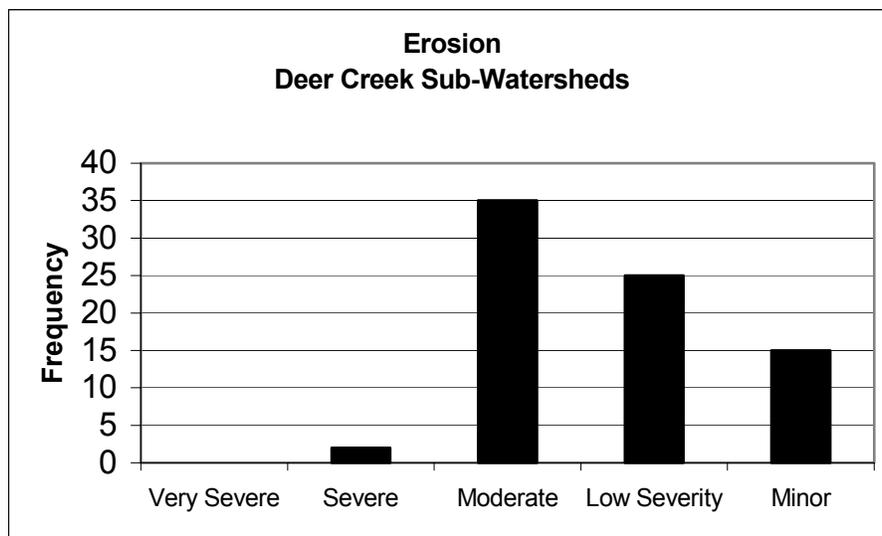
Figure 5a. Histogram showing the frequency of severity ratings given to erosion sites during the Deer Creek SCA survey.

The SCA survey found 77 eroding stream banks over the length of 77,228 feet (14.63 miles) of stream. The severity and location of erosion sites is shown in Figure 5b, and 5c. Two sites are ranked as very severe (Figure 5a). These severe sites were Site 028103 and Site 073101.

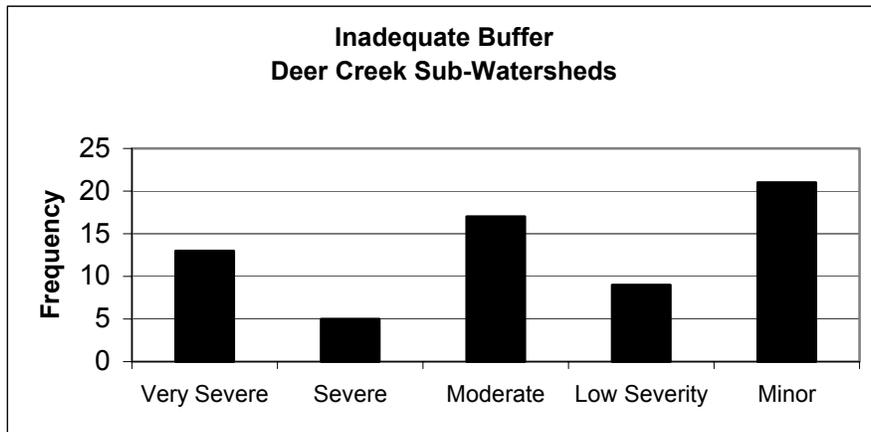
Figure 6a. Histogram showing the frequency of severity ratings given to inadequate buffer sites during the Deer Creek SCA survey.

Survey crews identified 65 inadequate buffer sites with a total length of 72,125 feet (13.66 miles). The severity and location of inadequate buffer sites is shown in Figure 6b, and 6c. Eighteen of these sites are ranked as very severe or severe, while the other sites are moderate, of low severity, or minor (Figure 6a). Land use along the stream at inadequate buffer sites, were reported as mostly shrubs and small trees, lawn and pasture.

Any inadequate buffer site would benefit from the restoration of trees along both stream banks. For sites on agricultural land, farmers also may qualify for federal and state government financial incentives for allowing 50-foot forest buffers to grow on their farmland. Those sites that may have particular natural resource value are headwater streams, or those that form gaps in existing forested buffer areas.

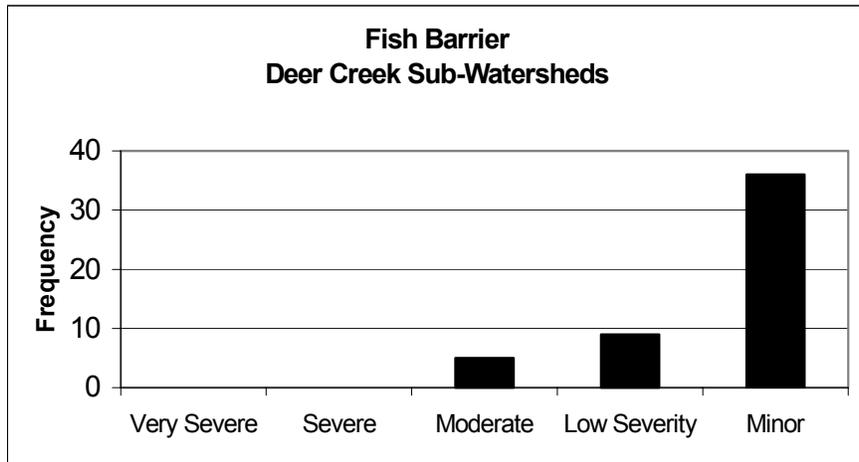
Figure 7a. Histogram showing the frequency of severity ratings given to fish barrier sites during the Deer Creek SCA survey.

The Deer Creek SCA survey found 50 fish migration barriers. The locations of fish blockages are shown in Figure 7b and 7c. Fish barriers in this watershed are due natural falls (17), road crossings (15), beaver dams (2), and debris dams (12), instream ponds (2) and other causes (2). Five of these sites received a moderate rating. In Big Branch the barriers will be to resident fish, because of the dam at Eden Mill.

In restoration work, priority is given to removing fish barriers that will yield access to the greatest quality and quantity of upstream habitat per dollar spent. The mainstem is ideally kept as barrier-free as possible, allowing anadromous fish to migrate to spawn and a source of fish species for tributaries in the event of a disturbance. Restoration planning includes targeting barriers for removal that isolate entire tributaries, those that isolate significant portions of the upper tributary, and those that isolate quality fish habitat. The best restoration sites also are far from other existing fish barriers.

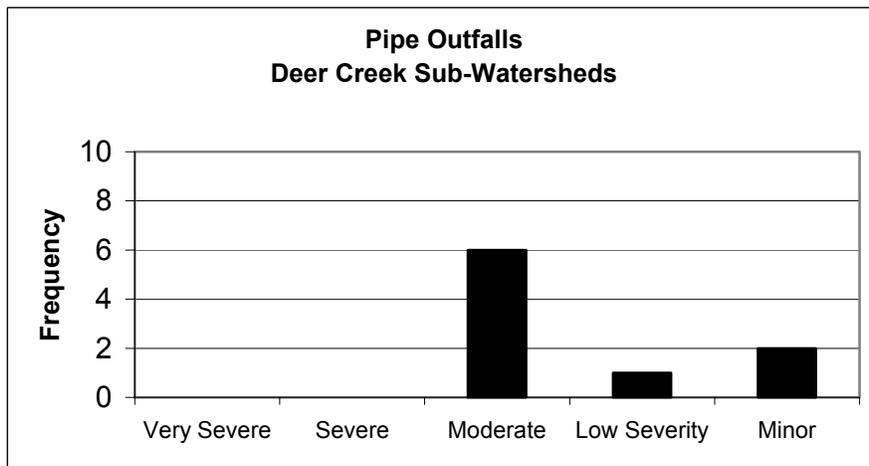
Figure 8a. Histogram showing the frequency of severity ratings given to pipe outfalls sites during the Deer Creek SCA survey.

Pipe outfalls include any pipes or small, constructed channels that discharge into the stream through the stream corridor. Pipe outfalls are considered a potential environmental problem in the survey because they can carry uncontrolled runoff and pollutants such as oil, heavy metals and nutrients to a stream system. The survey crew identified a total of 9 pipe outfalls. The severity and location of pipe outfall sites is shown in Figure 8b. All the pipe outfalls were located in the Coolbranch Run and Tobacco Run Sub-Watershed.

Six of the pipes had a discharge. All were clear with no odor. The pipes were rated as moderate. The remaining pipes did not have any discharge.

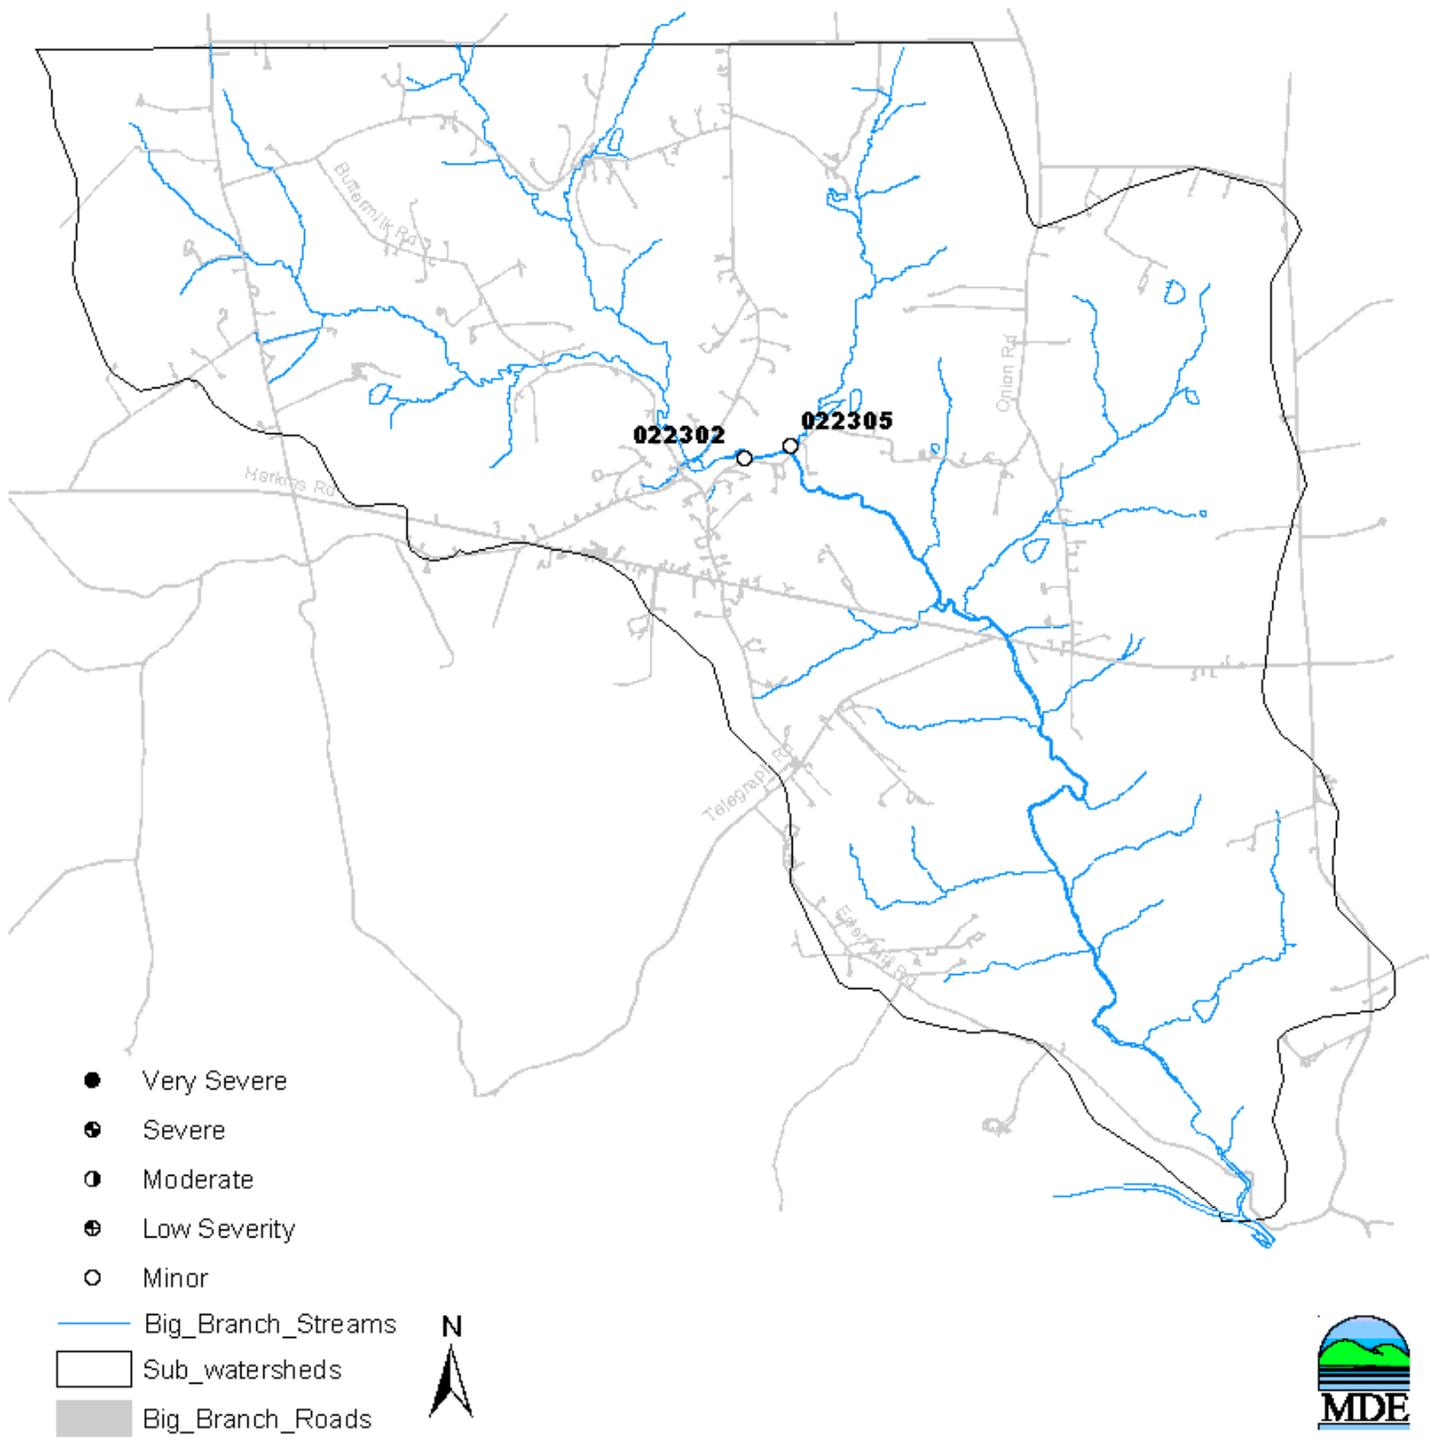
Figure 9a: Map showing the locations of Channel Alterations in Big Branch

Results of this survey show recognizably altered stream channels at 4 sites. The severity and location of channel alteration sites is shown in Figure 9a and 9b. The total length of stream affected by channelization is estimated to be 240 feet (0.05 miles). All the sites were rated as minor.

Restoring channel alteration sites can increase fish and wildlife habitat and may allow for more time for nutrient uptake in the waterway. In its simplest form, restoration for earth channels would include allowing vegetation and/or tree roots to stabilize the sediment along the channel, causing sinuosity to re-form naturally. This sinuosity may reform within the bed of the channelization or along its banks, depending on the site and the depth of the channel alteration.

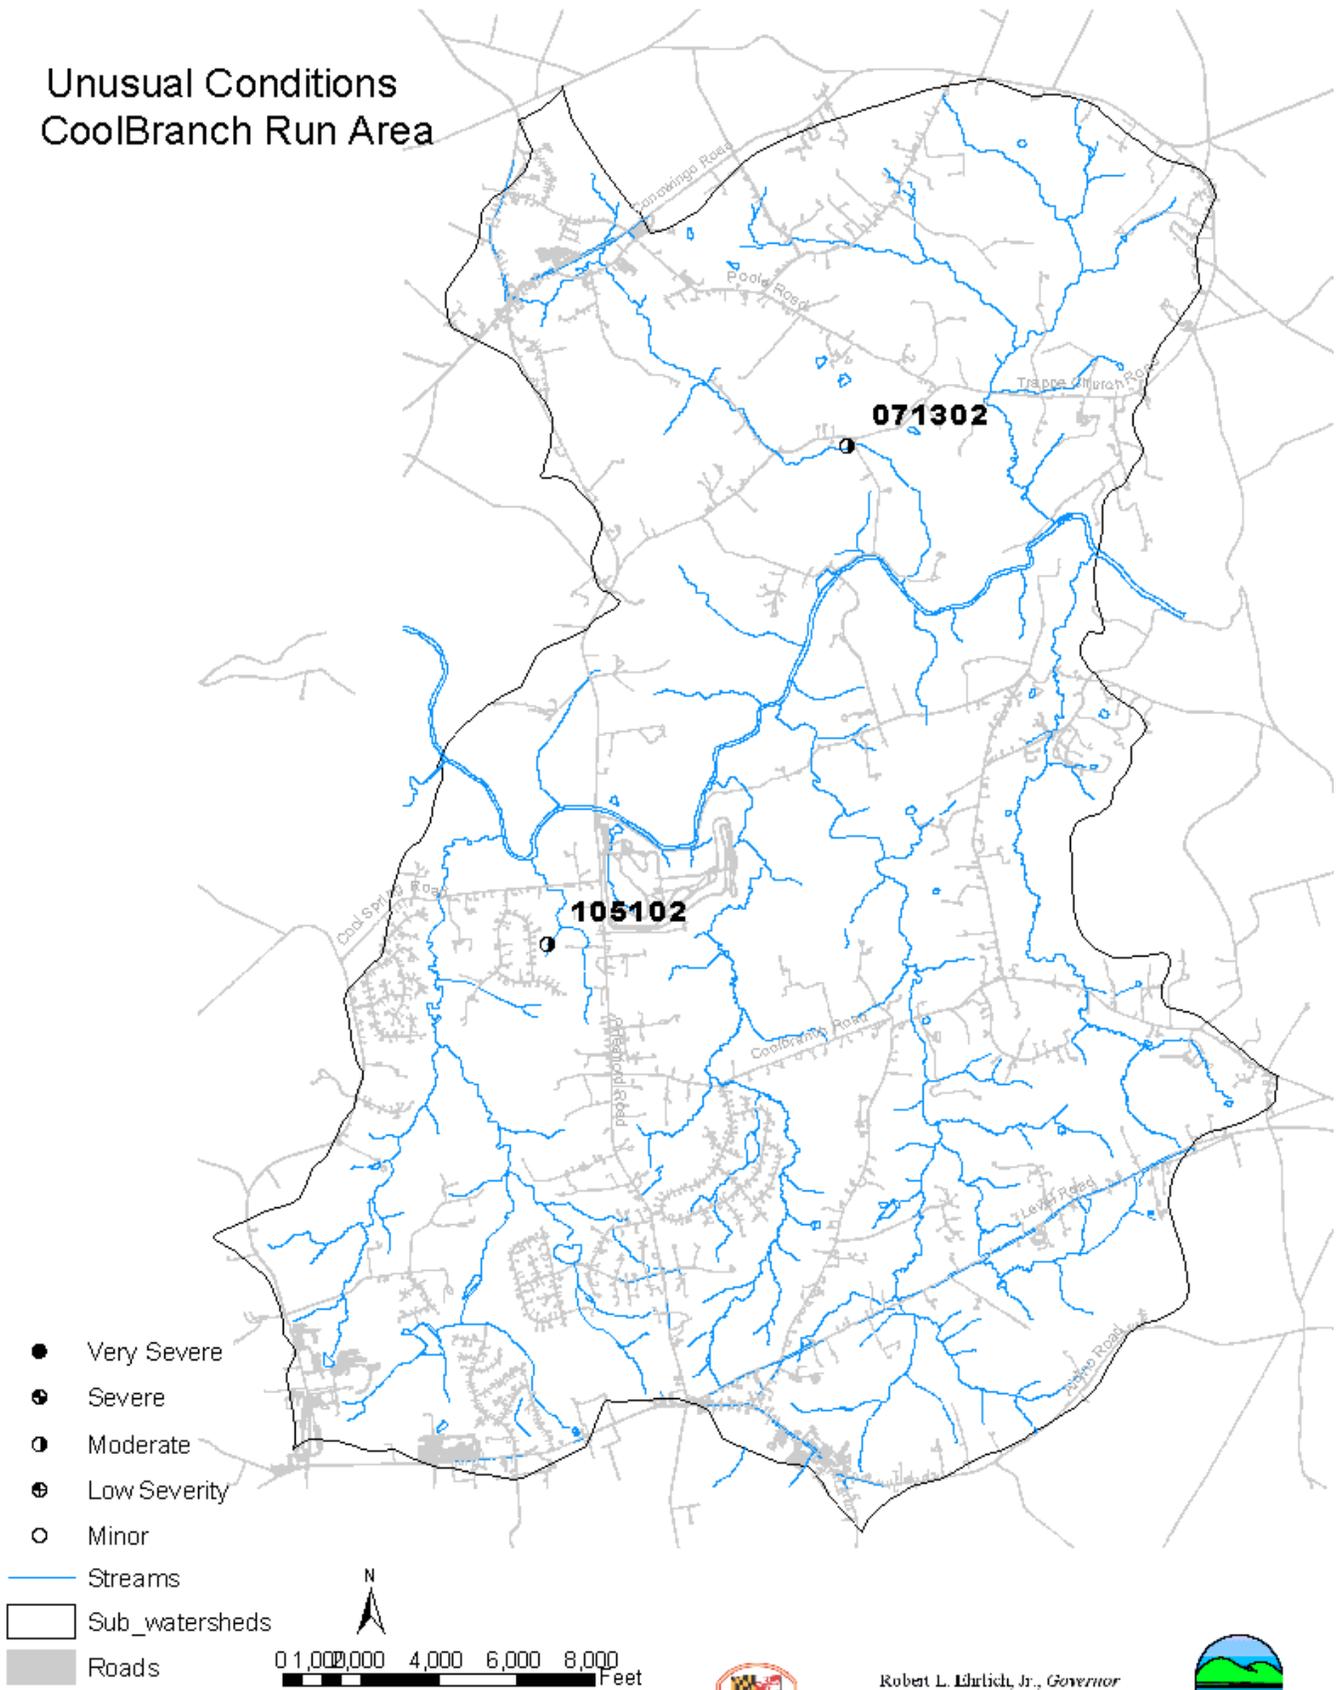
Figure 12: Map showing the locations of Unusual Conditions in Coolbranch Area

Survey teams record unusual conditions or comments to note the location of anything out of the ordinary observed during the survey or to provide additional written comments on a specific problem site. The survey crew identified 2 unusual conditions and 4 comments. The severity and location of unusual condition sites is shown in Figure 12.

Comment sites include data on places where survey crews encountered a stream dried up, pond breach created heavily eroded and unstable banks, a drainage ditch, and at the Exposed pipe Site 130105, the pipe may no longer be in use.

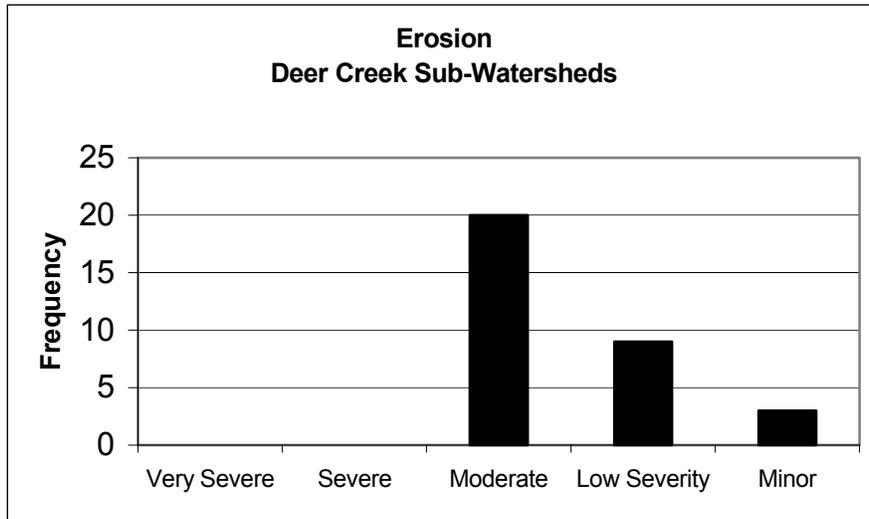
Figure 14a. Histogram showing the frequency of severity ratings given to erosion sites during the Deer Creek SCA survey.

The survey found 32 eroding stream banks over the length of 23,740 feet (4.5 miles) of stream. The severity and location of erosion sites is shown in Figure 14b, and 14c.

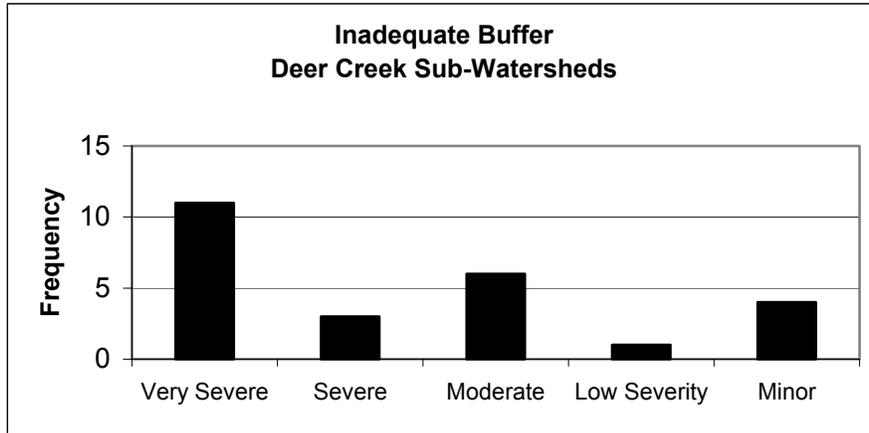
Figure 15a. Histogram showing the frequency of severity ratings given to inadequate buffer sites during the Deer Creek SCA survey.

Survey crews identified 25 inadequate buffer sites with a total length of 36,000 feet (6.8 miles). The severity and location of inadequate buffer sites is shown in Figure 15b, and 15c. Fourteen of these sites are ranked as very severe or severe, while the other sites are moderate, of low severity, or minor (Figure 15a). Land use along the stream at inadequate buffer sites, were reported as mostly shrubs and small trees, lawn and pasture.

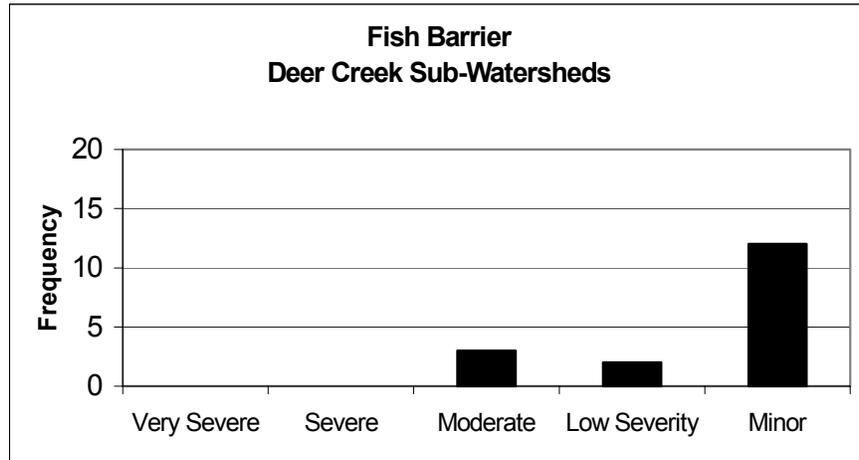
Figure 16a. Histogram showing the frequency of severity ratings given to fish barrier sites during the Deer Creek SCA survey.

The survey identified 17 fish migration barriers. The locations of fish blockages are shown in Figure 16b and 16c. Fish barriers in this watershed are due natural falls (4), road crossings (3), debris dams (8), and instream ponds (1). Three of these sites received a moderate rating.

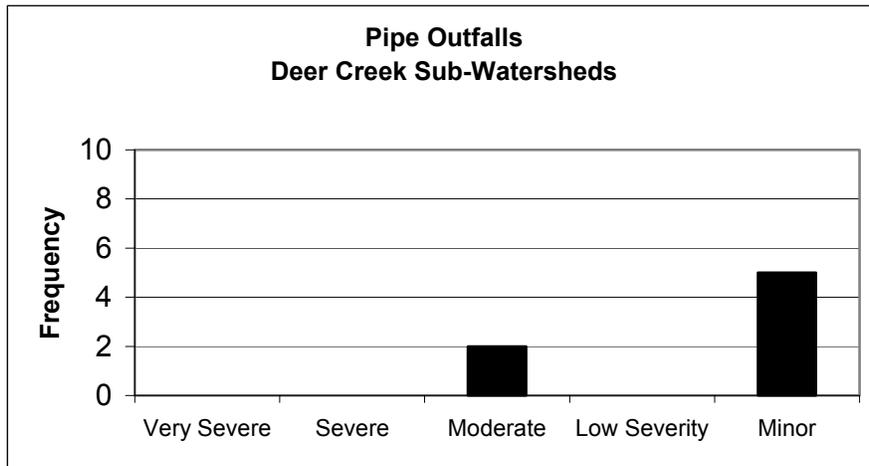
Figure 17a. Histogram showing the frequency of severity ratings given to pipe outfalls sites during the Deer Creek SCA survey.

The survey crew identified a total of 7 pipe outfalls. The severity and location of pipe outfall sites is shown in Figure 17b and 17c. Two of the pipes had a discharge. Both were clear with no odor. The pipes were rated as moderate. The remaining pipes did not have any discharge.

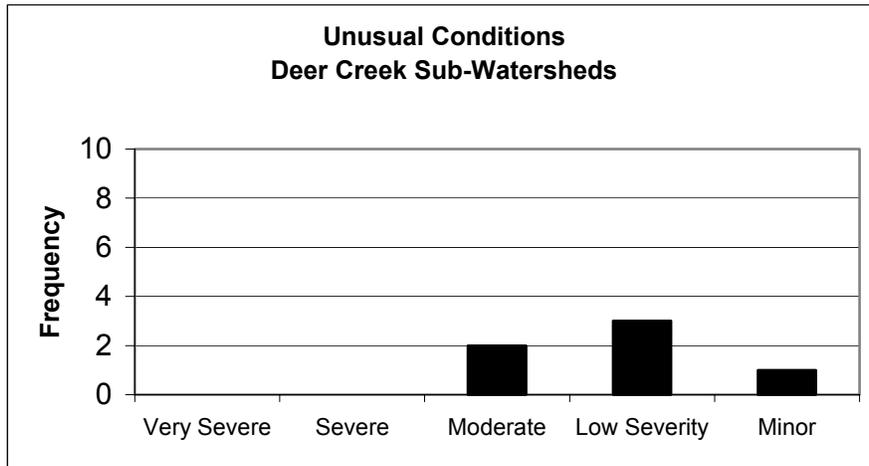
Figure 18a. Histogram showing the frequency of severity ratings given to unusual condition sites during the Deer Creek SCA survey.

The survey crew identified 6 unusual conditions and 1 comment. The severity and location of unusual condition sites is shown in Figure 18b. Two unusual conditions were where there were tractor/truck stream crossings. One of which was indicated to have some sediment issues. Site 399105 was reported to have excessive algae. Site 358211 was an area where the stream has been piped. Site 386103 is a place where sand bags have been placed in the stream to enhance a stone weir to create a pond. Site 337204 is an area where rocks have been placed as bank stabilization.

The comment site indicated an area where wood had been dumped in the stream.

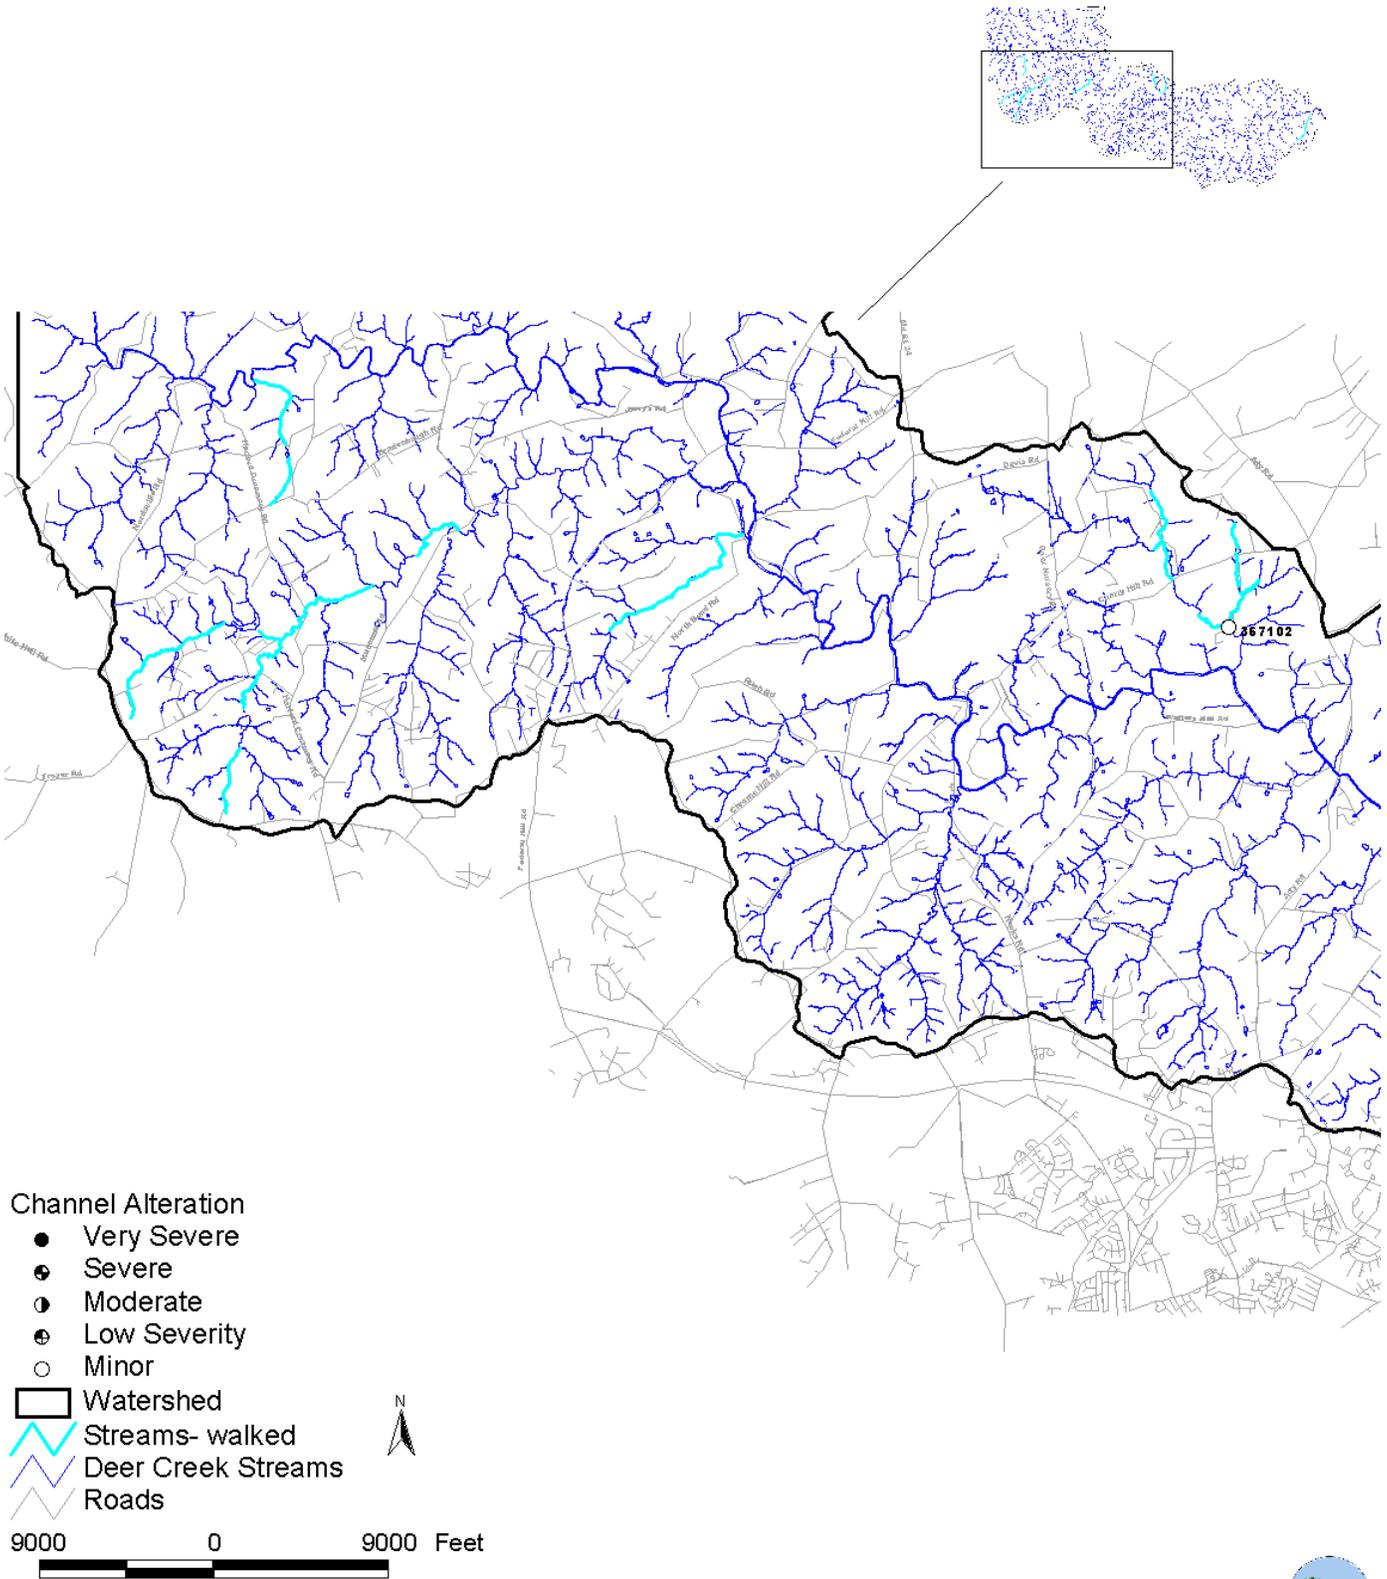
Figure 19a: Map showing the locations of the Channel Alterations in the second round of fieldwork in the Deer Creek Watershed

Results of this survey show recognizably altered stream channels at 2 sites. The severity and location of channel alteration sites is shown in Figure 19a and 19b. The total length of stream affected by channelization is estimated to be 350 feet.

Restoring channel alteration sites can increase fish and wildlife habitat and may allow for more time for nutrient uptake in the waterway. In its simplest form, restoration for earth channels would include allowing vegetation and/or tree roots to stabilize the sediment along the channel, causing sinuosity to re-form naturally. This sinuosity may reform within the bed of the channelization or along its banks, depending on the site and the depth of the channel alteration.

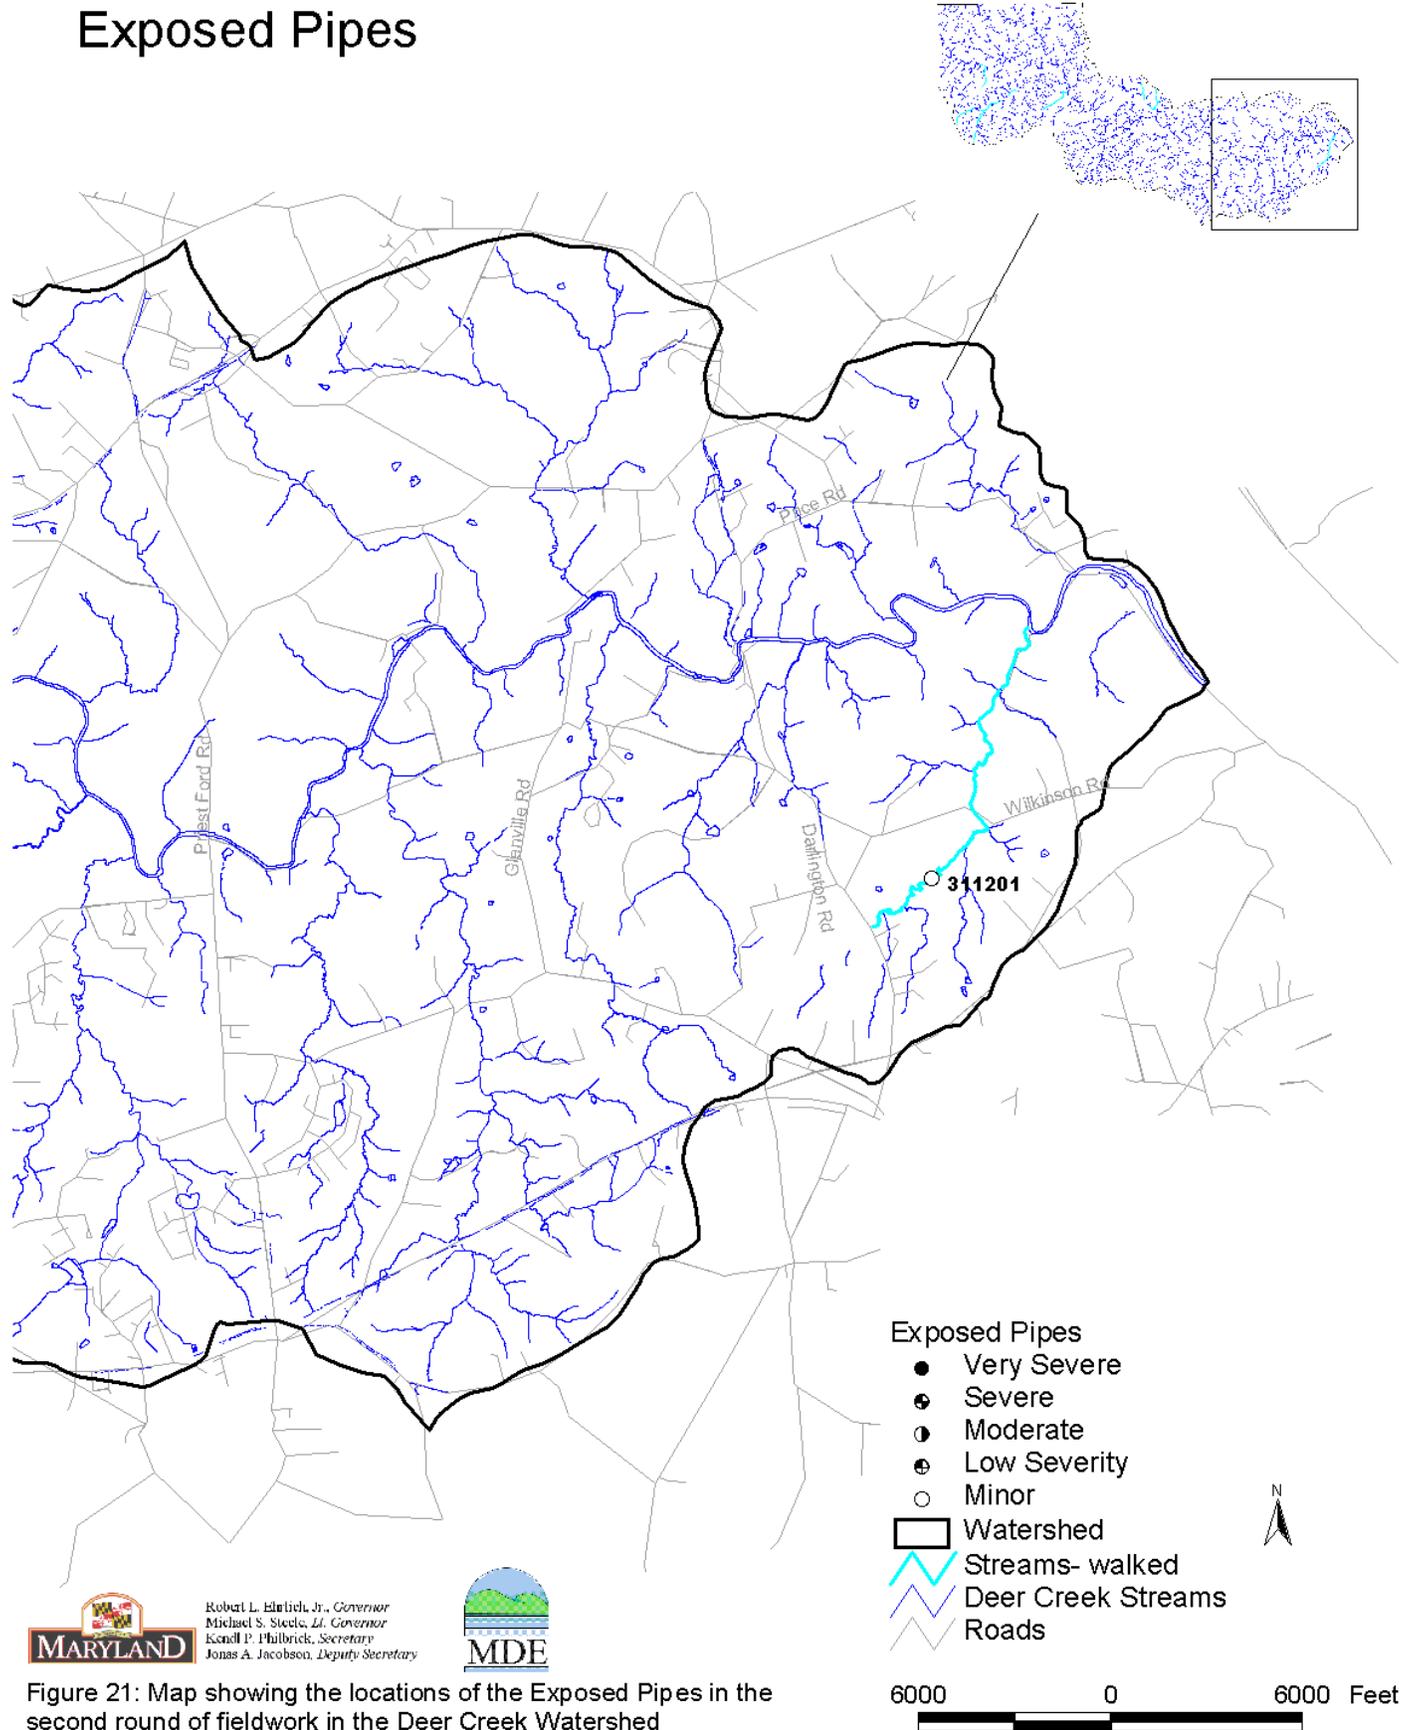
Figure 21: Map showing the locations of the Exposed Pipes in the second round of fieldwork in the Deer Creek Watershed

Field crews observed one exposed pipe during the survey. The one pipe was rated minor in severity. The pipe was reported to not have any discharge at the time of the survey. Location of this site is shown in Figure 21.
