Stream Corridor Assessment Survey Of The Little Patuxent River In Howard County

Watershed Restoration Division
Chesapeake & Coastal Watershed Services
Maryland Department of Natural Resources
September 2001

**STREAM CORRIDOR
ASSESSMENT SURVEY
OF THE
LITTLE PATUXENT RIVER
IN HOWARD COUNTY**

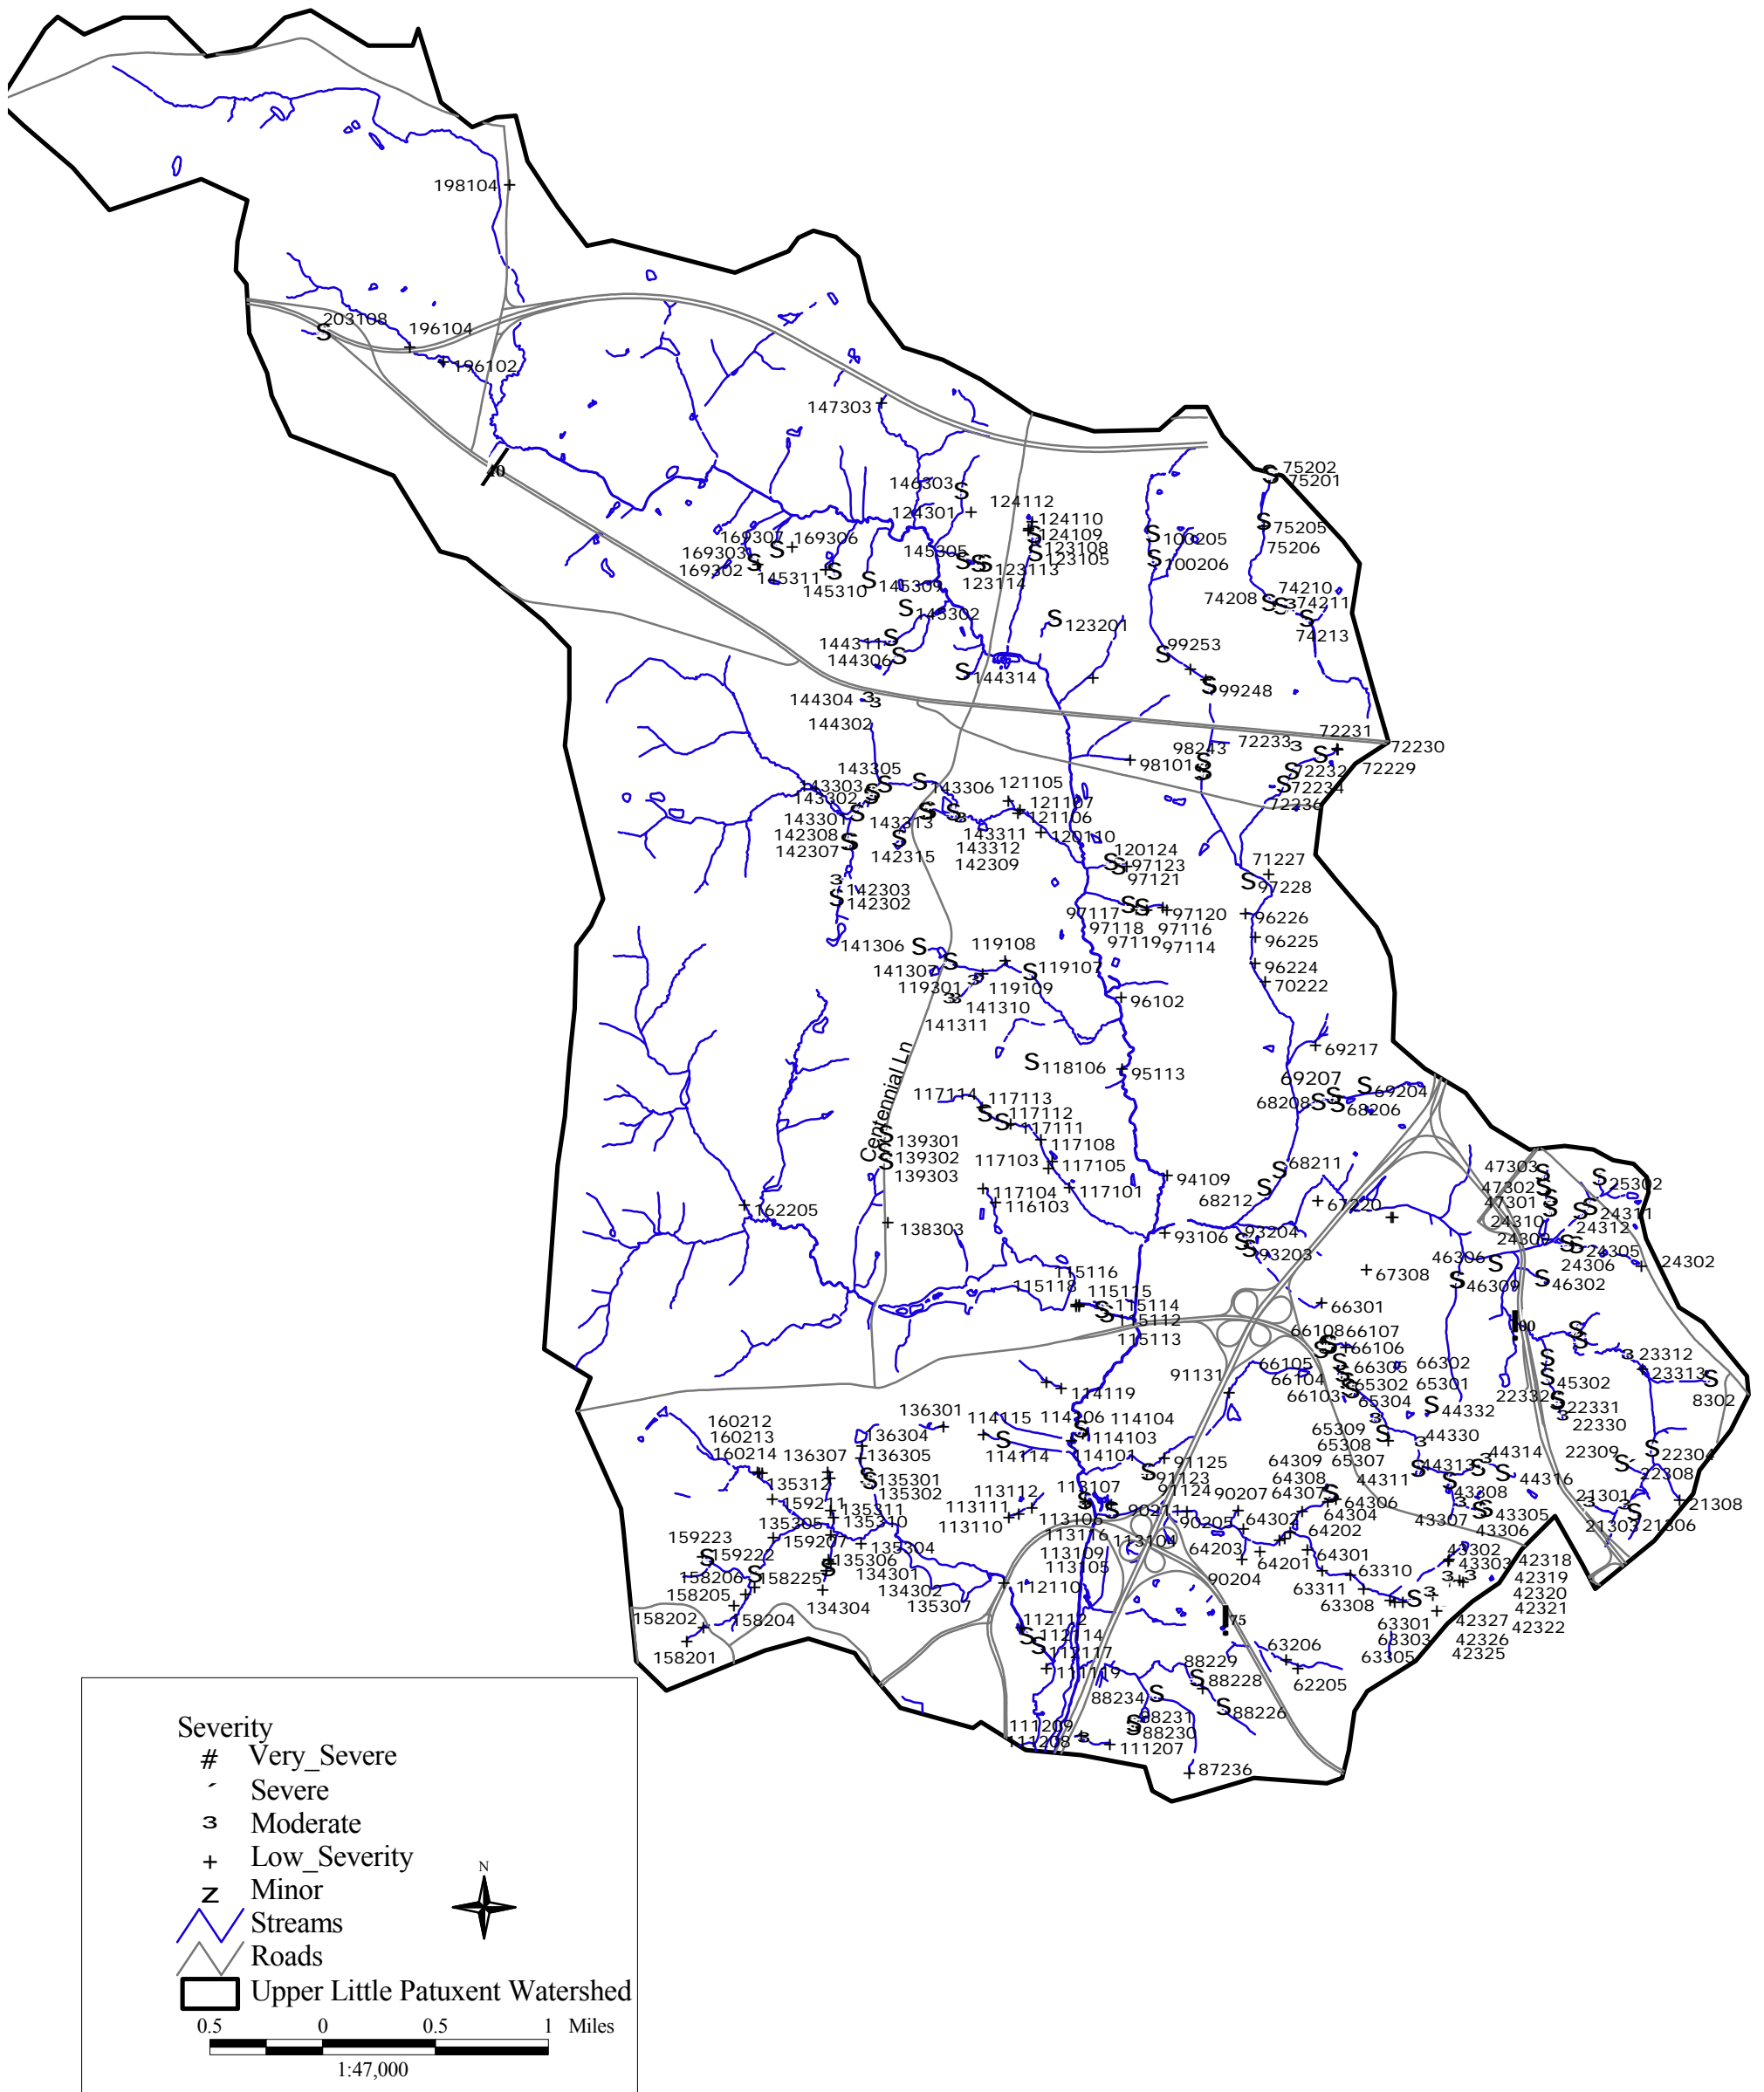
Figure 4a: Map of Upper Little Patuxent Watershed Pipe Outfalls

Pipe outfalls include any pipes or small man made channels that discharge into the stream through the stream corridor. Pipe outfalls are considered a potential environmental problem in the survey because they can carry uncontrolled runoff and pollutants such as oil, heavy metals and nutrients to a stream system. A total of 529 pipe outfalls were identified during the survey, making it the most frequently reported problem (Figure 4a). This is not surprising since much the Little Patuxent River flows through the communities of Columbia, Guilford and Savage and much of the land in the watershed has been urbanized. The locations of pipe outfalls are shown in Figure 4 a & b. As expected, most of the pipe outfalls are located in the more urbanized central portion of the watershed.

Figure 4c shows the frequency of the severity rating given to pipe outfalls during the survey. As can be seen from the graph, the majority of the pipe outfalls were given either a very low or minor severity rating. Only one problem at Site LP110234 received a very severe rating. During the survey, field crews found an open manhole that was discharging sewage at a rapid rate at this site. This problem was reported to Howard County and was corrected immediately. Two other sites (Sites LP022308 and LP082342) received a severe rating and at both of these sites, a colored discharge and a sewage smell were reported. There were no estimates of the amount of fluid coming from the pipes. No immediate follow up actions were taken as part of this study to determine the source of the color or smell coming from any of the pipes. In some cases, coloration or smell from a storm drainpipe may be a sporadic occurrence. This is especially true in areas where there is no stormwater management system present.

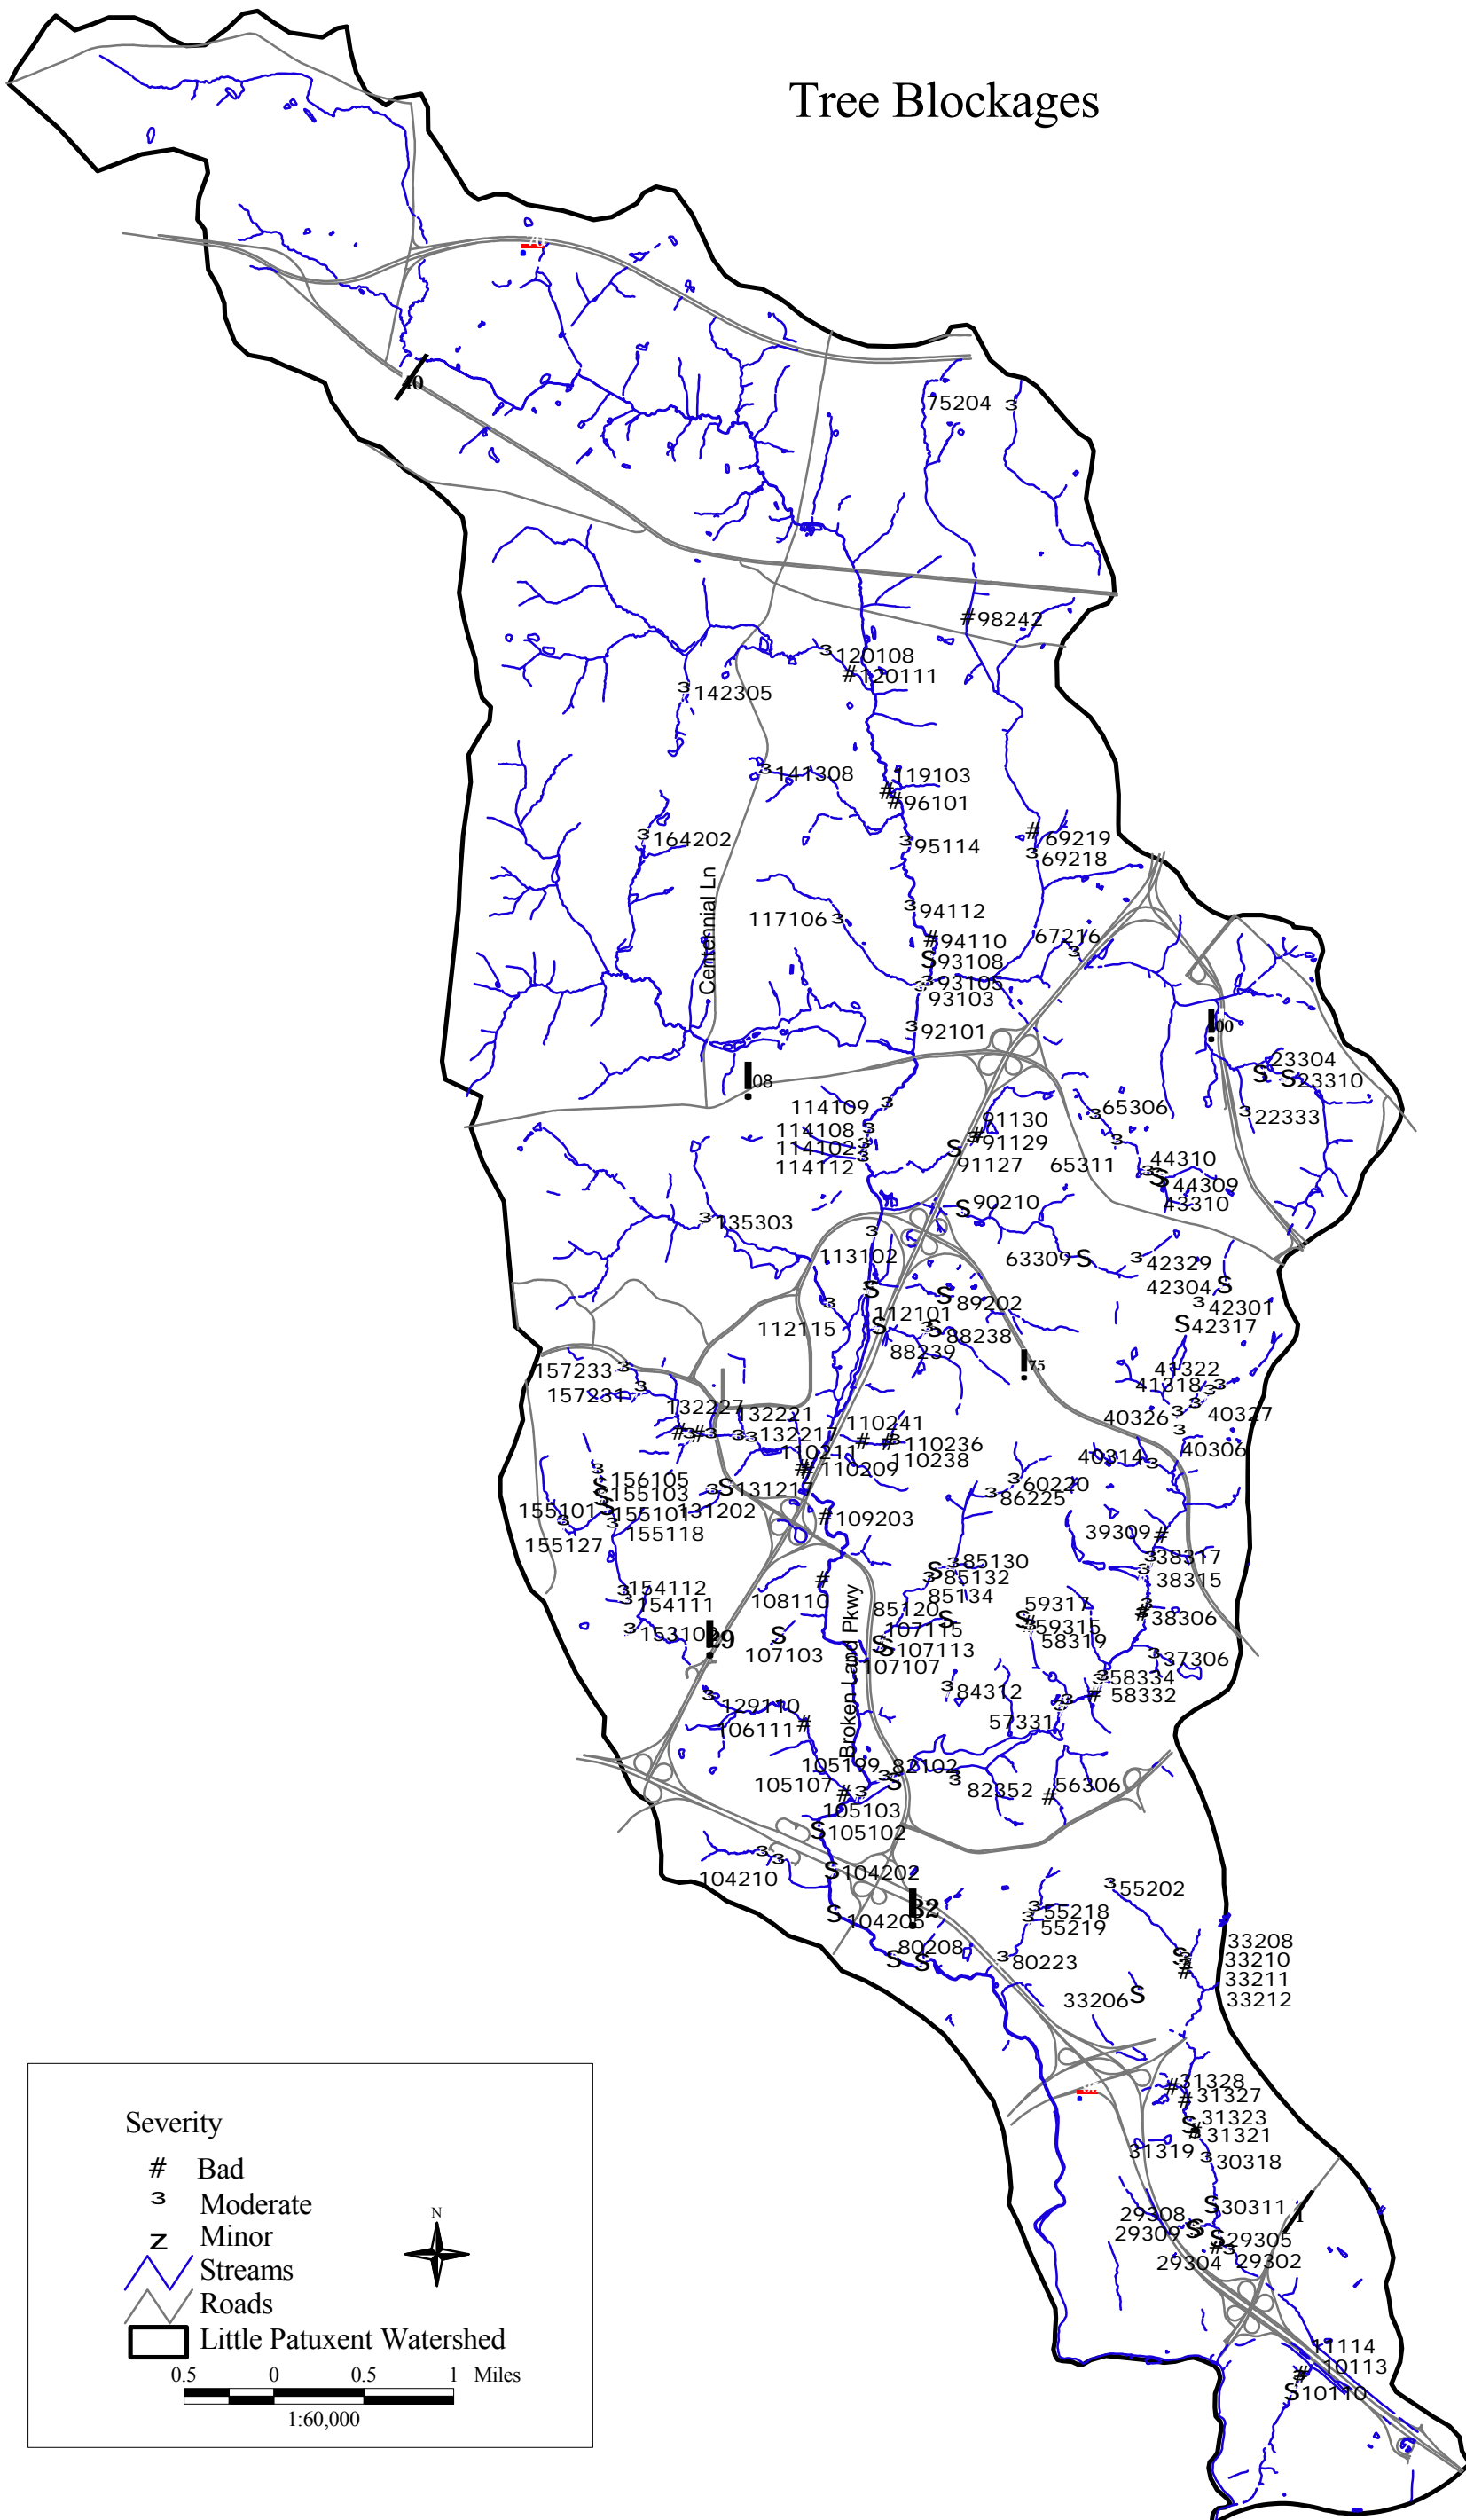
Figure 5: Map of Little Patuxent Watershed Tree Blockages

The survey crew recorded one hundred forty-eight tree blockage sites. The locations of tree blockages are shown in Figure 5. Thirty-two of these blockages were within 250 feet of a bridge or culvert and 30 were within 1000 feet. Severity was recorded as “bad” at 28 sites, “moderate” at 82 sites, and “minor” at 38 sites. This severity rating is based to the size of the blockage and the amount of debris present at a site. Most of the tree blockages are concentrated in the central portion of the watershed. This area is much more developed and has a larger amount of erosion that can lead to trees slumping down into the stream. Only 15% of the tree blockages were located in an area described as “natural”. “Natural” areas were forested areas without development of any kind. The remaining 85% occurred in areas that were considered partially to fully developed. No serious debris jams of road crossings were observed during this survey.

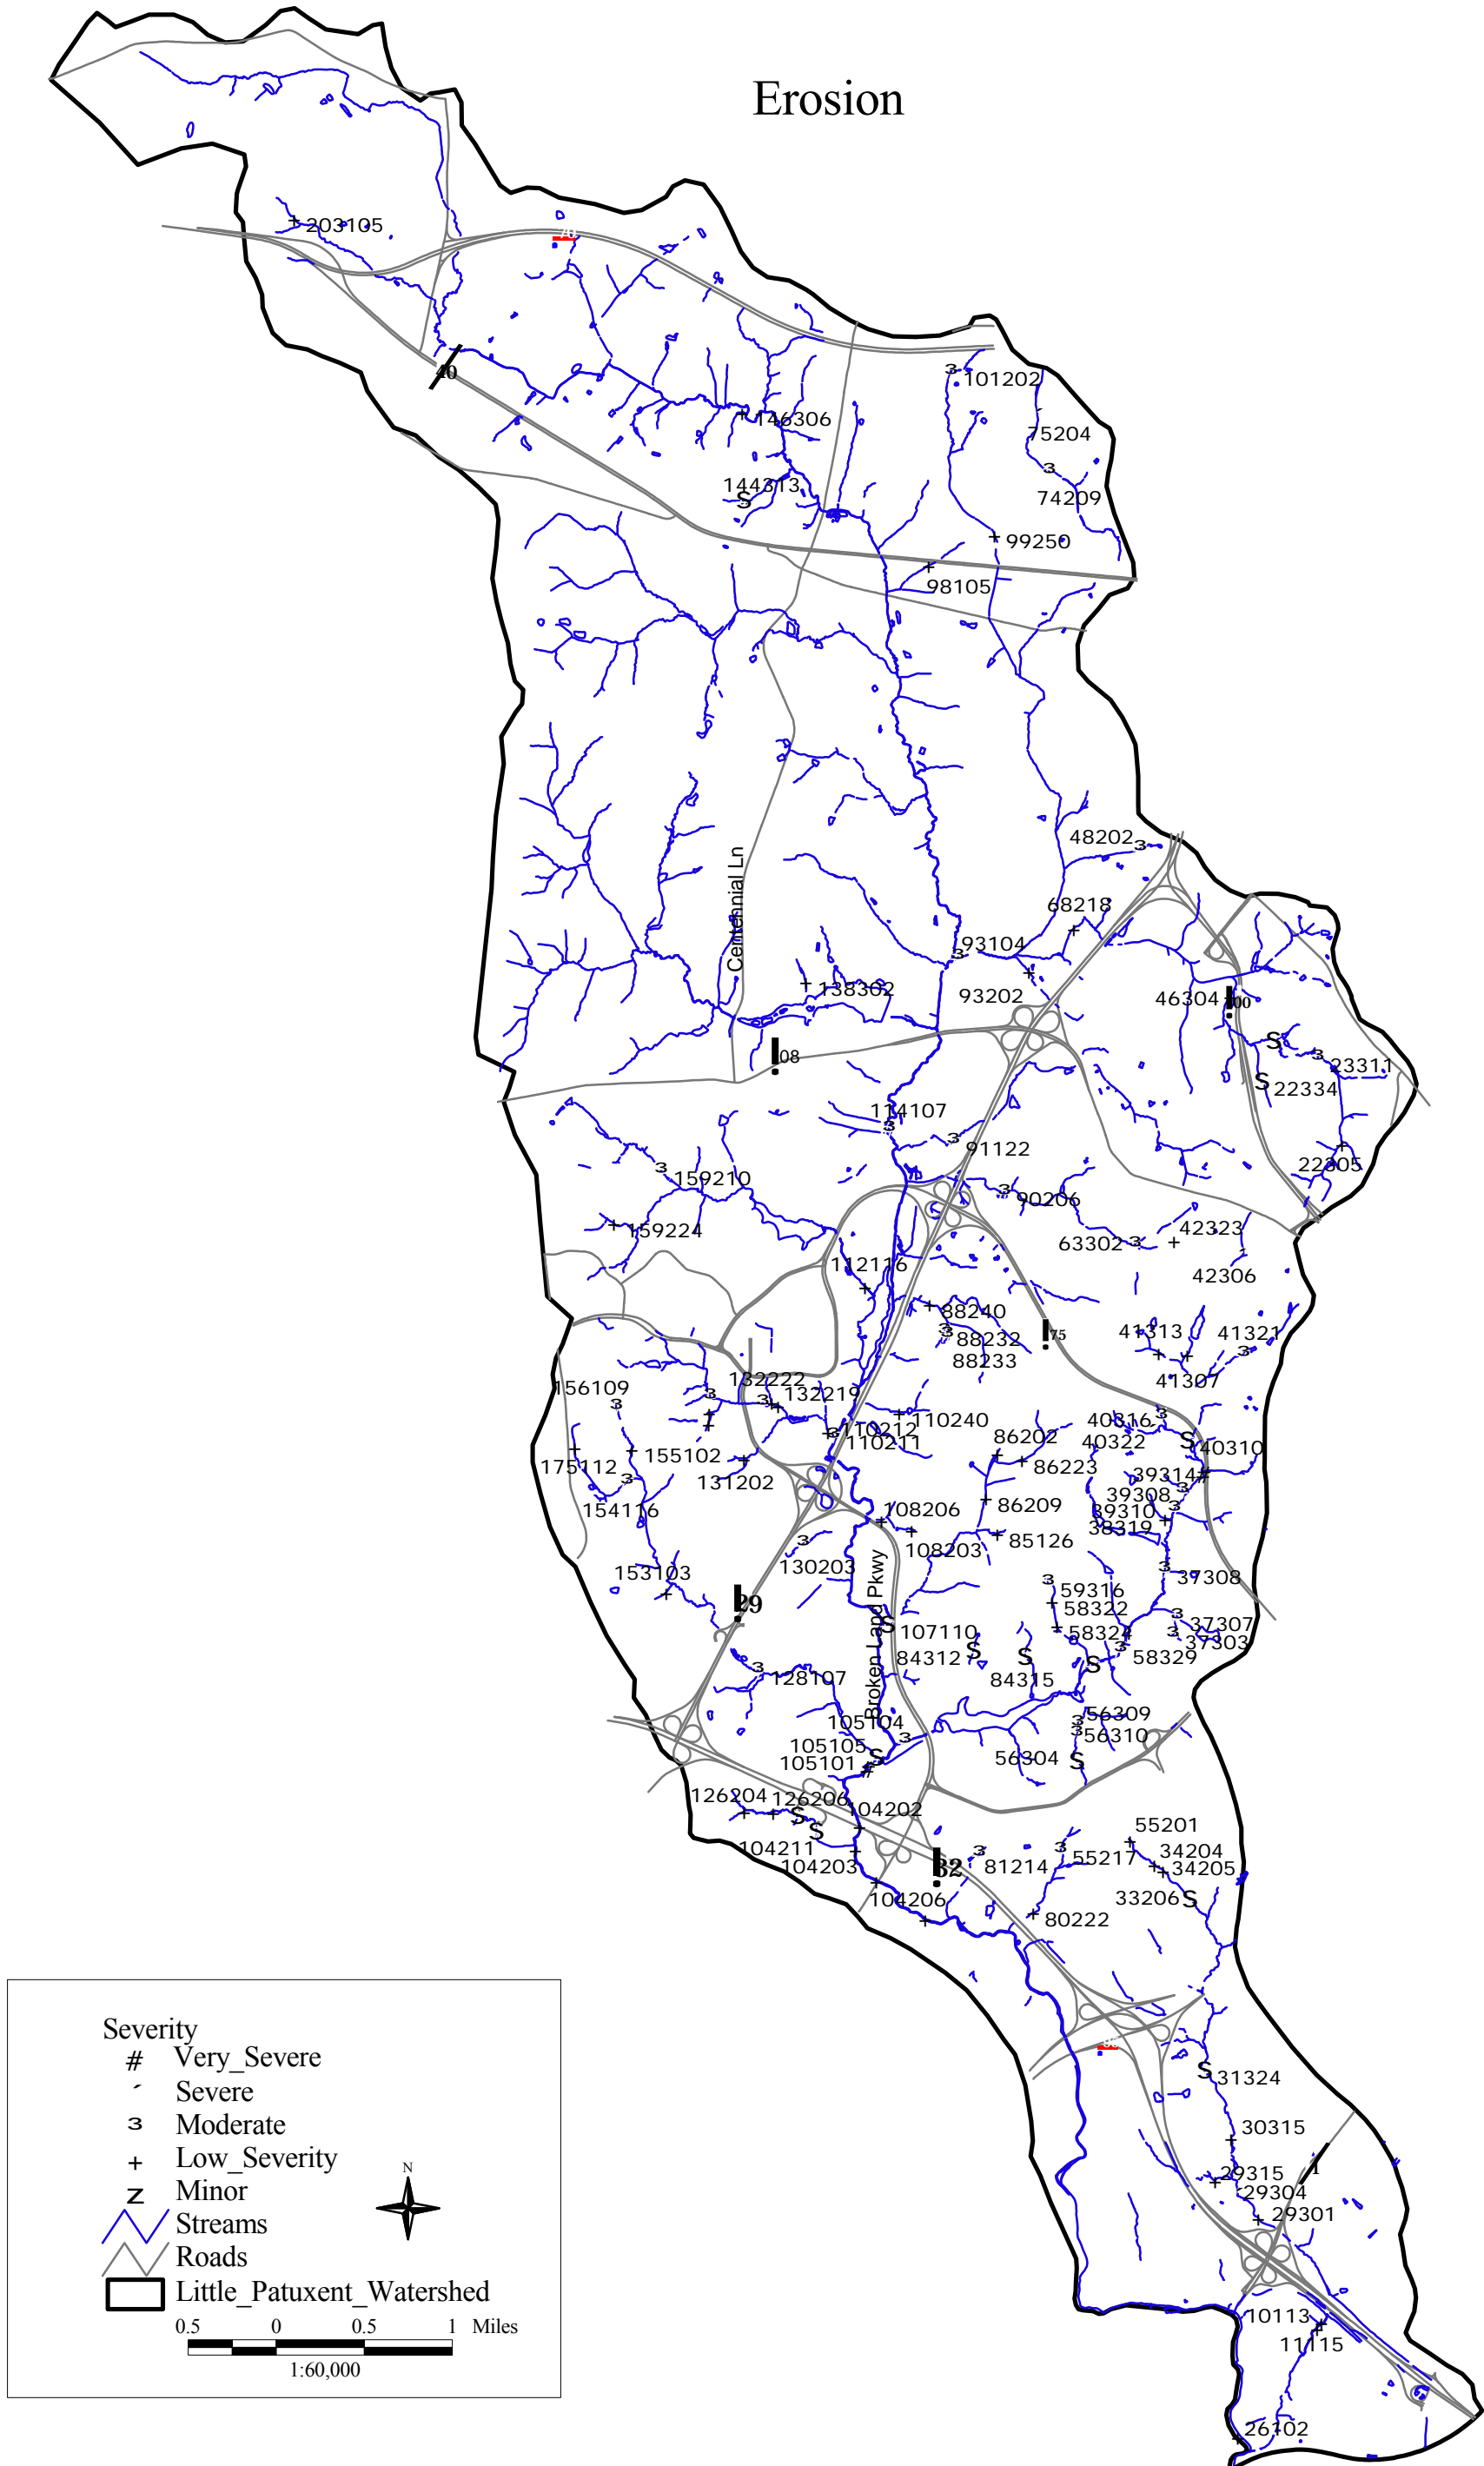
Figure 6a: Map of Little Patuxent Watershed Erosion Sites

Unstable eroding streams are areas where the stream banks are almost vertical and the roots from the vegetation along the stream's banks are unable to hold the soil on the banks. Unstable eroding stream banks were reported at 103 sites during the survey (Figure 6a). The majority of the erosion sites showed moderate to minor erosion that extended over long distances. The lengths of stream segments that were recorded as having unstable banks varied from 6 feet in some areas, to other areas where up to 2 miles of stream was found to have an erosion problem (Appendix C). Overall, results indicate approximately 9.7 miles of unstable eroding banks in the Little Patuxent watershed. Figure 6b shows the frequency of the severity rating given to erosion sites. Only two sites received a very severe rating and five other sites were rated as severe.

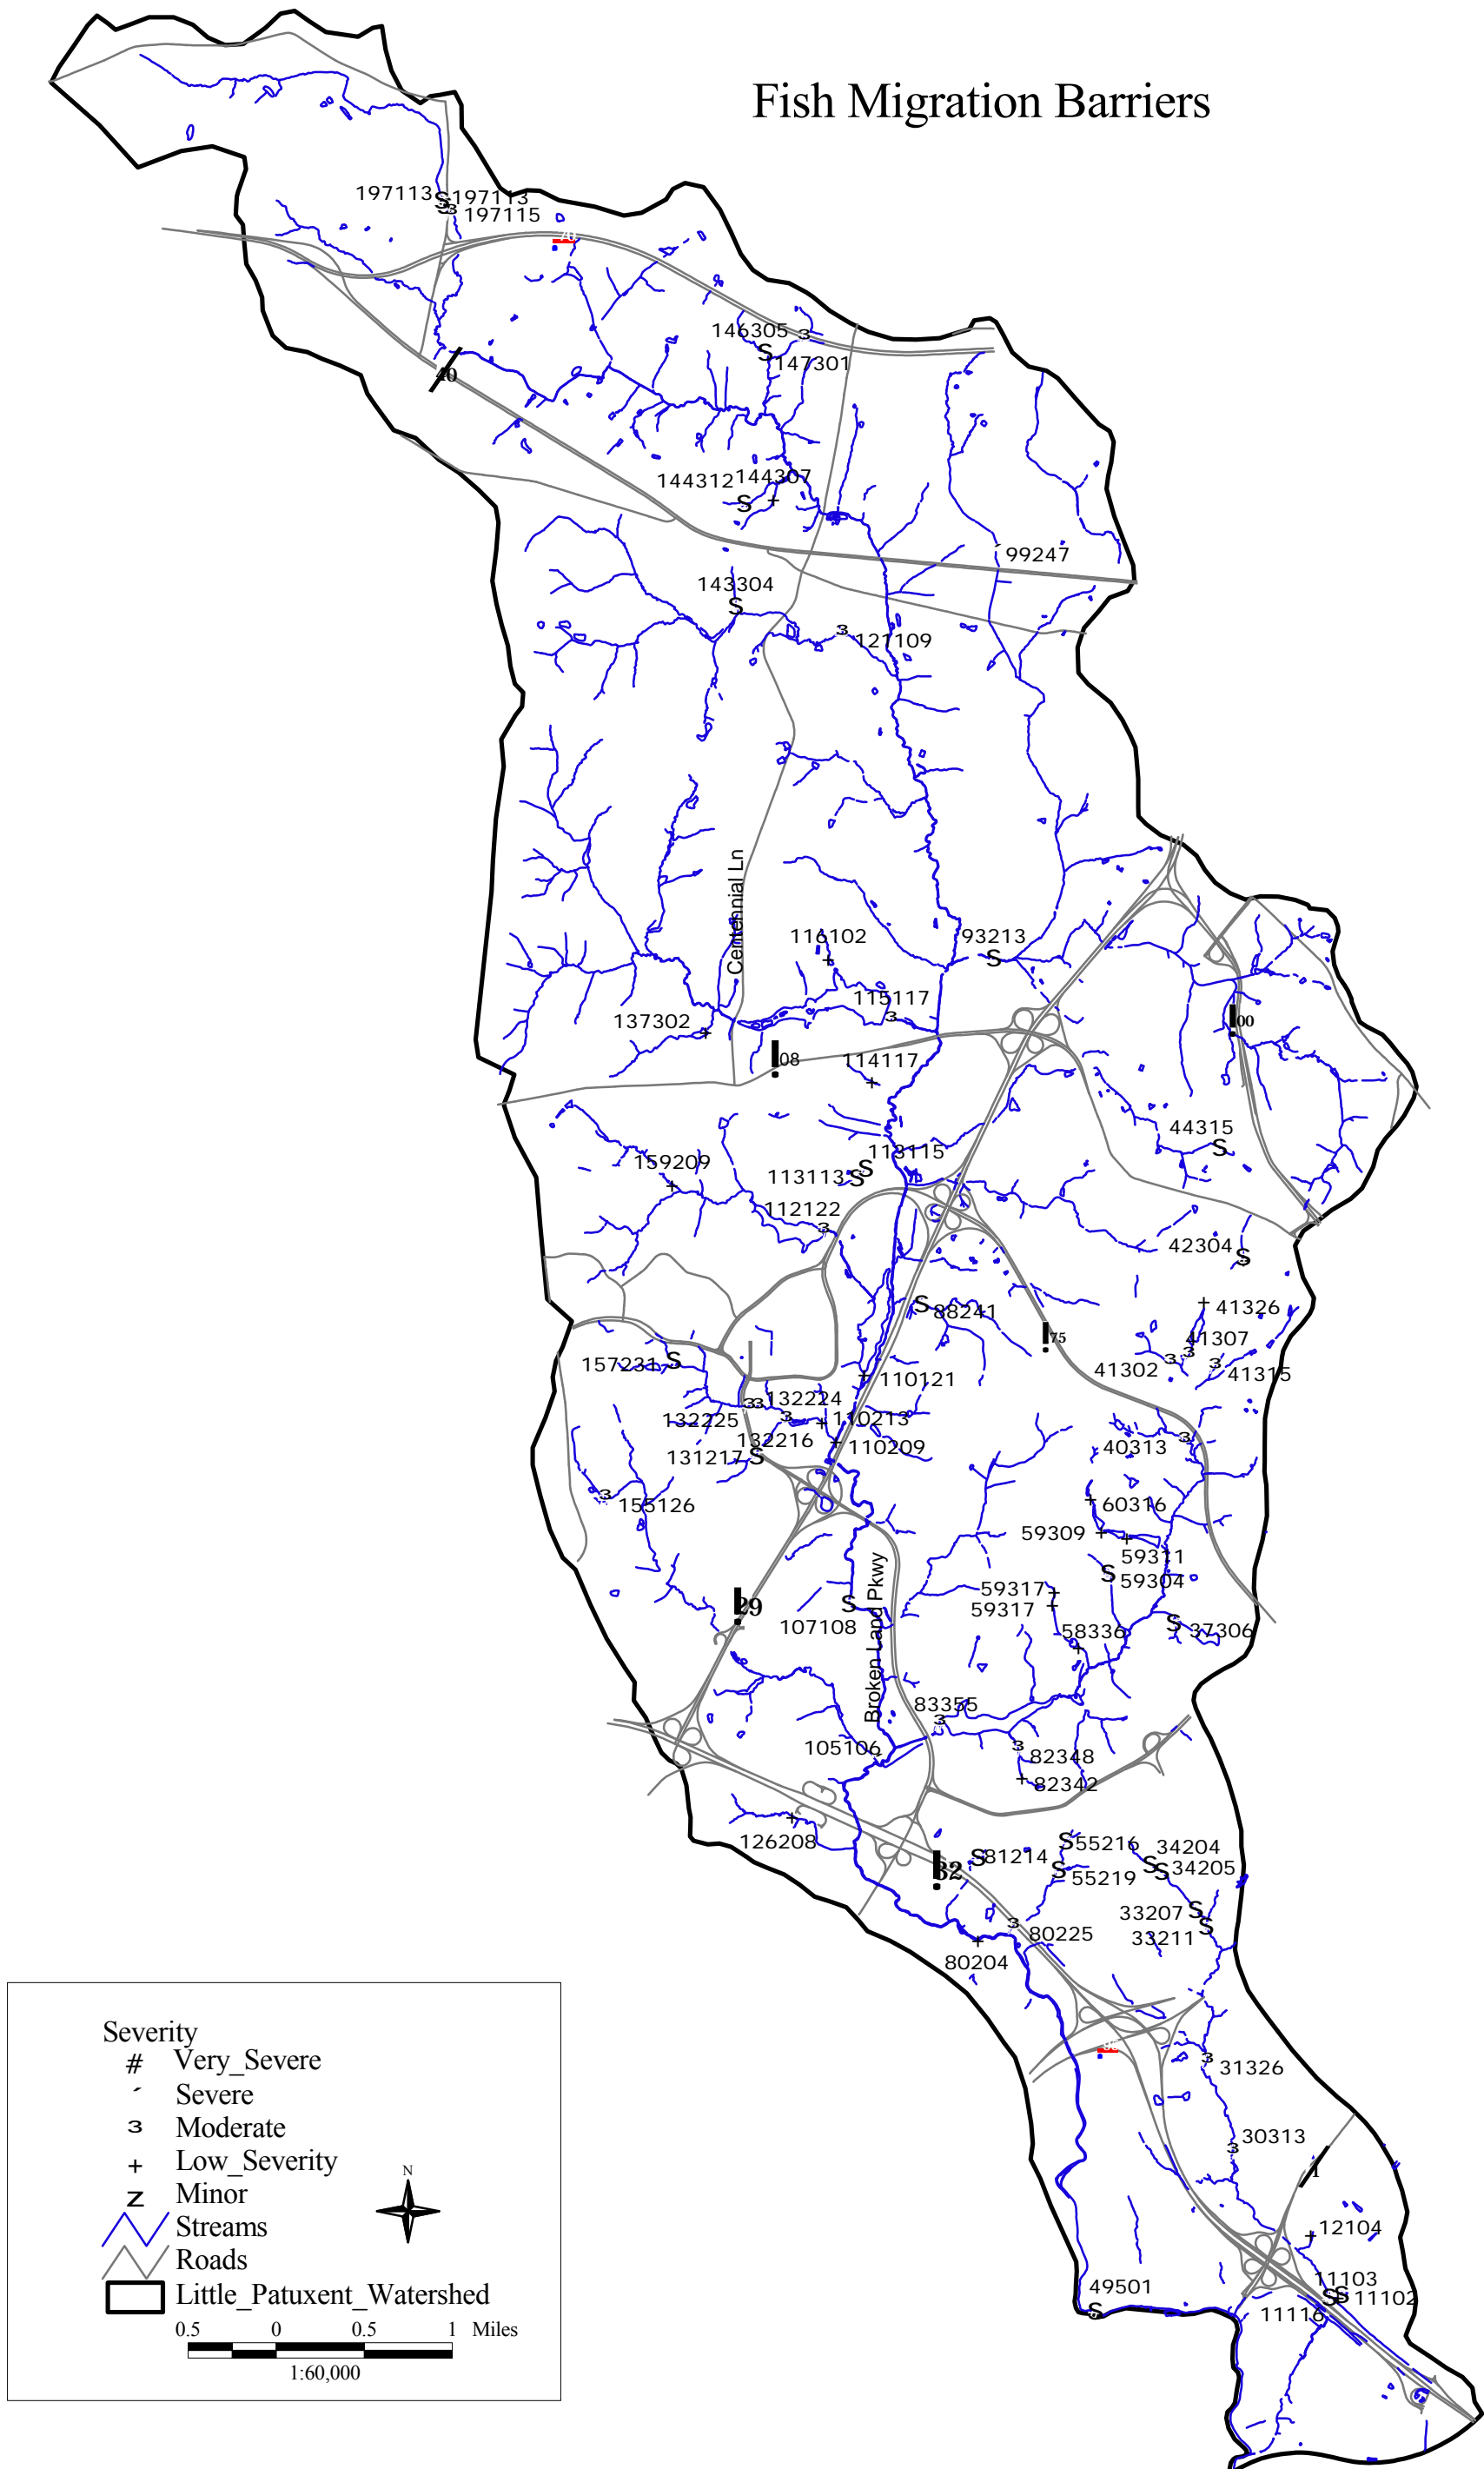
Figure 8a: Map of Little Patuxent Watershed Fish Migration Barrier Sites

Sixty-seven fish migration barriers were reported during the survey. The locations of fish migration blockages are shown in Figure 8a. The blockages were due to a number of reasons including small dams (10), road crossings (17), pipe crossings (5), channelized stream sections (5), natural falls (8), ponds (7), and debris dams (11). Of the remaining fish blockages, gabion baskets and a weir were reported to cause one fish migration blockage each. Most of the sites were given moderate to minor severity ratings (Figure 8b). Overall, the mainstem of the Little Patuxent River is relatively barrier free. The only man made structures on the River's main stem are two small dams (Sites LP110121 and LP105106), which were in the upper portion of the watershed. Downstream of the area that was surveyed there is a dam at the Fort Meade Wastewater Treatment plant. This dam, however, does have a working fish ladder and the migration of Blueback herring and alewife through the ladder has been documented. Once these anadromous fish pass through the fish ladder at Fort Meade, there are no presently known blockages to their migration until they reach Savage Mill. Savage Mill is located at the fall line between the Coastal Plain and Piedmont physiographic provinces and there is a natural waterfall present at Site LP049501. The waterfall is composed of a series of greater than 1-foot water drops and it is presently believe that alewife and herring would have difficulty migrating upstream through this area. This site was given a minor ranking because it is a natural barrier.

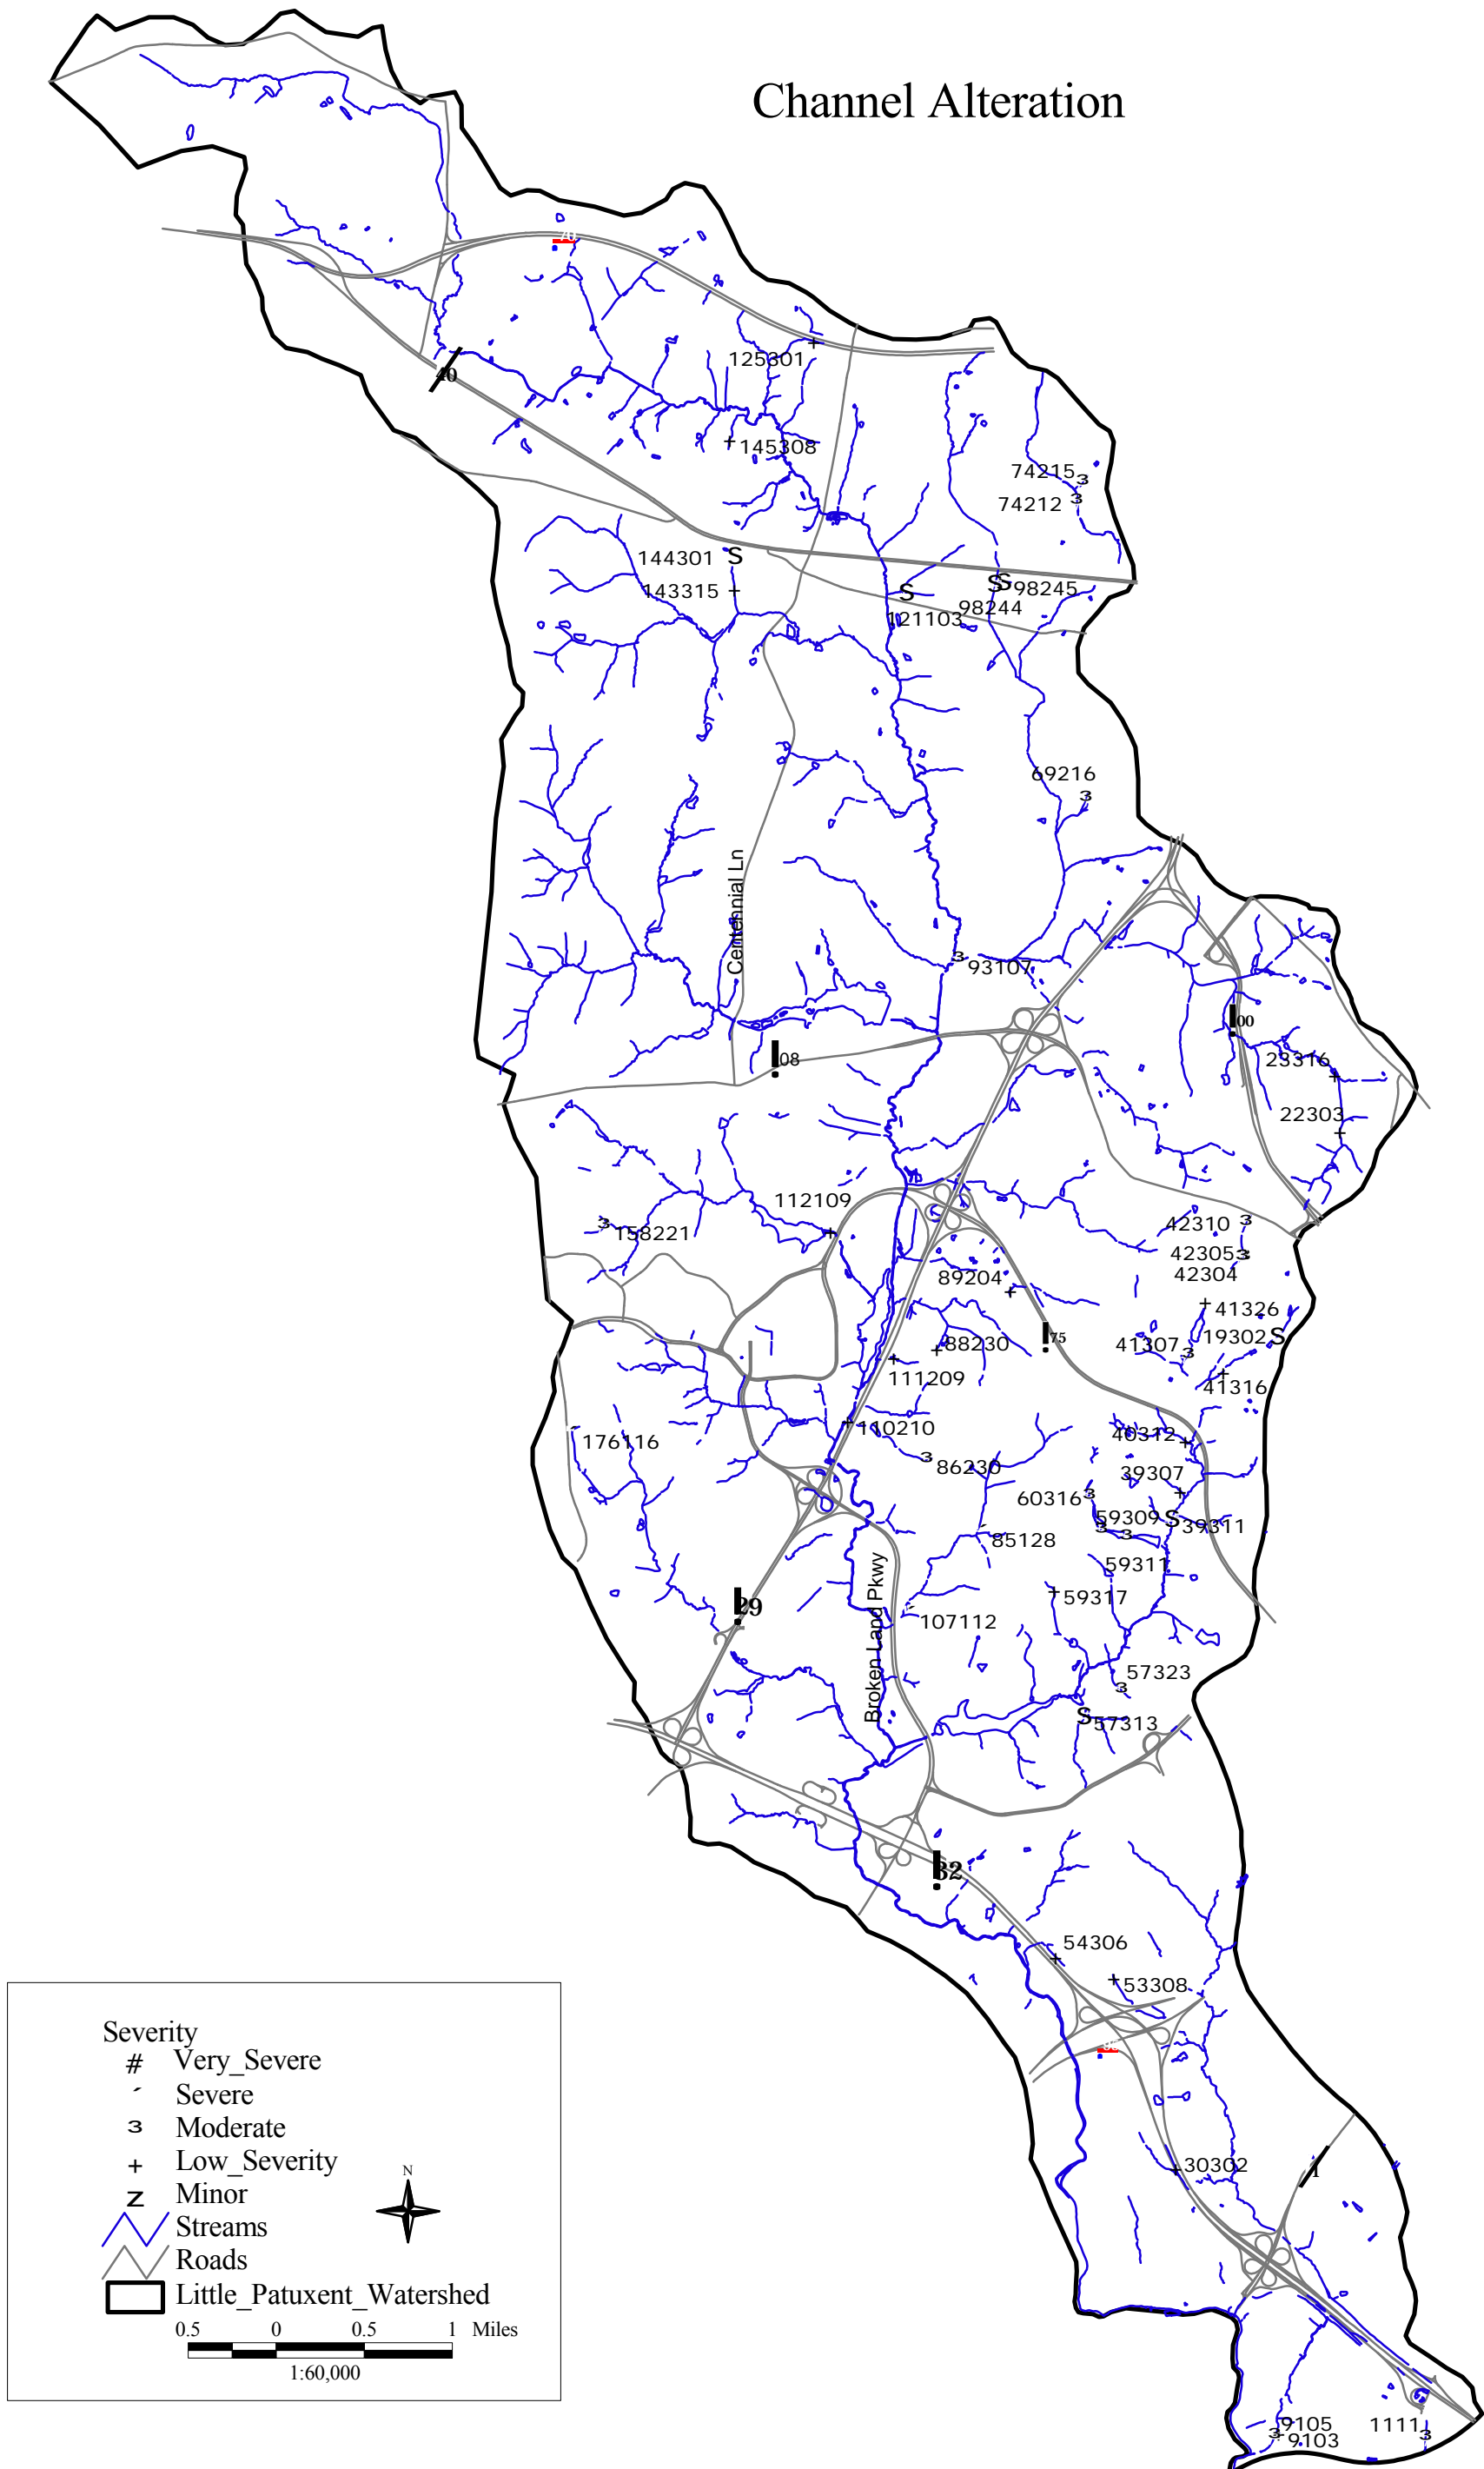
Figure 9a: Map of Little Patuxent Watershed Channel Alteration Sites

Results of this survey indicate that the stream has been recognizably altered in 45 areas and their locations are shown in Figure 9a. The total length of stream affected by channelization was estimated to be 14,262 feet or about 2.7 miles. There were no major stream systems reported in the survey as being extensively channelized and most of the sites were given a moderate to minor severity rating (Figure 9b). Most of the sites identified were also on small channels. Over half of the sites were channelized with concrete (25), while 9 were earthen channels that had been straightened, 8 were armored with rip-rap, 1 channel was lined with gabion baskets, and 2 were lined with wood. The correctability rating given for most of these sites were high because of the difficulty and expense of removing concrete. At one site, LP125301, it appears that the concrete channel is failing and the stream is beginning to flow underneath the concrete. Though this site received a low severity rating because of its short length, extensive gullying could occur beneath the concrete if it is not fixed.
