Stream Corridor Assessment Survey Of The Little Patuxent River In Howard County

Watershed Restoration Division
Chesapeake & Coastal Watershed Services
Maryland Department of Natural Resources
September 2001

**STREAM CORRIDOR
ASSESSMENT SURVEY
OF THE
LITTLE PATUXENT RIVER
IN HOWARD COUNTY**

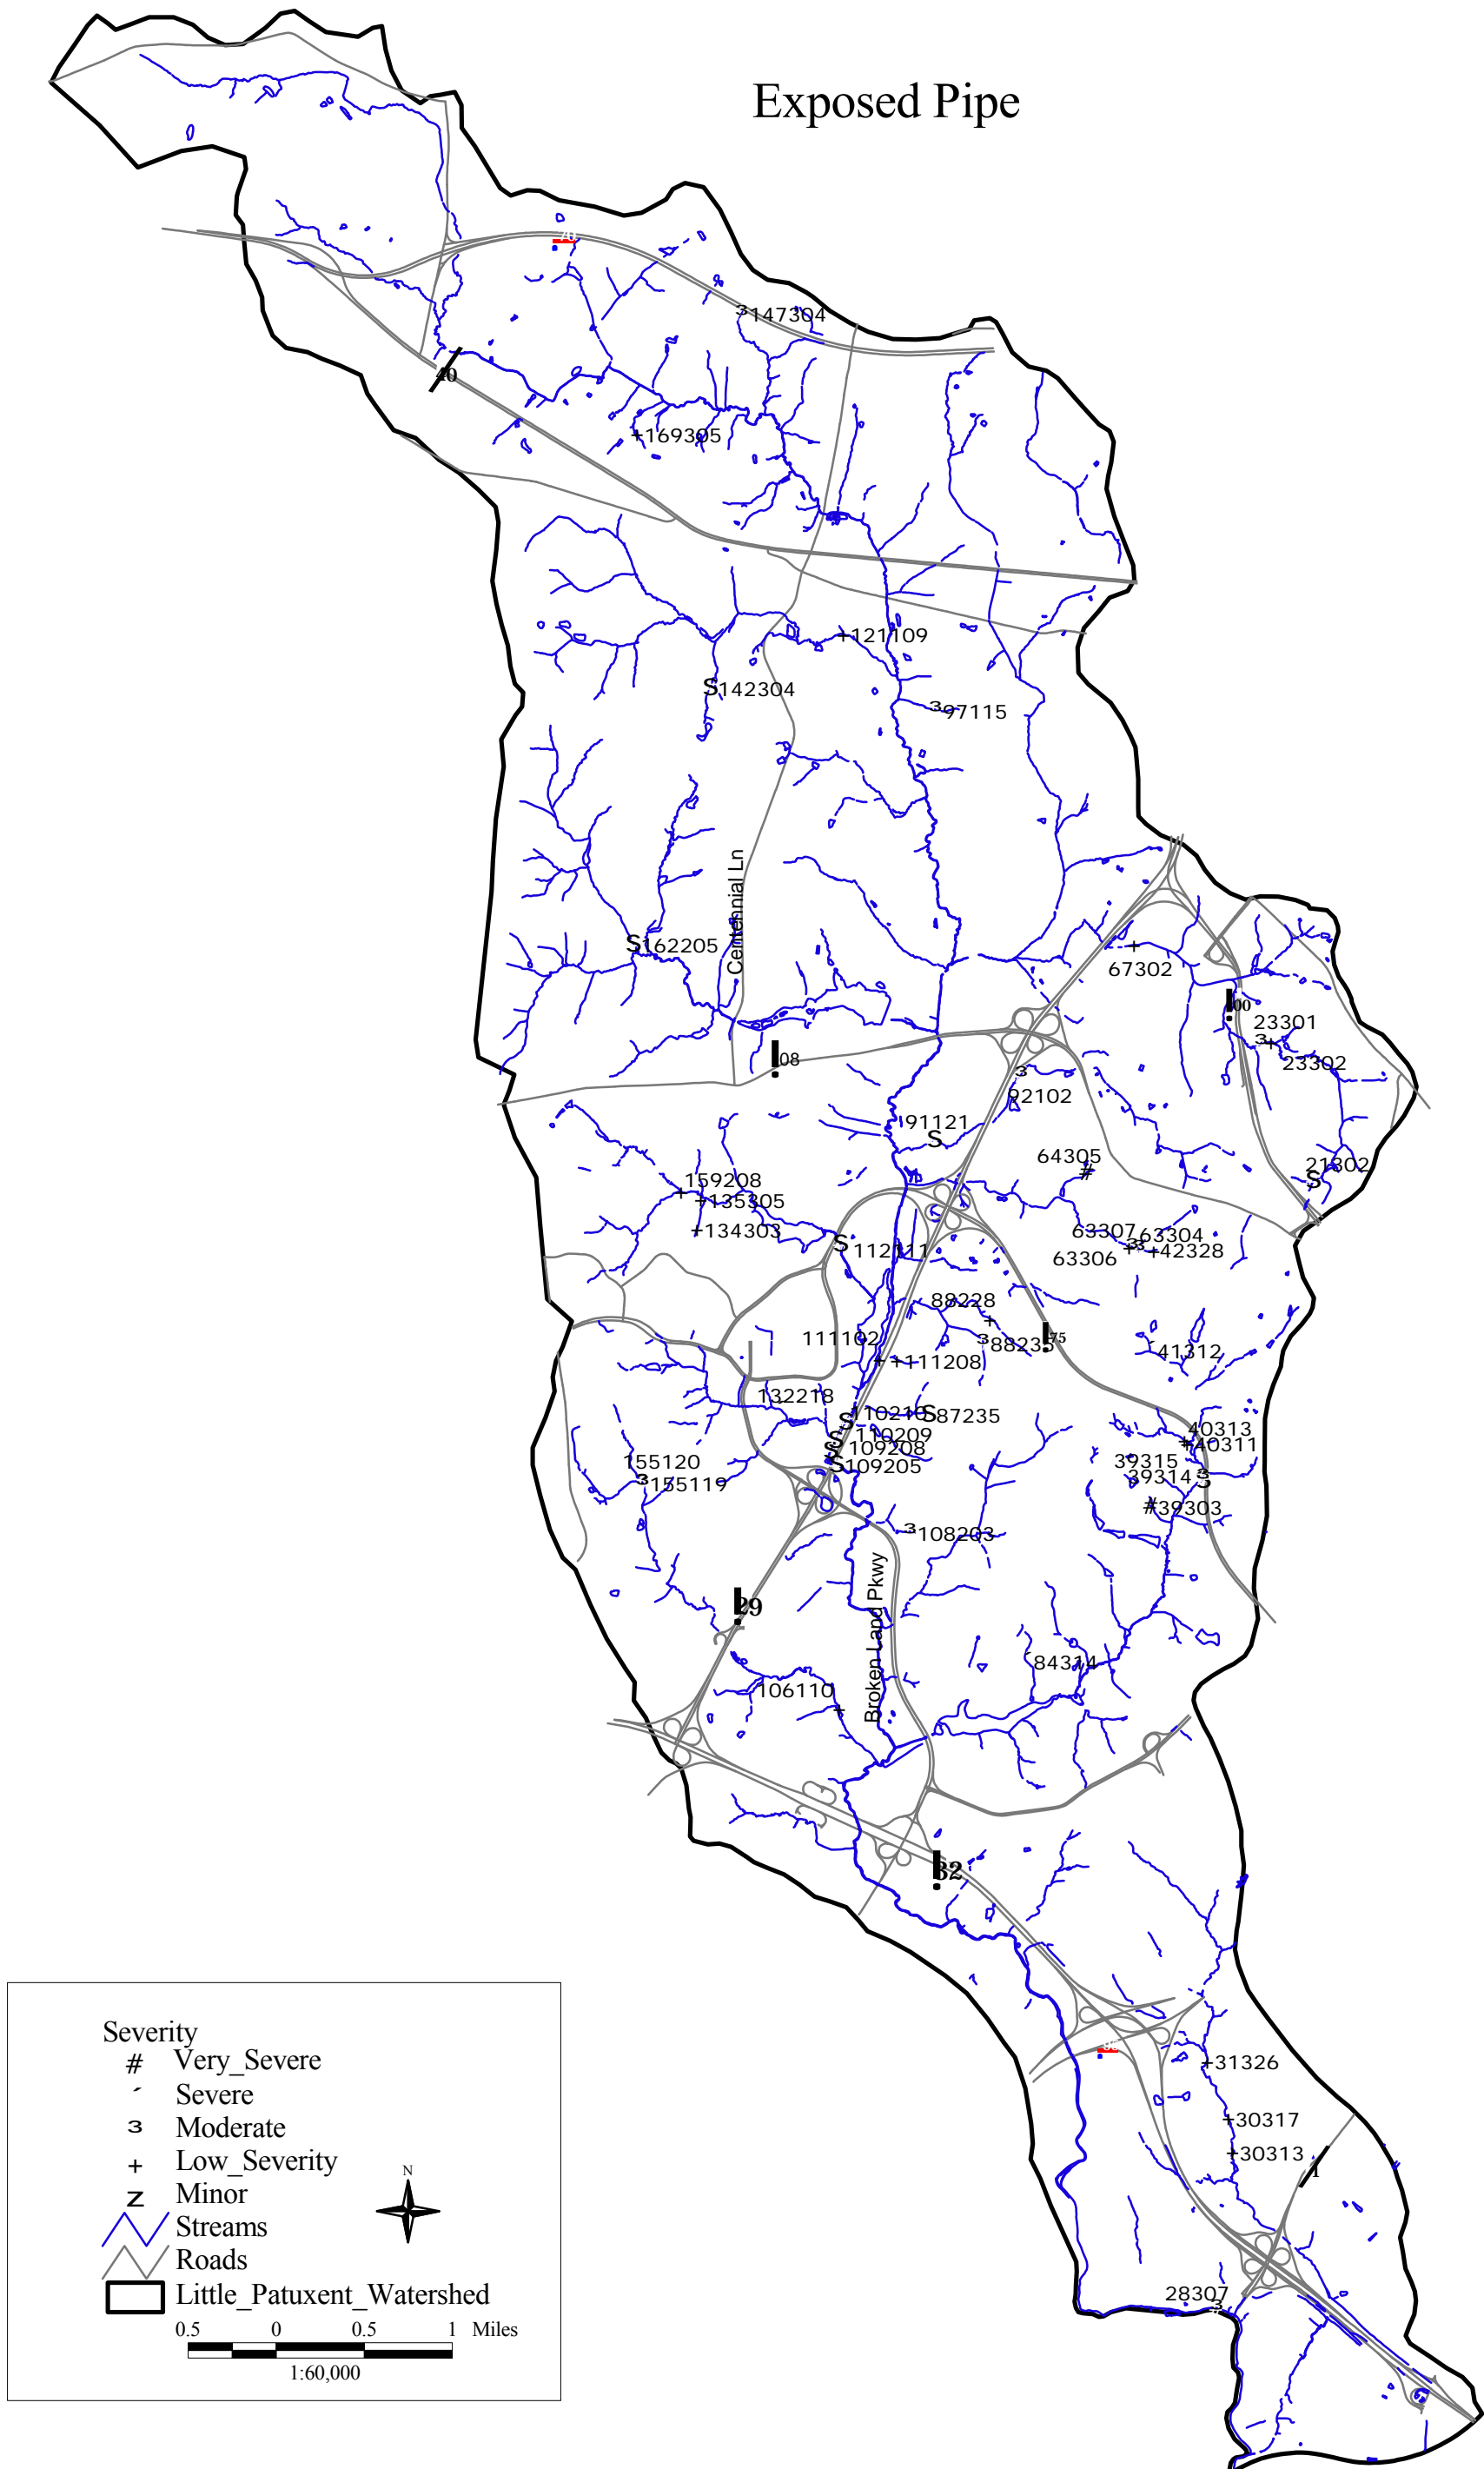
Figure 10a: Map of Little Patuxent Watershed Exposed Pipe Sites

Exposed pipes were reported at forty-six sites during the survey. Locations of these sites are shown in Figure 10a. Of those, thirteen were manhole stacks, twenty-three were places where pipelines crossing the bottom of the stream had been exposed, seven sites had pipes exposed along the edge of the stream channel, and pipes were located crossing above the stream at 3 sites. Field survey teams reported 2 sites as having very severe problems. Sites LP039303 and LP064305 had discharges with a sewage odor and should be investigated further.

No other discharges were reported during the survey and most sites were give a moderate to low severity rating (Figure 10b). All exposed pipe photos should be reviewed by public works officials and follow-up visits should be done based on their evaluations.

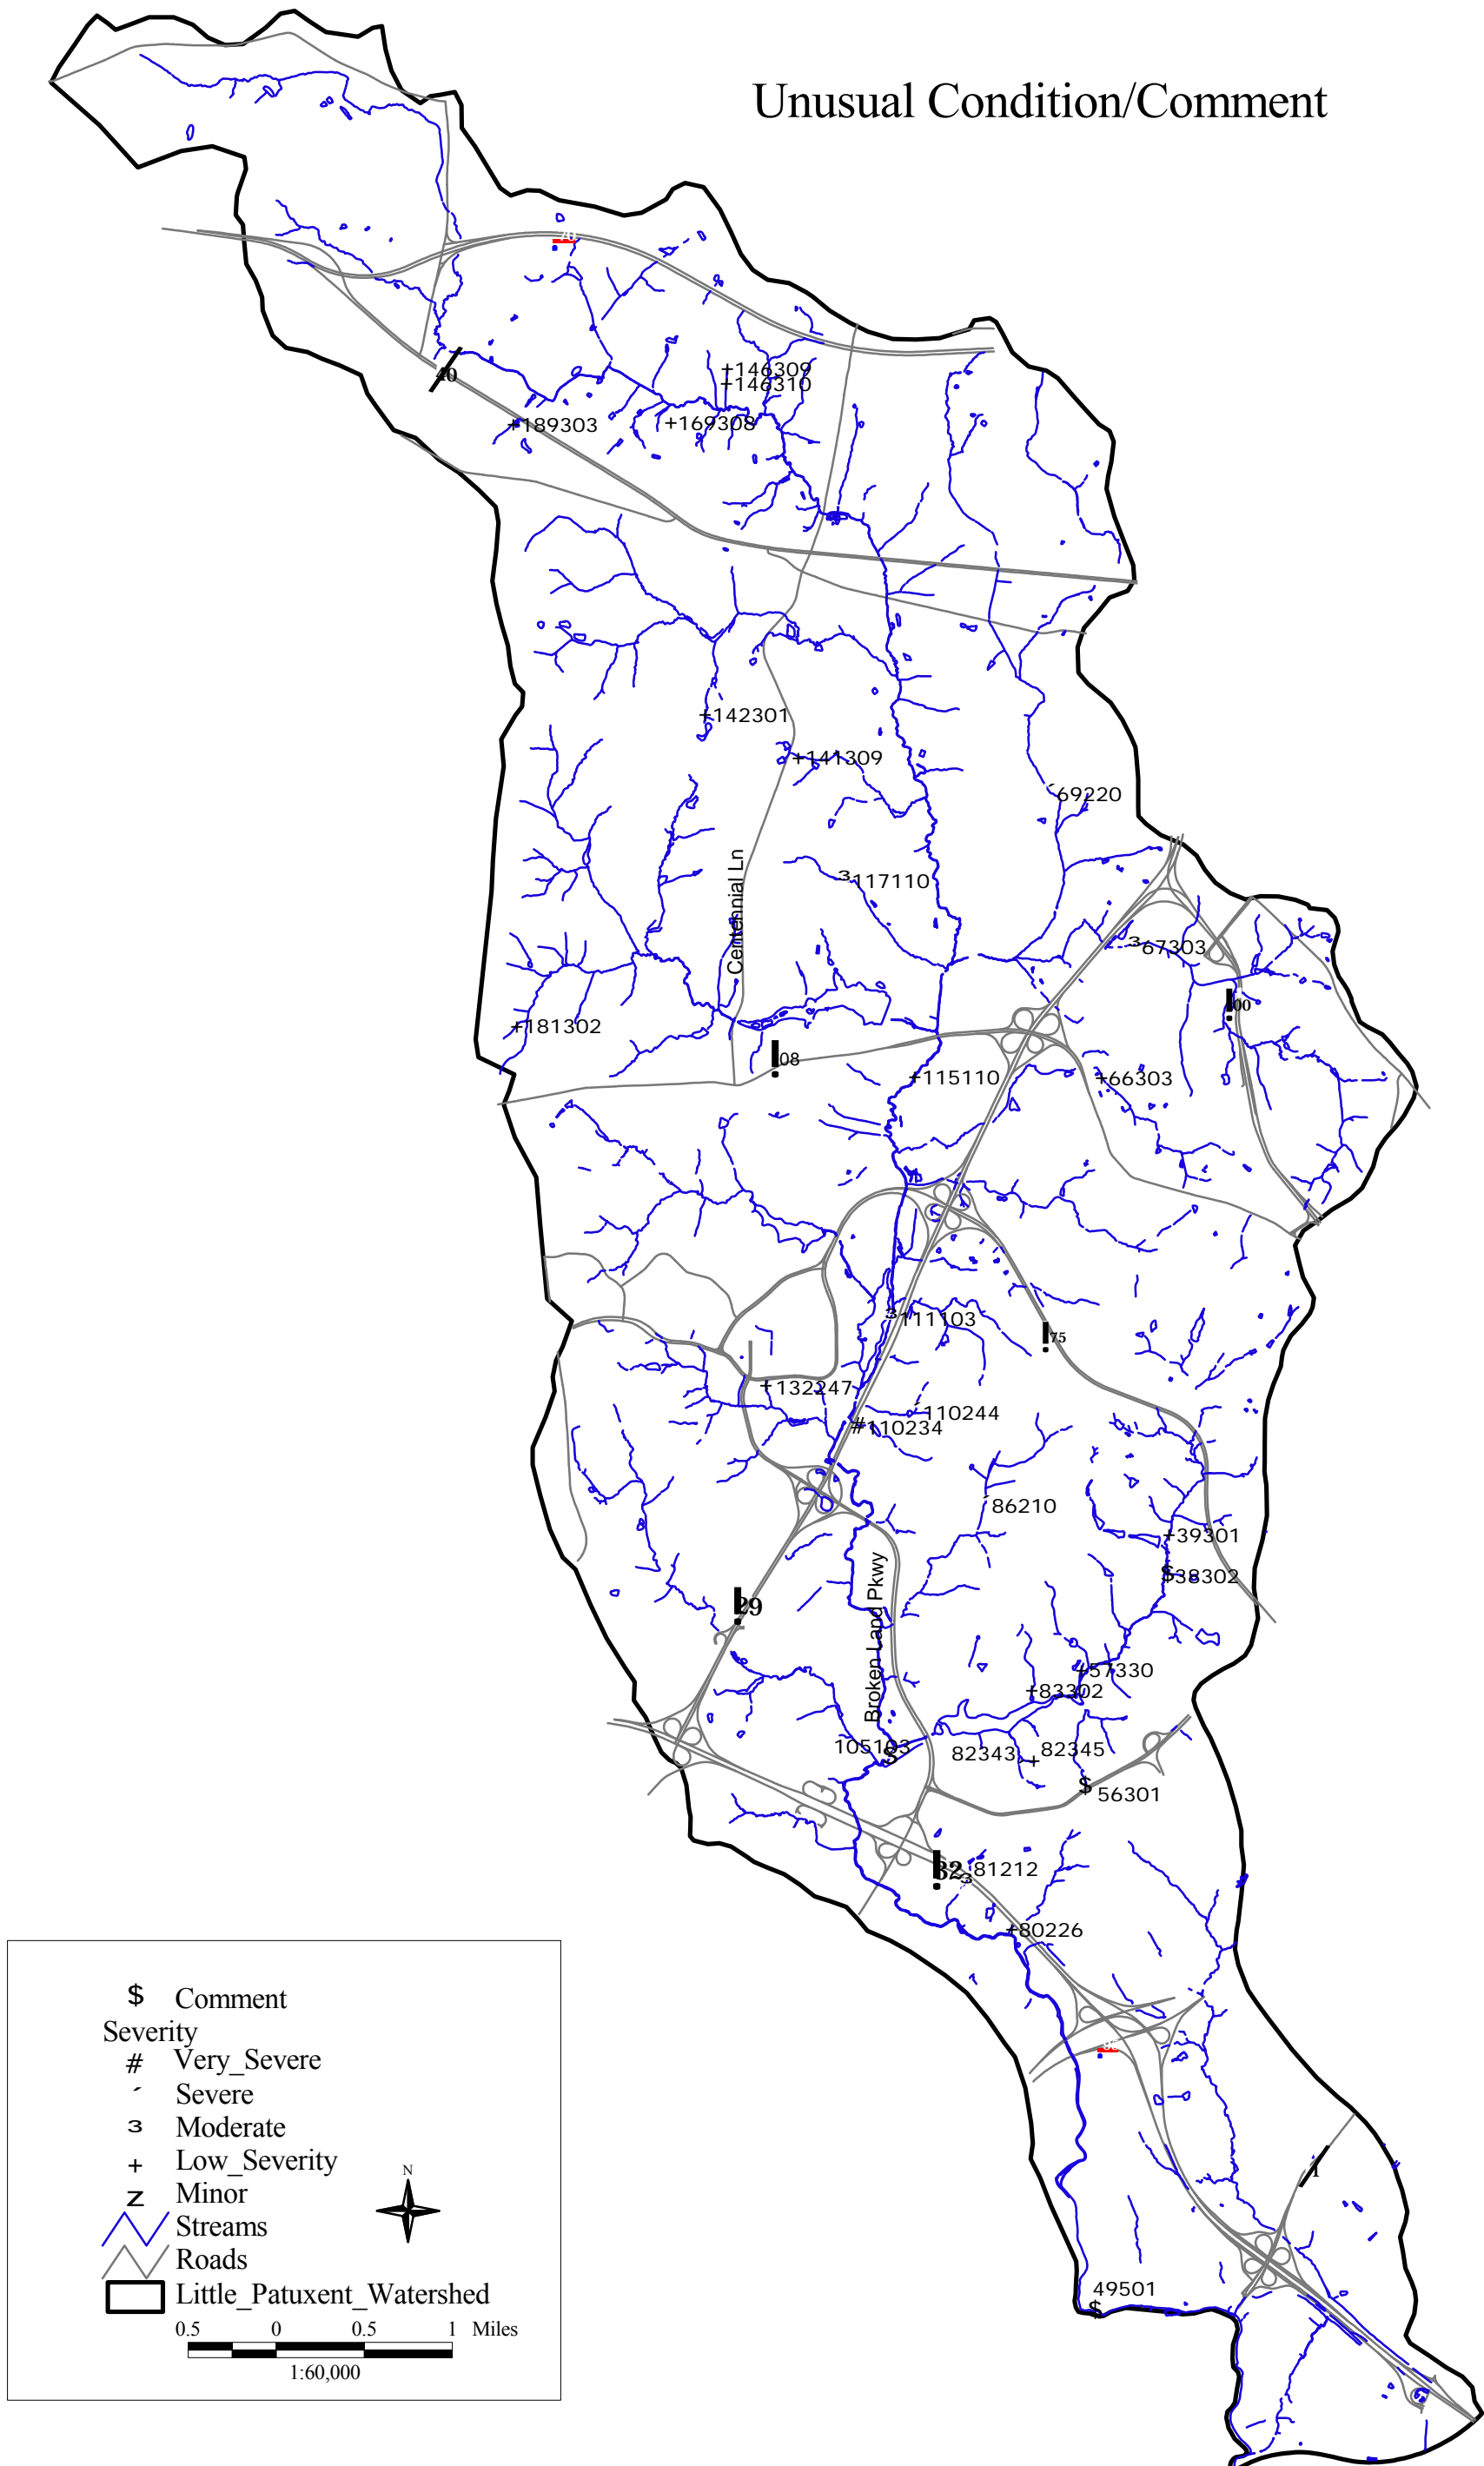
Figure 11a: Map of Little Patuxent Watershed Unusual Condition/Comment Sites

The unusual condition/comment data sheets are used by survey teams to record the location of anything out of the ordinary seen during the survey or to provide some additional written comments on a specific problem. Twenty-five unusual condition sites were found during the Little Patuxent survey (Figure 11a) and two comment data sheets were filled out. Site LP110234, a manhole discharging sewage, was given the highest severity rating. Three other sites were reported to have a sewage odor, but were not associated with an exposed pipe or pipe outfall. The other problems frequently recorded were red flock and large amounts of algae. These were given lower severity ratings (Figure 11b).

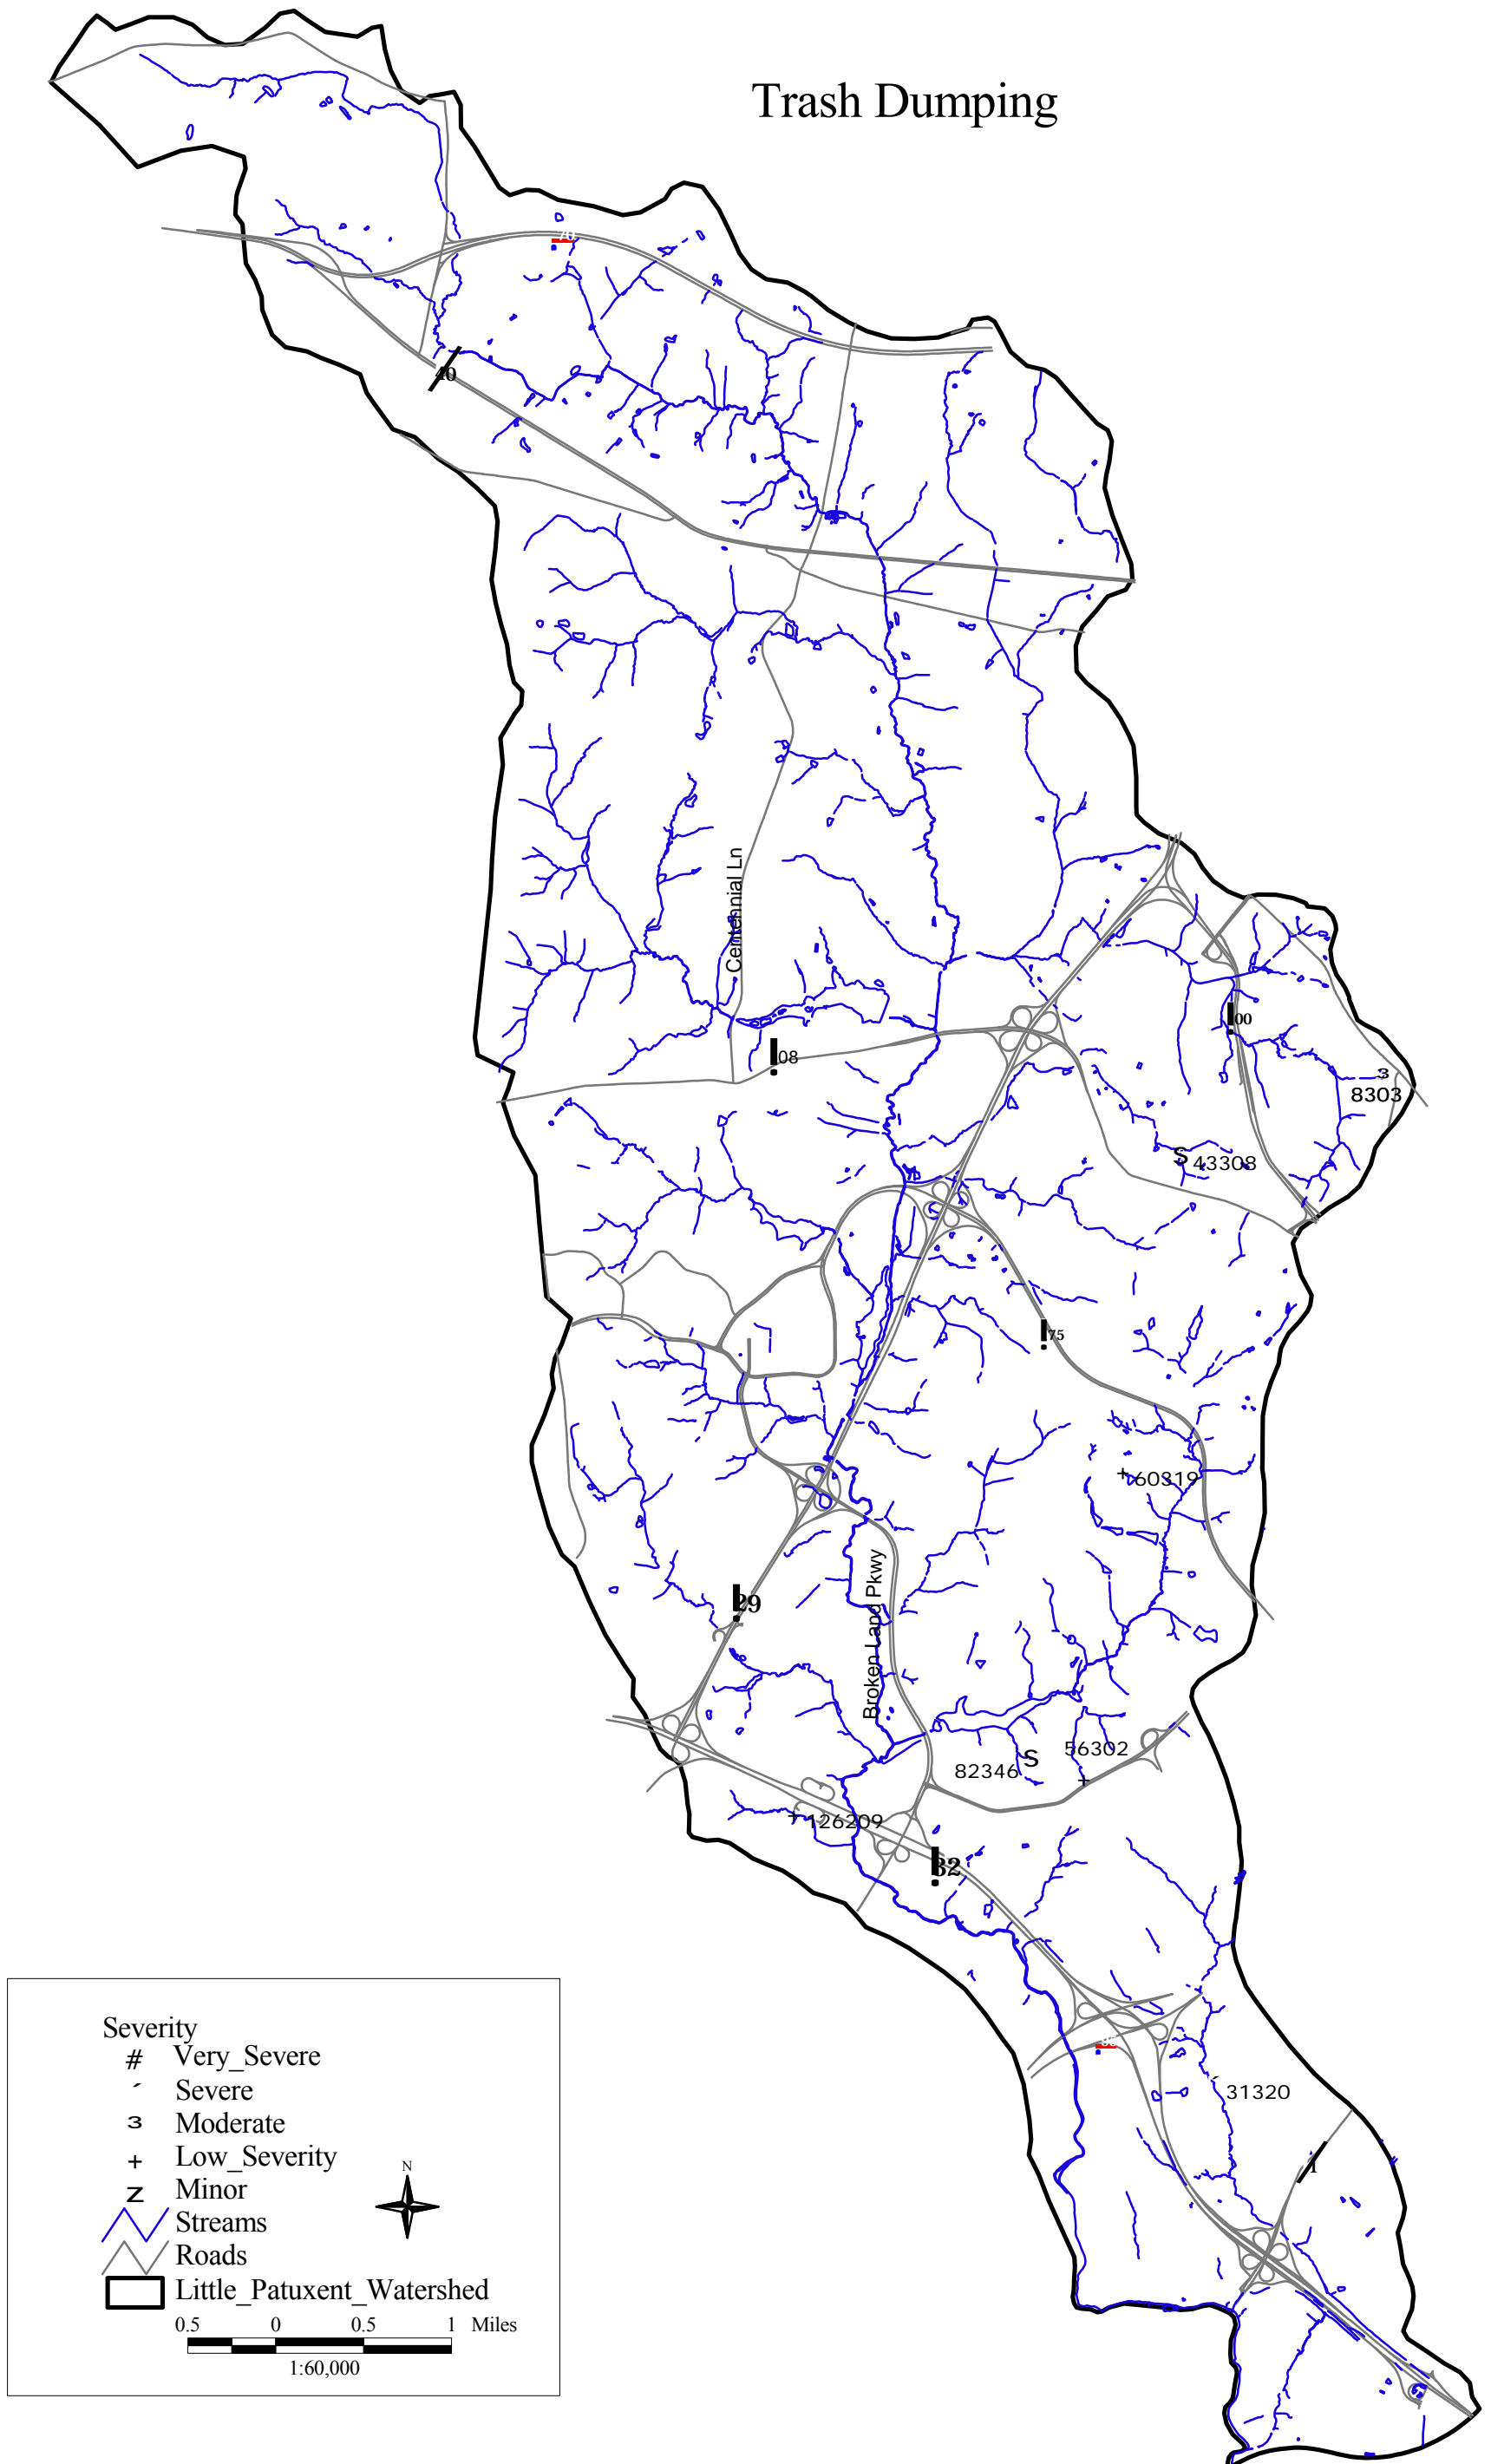
Figure 12a: Map of Little Patuxent Watershed Trash Dumping Sites

The trash dumping data sheets are used to record the location of places where large amounts of trash has been dumped inside the stream corridor or to note places where trash tends to accumulate. The field survey crew found seven sites where there was excessive trash and their locations are shown in Figure 12a. Only one was recorded as severe, Site LP031320, which is a construction site. It was estimated to require 15 pick-up truckloads to remove all the trash from this site. Four sites were recorded as having yard waste, one had residential waste and one had industrial waste. These sites were given severity rating ranging from moderate to minor (Figure 12b).

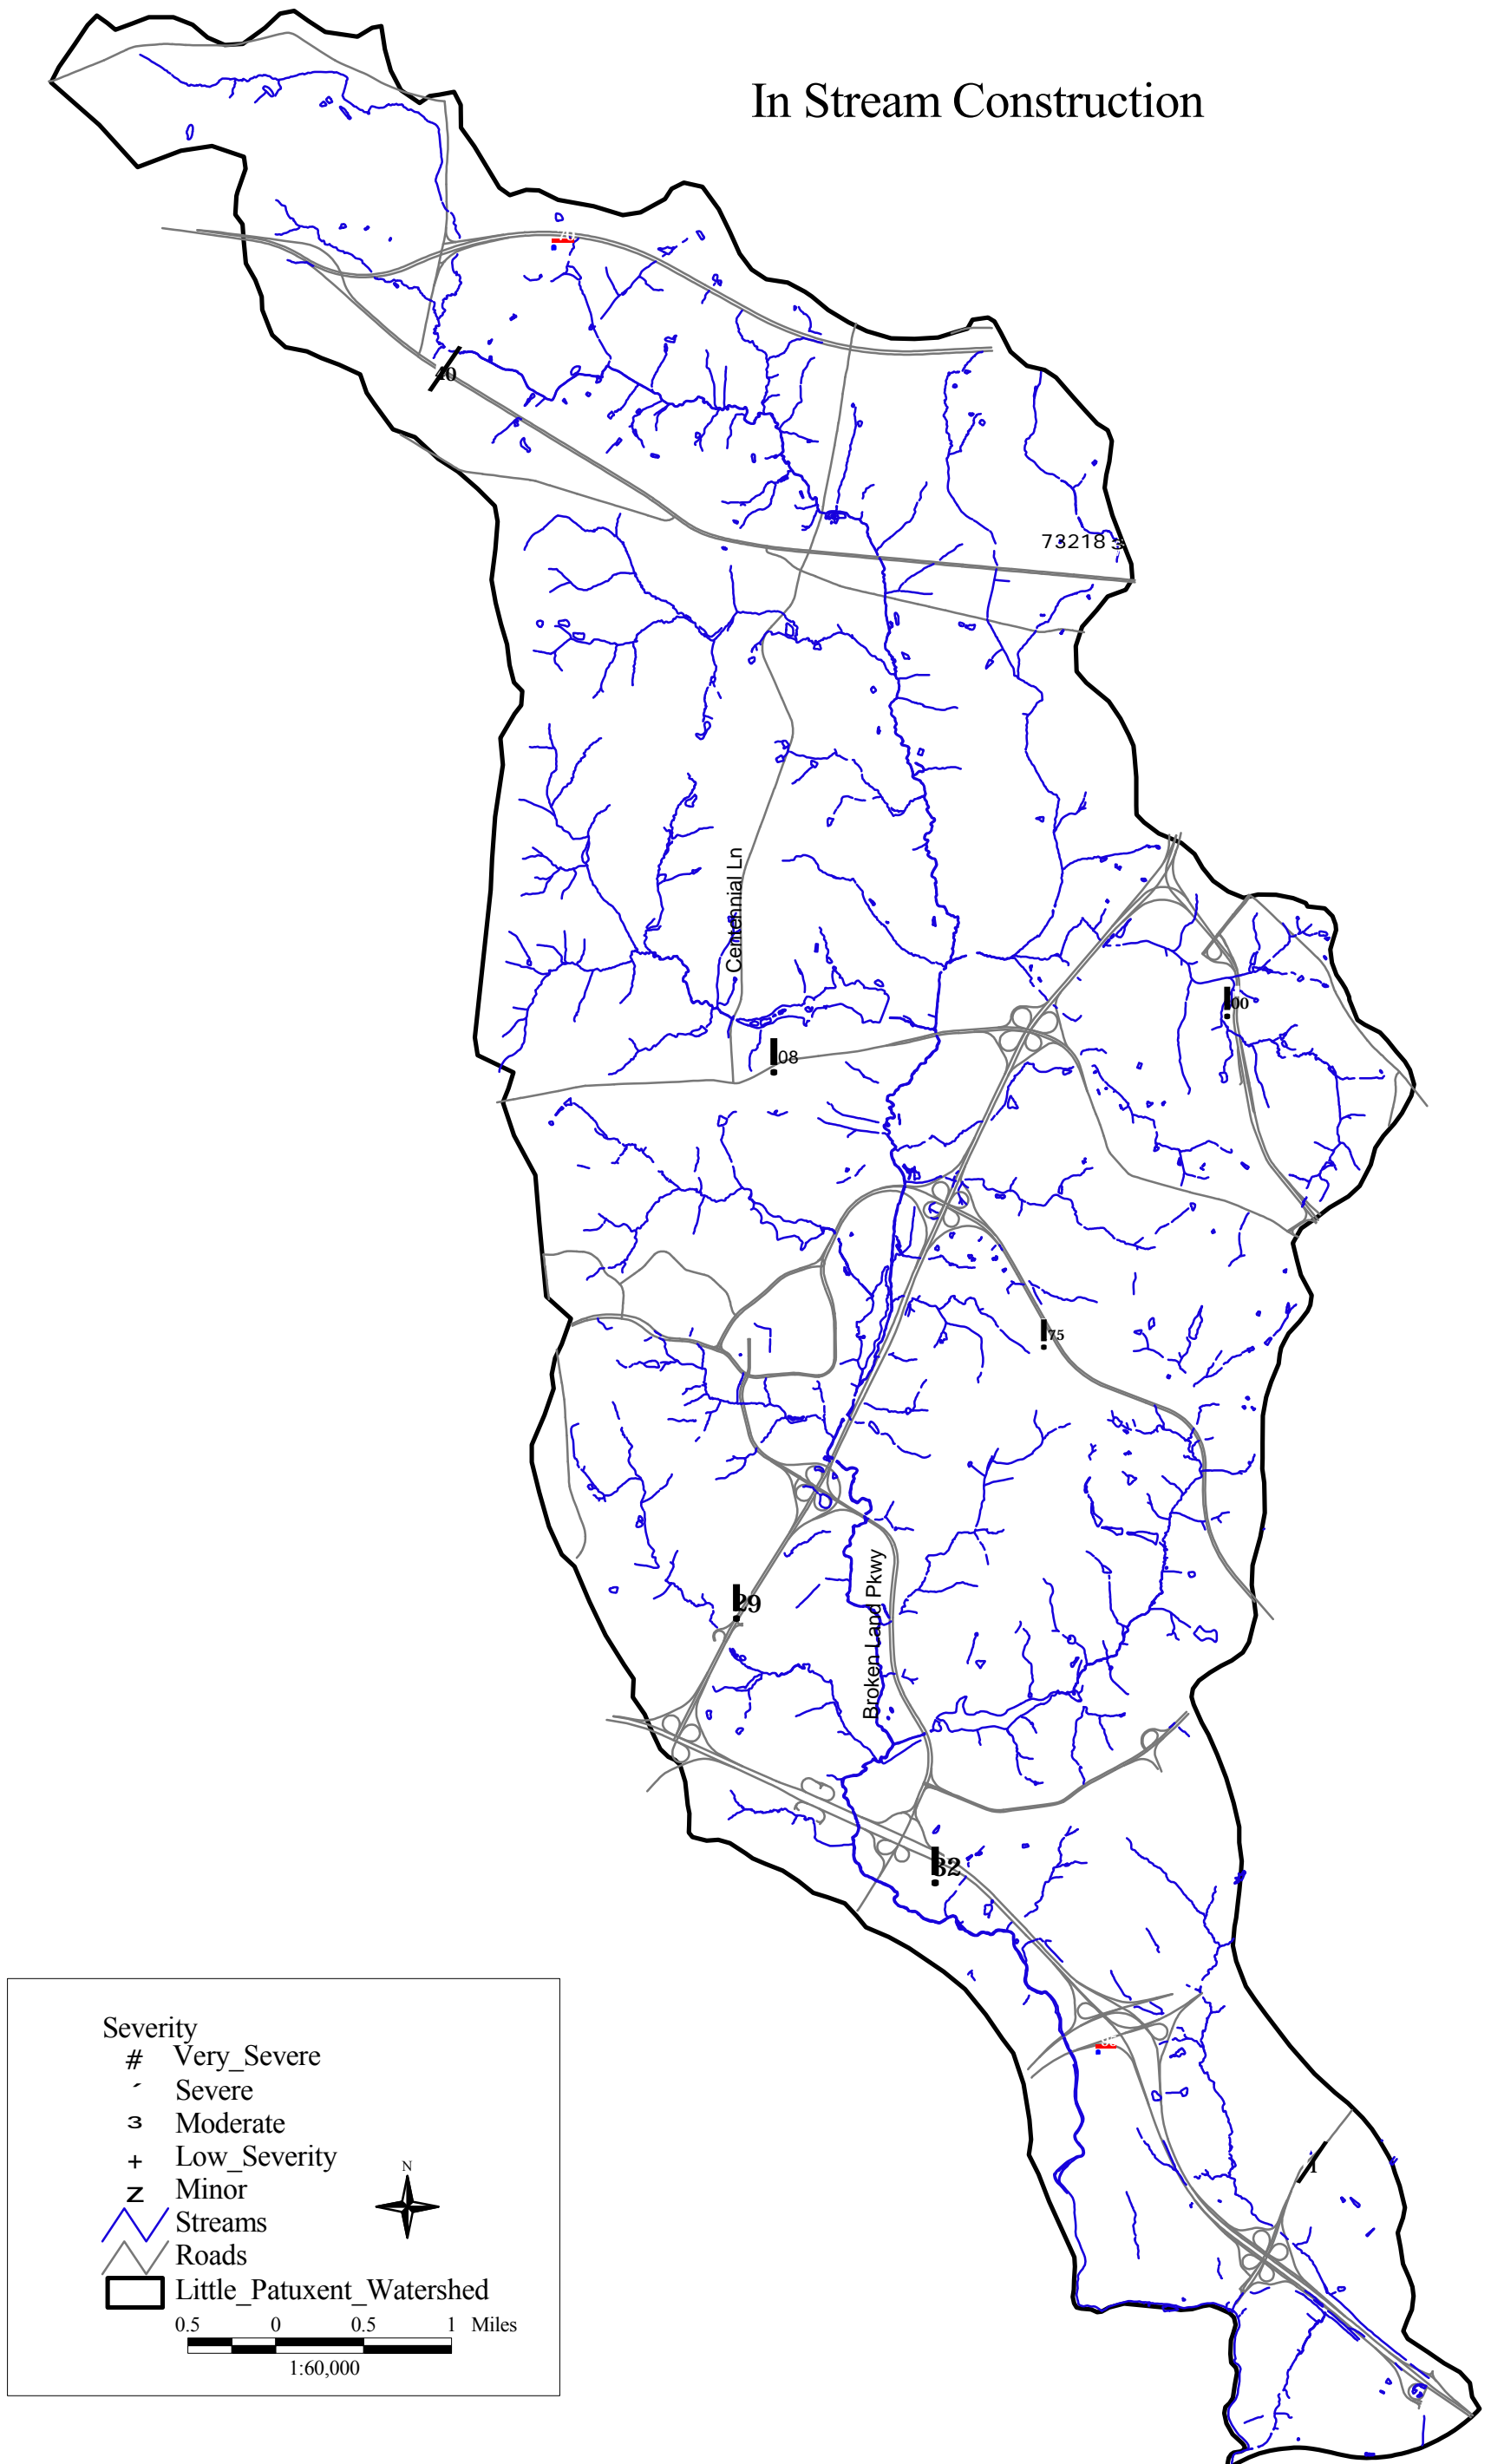
Figure 13: Map of Little Patuxent Watershed In Stream Construction Sites

In or near stream construction data sheets are used to document the locations where major disturbances are occurring inside or near the stream corridor at the time of the survey. Survey teams report evidence of inadequate sediment control measures or if sediment pollution from the site has affected the stream. In or near stream construction was only reported at one site during the Little Patuxent survey (Figure 13). Site LP073218 was reported to have excess sediment in the stream channel and the field survey crew was unaware of any sediment control measures.

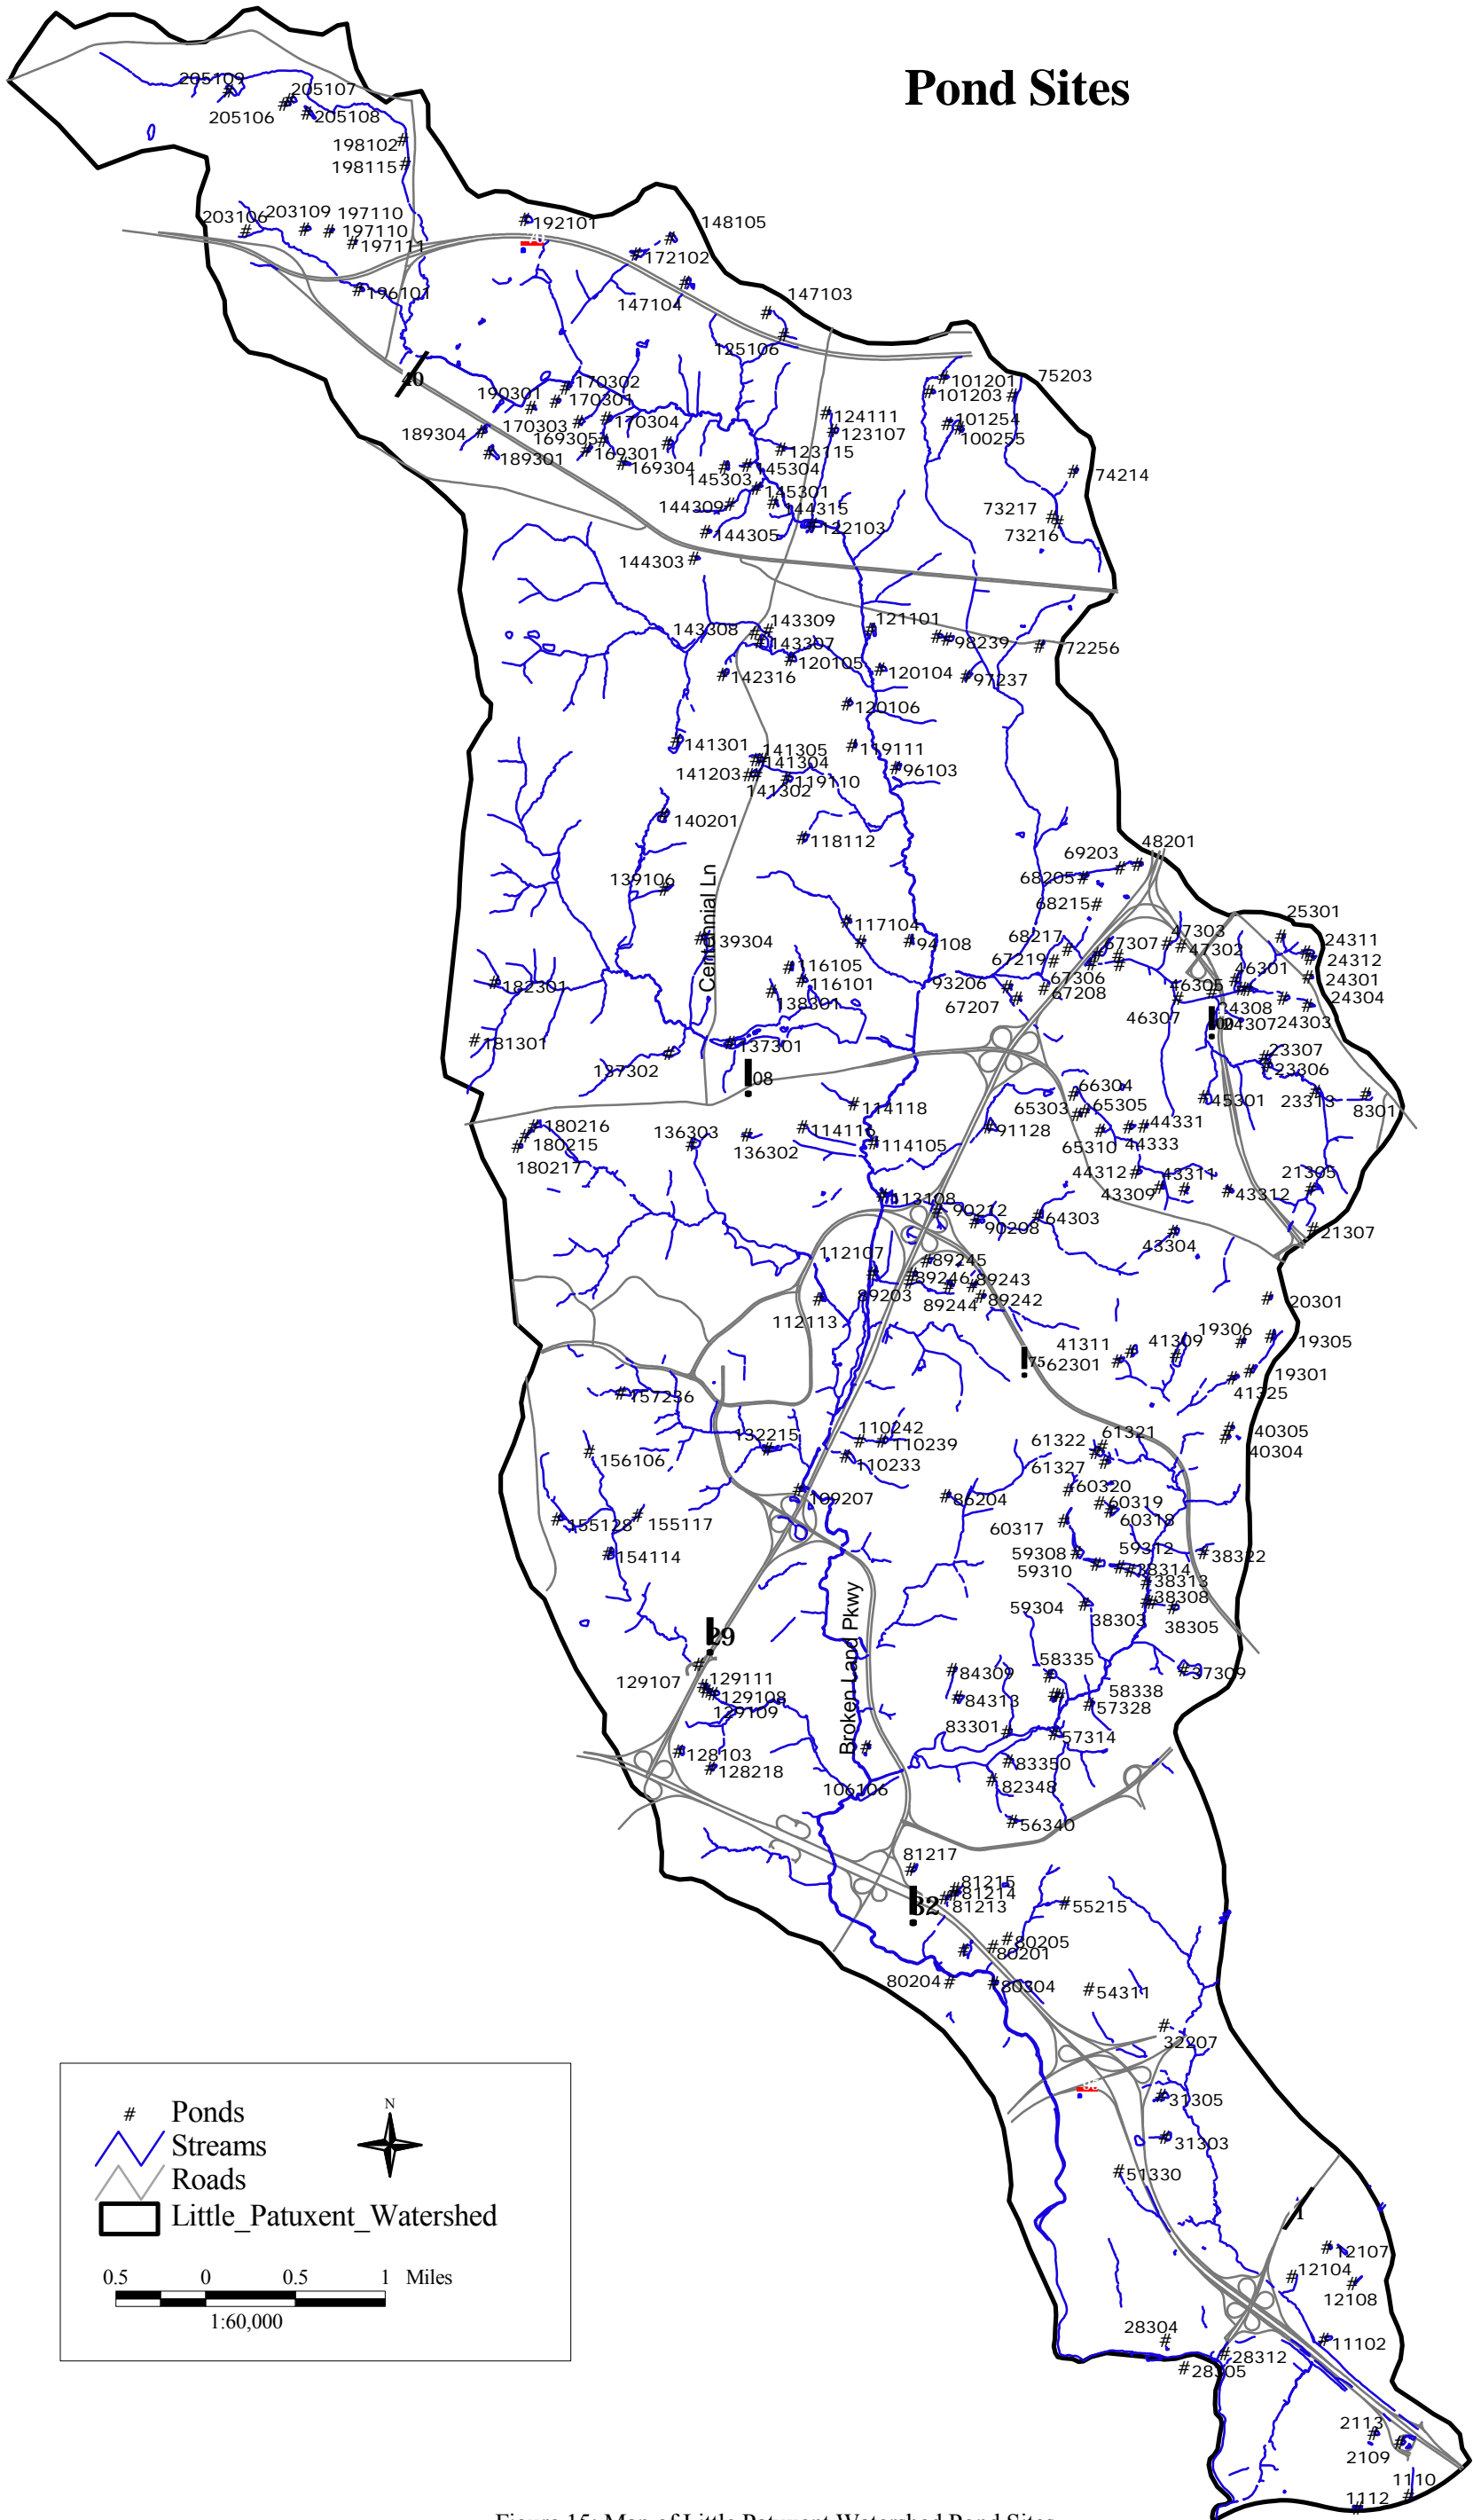
Figure 15: Map of Little Patuxent Watershed Pond Sites

Two hundred twenty-nine pond sites were found during this survey, and their locations are shown in Figure 15. Of those, 167 were recorded as having trees or animal burrows on the embankment (Appendix C). It is not clear how many of those sites actually had trees or burrows on the embankment, or if they were mistakenly recorded. What was apparent from the photographs that were taken was most of the sites were adequately maintained storm water management ponds. However, it was not possible from the photographs to determine if all sites were adequately maintained, but had trees present on some pond embankments. Only 11 ponds were recorded as abandoned and 12 ponds were reported as un-maintained.
