Middle Chester River Stream Corridor Assessment Survey

Watershed Restoration Division
Chesapeake & Coastal Watershed Services
Maryland Department of Natural Resources
April 2002

MIDDLE CHESTER STREAM CORRIDOR ASSESSMENT SURVEY

April 22, 2002

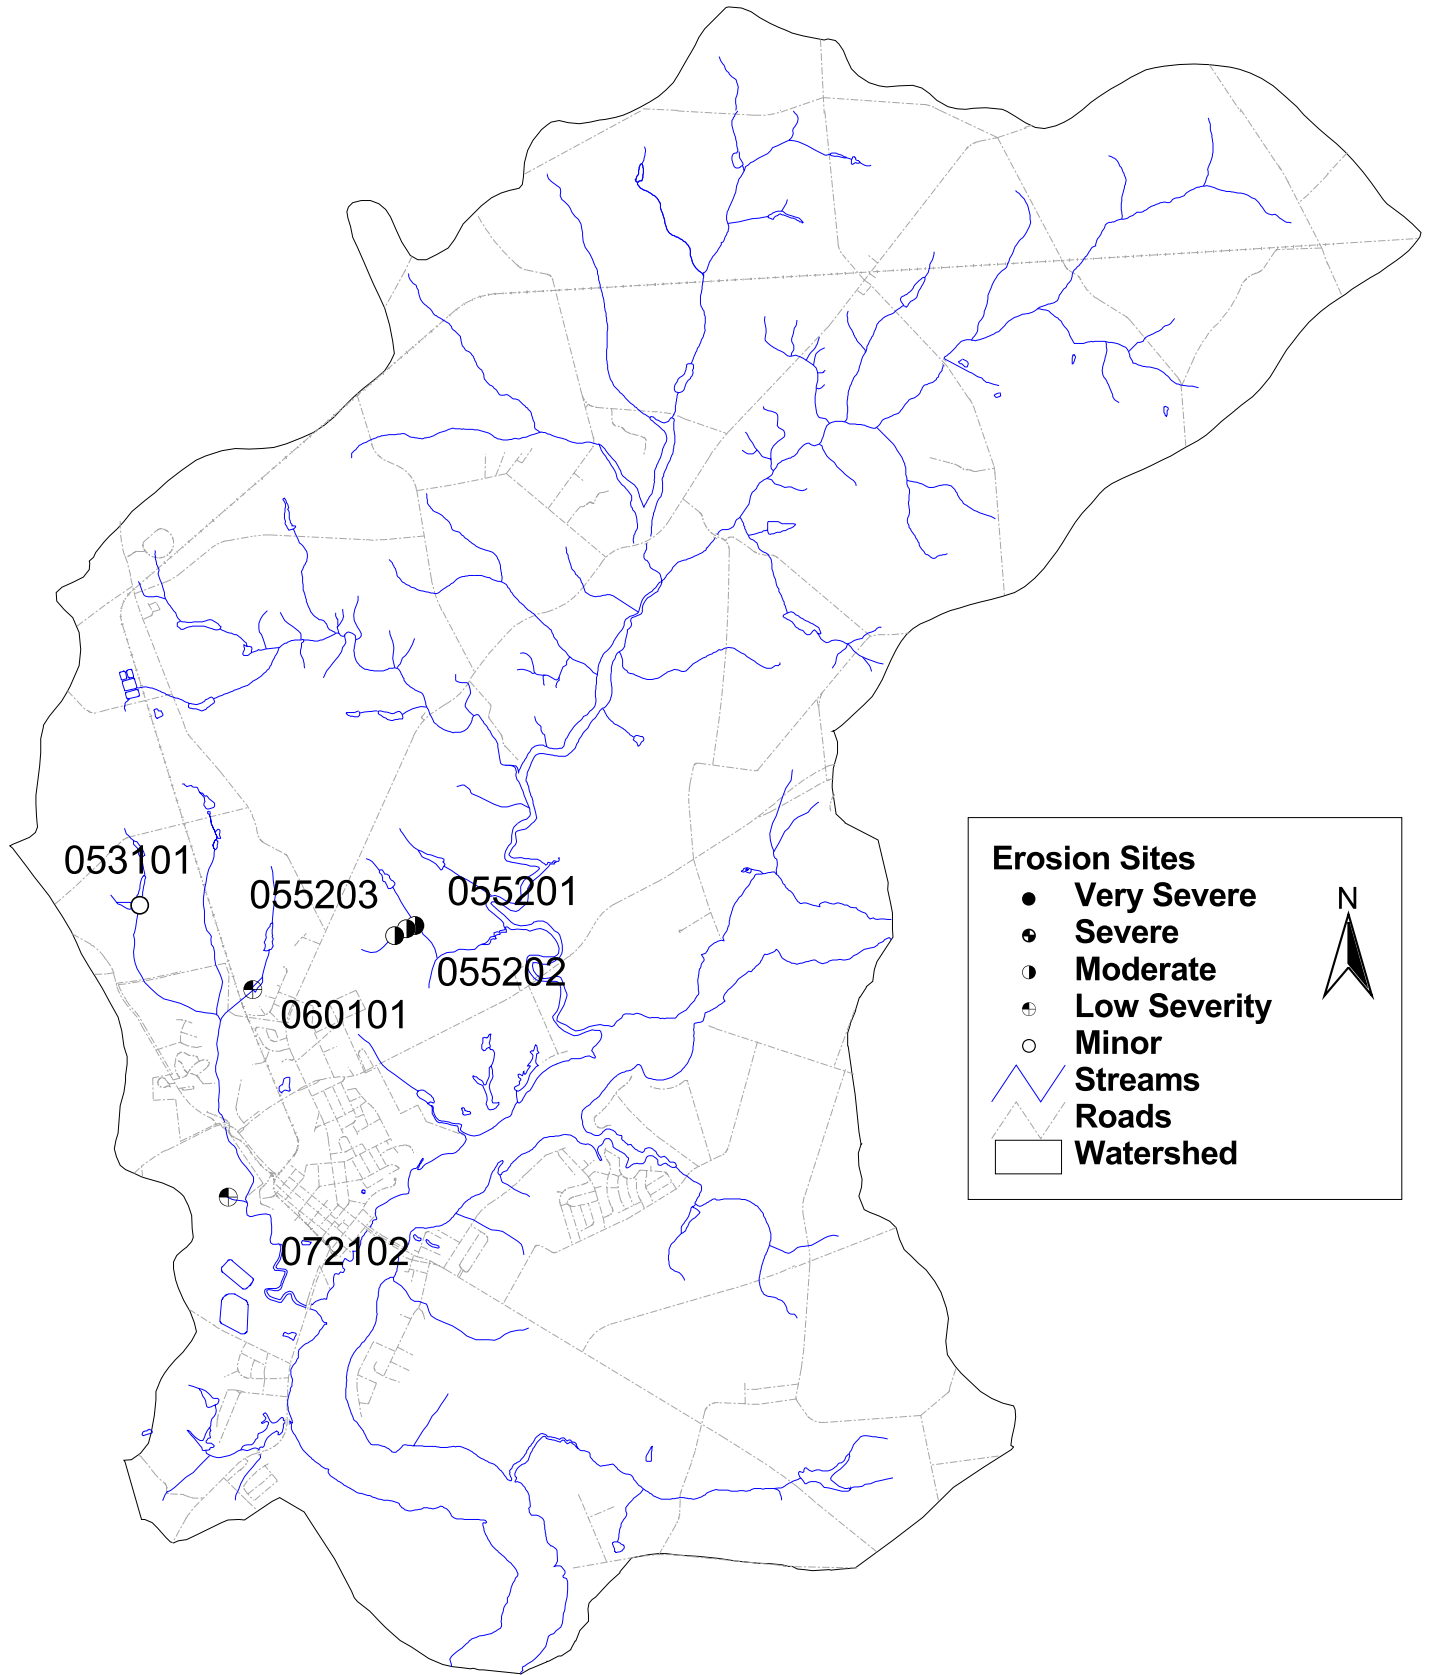
Figure 6b

Unstable eroding streams are areas where the stream banks are almost vertical and the roots from the vegetation along the stream's banks are unable to hold the soil on the banks. Unstable eroding stream banks were reported at six sites during the survey and their locations are shown in Figure 6b. All erosion sites were given moderate to minor severity rating (Figure 6a). The most significant erosion problems (Sites 055203, 055201 & 055202) were on a small unnamed tributary to Morgan Creek. At Site 055203 field teams reported that an active head cut was present.

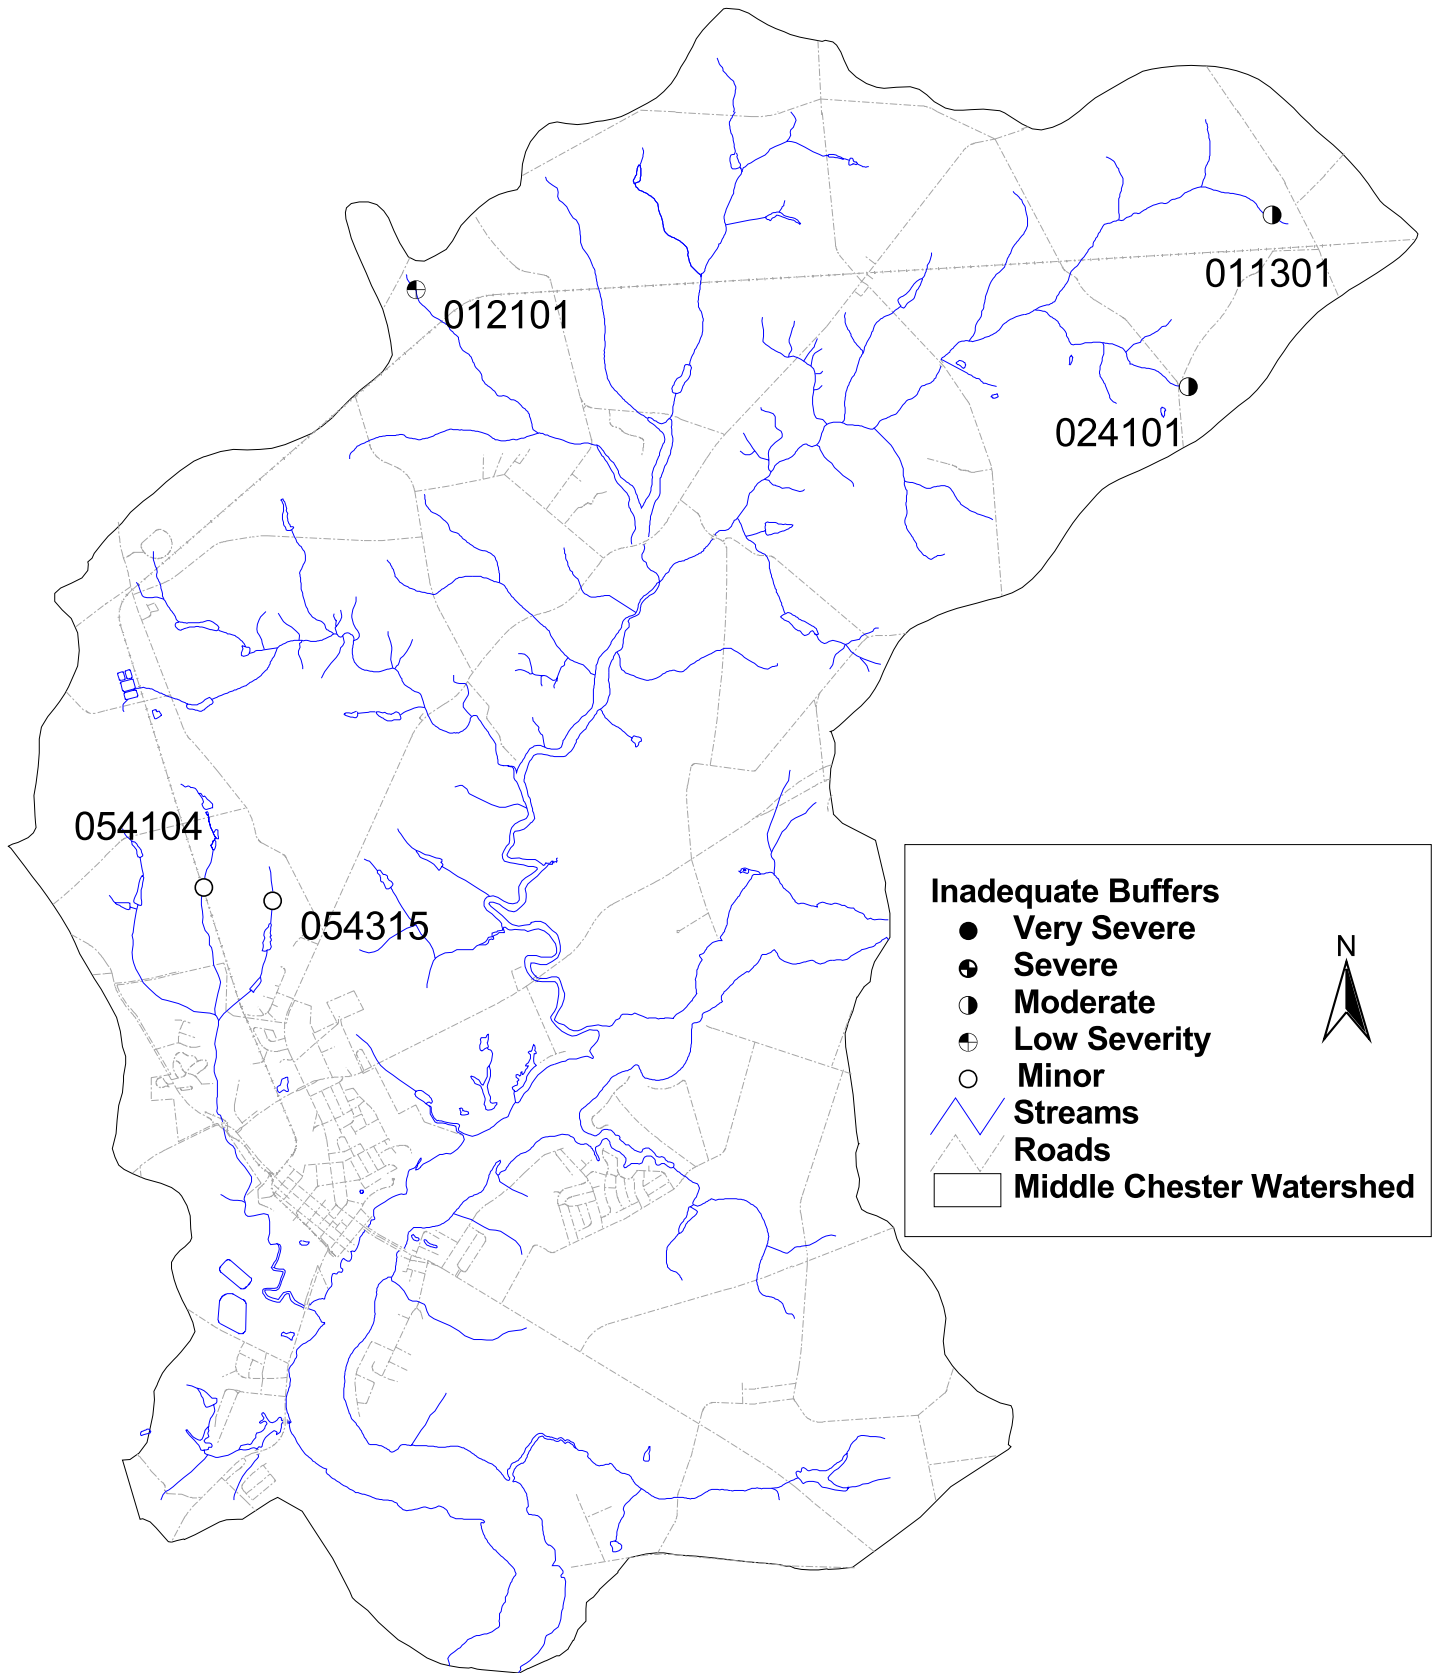
While there is no single minimum standard for how wide a stream buffer should be in Maryland, for the purposes of this study a buffer is generally considered inadequate if it is less than 50 feet wide, measured from the edge of the stream. Inadequate buffers were reported at five sites during the survey and their locations as shown in Figure 7b. The field crew provided a rough estimate of the length of the inadequate stream buffer at all sites (Appendix B). Based on the data that was collected, there are approximately 5,775 feet (1.09 miles) of inadequate buffer in the Middle Chester watershed. Field teams found inadequate buffers ranging in distance from 75 feet to 3000 feet. All sites received a moderate to low severity rating (Figure 7a). This would indicate that most of the stream reaches with inadequate buffers were not very long or some trees were already present at many of the sites.

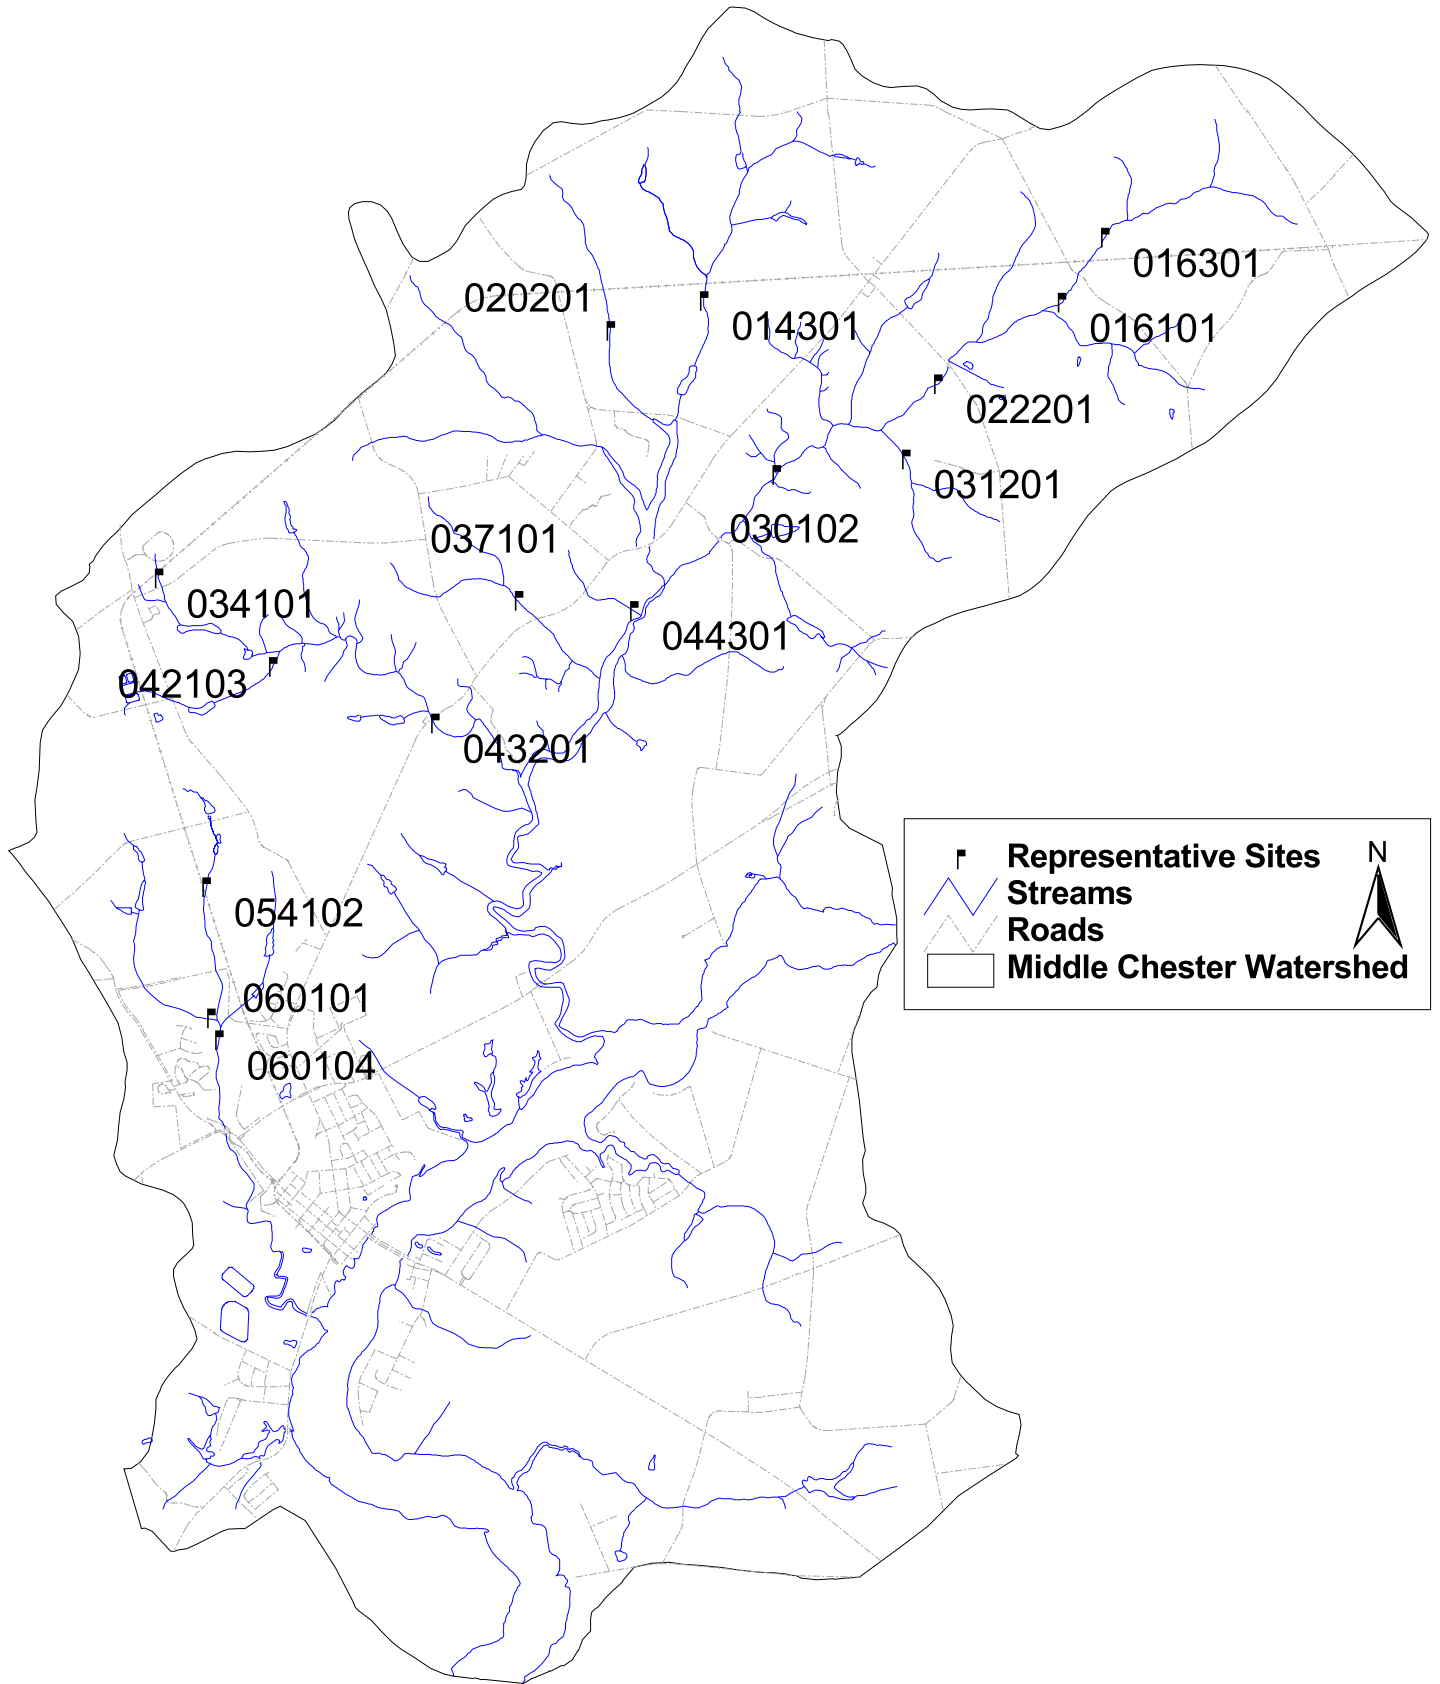
Representative site evaluations were done at approximately ½ mile intervals along the stream. Fifteen representative data sheets were filled out during this survey. Locations of representative sites are shown in Figure 11 and the data is presented in Appendix B.

Overall, both Morgan and Radcliff Creeks received marginal or poor ratings for macroinvertebrate substrate, embeddedness, velocity and depth combination, and sediment deposition. This is not surprising since the streams are in the Coastal Plain on Maryland's Eastern Shore. Streams in this area naturally have sandy bottoms and may not have well formed riffles. The habitat evaluation sheets used in this survey were originally designed to be done on rocky bottom streams. Stream in the coastal plain usually score low in parameters like macroinvertebrate substrate and embeddedness. Other parameters such as channel alteration, channel flow, bank vegetation, bank condition and riparian vegetation tended to score optimal or sub-optimal. For the most part these results indicated that the streams in this area were generally stable with a forest buffer along the stream's banks.
