Stream Corridor Assessment Survey for the Miles River Watershed, Talbot County, Maryland

Department of the Environment
1800 Washington Boulevard, Suite 540
Baltimore MD 21230-1718

April 2006

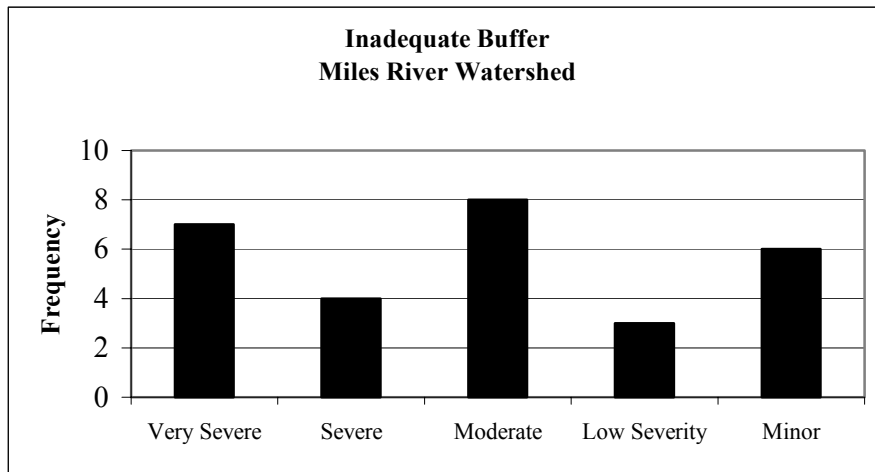
Figure 5a. Histogram showing the frequency of severity ratings given to inadequate buffer sites during the Miles River SCA survey.

Survey crews identified 28 inadequate buffer sites with a total length of 34,650 feet (6.6 miles), or approximately 22 percent of the 30 miles streams surveyed. The severity and location of inadequate buffer sites is shown in Figure 5b. Eleven of these sites are ranked as very severe or severe, while the other fifteen sites are moderate, of low severity, or minor (Figure 5a). Land uses along the stream at inadequate buffer sites were reported as mostly crop fields and golf course.

Any inadequate buffer site would benefit from the restoration of trees along both stream banks. For sites on agricultural land, farmers also may qualify for federal and state government financial incentives for allowing 50-foot forest buffers to grow on their farmland. Those sites that may have particular natural resource value are headwater streams, or those that form gaps in existing forested buffer areas.

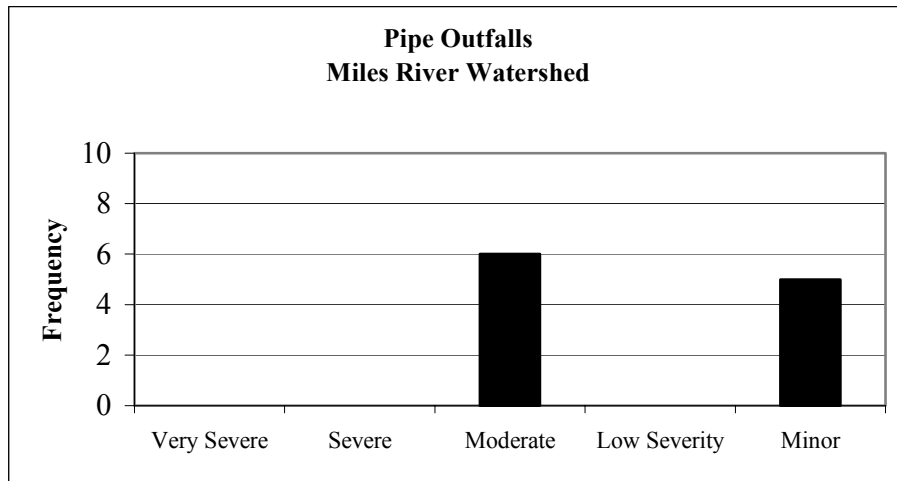
Figure 6a. Histogram showing the frequency of severity ratings given to pipe outfalls sites during the Miles River SCA survey.

The survey crew identified a total of 11 pipe outfalls. The severity and location of pipe outfall sites is shown in Figure 6b. Six of the pipes had a discharge. All were clear with no odor. The pipes were rated as moderate. The remaining pipes did not have any discharge.

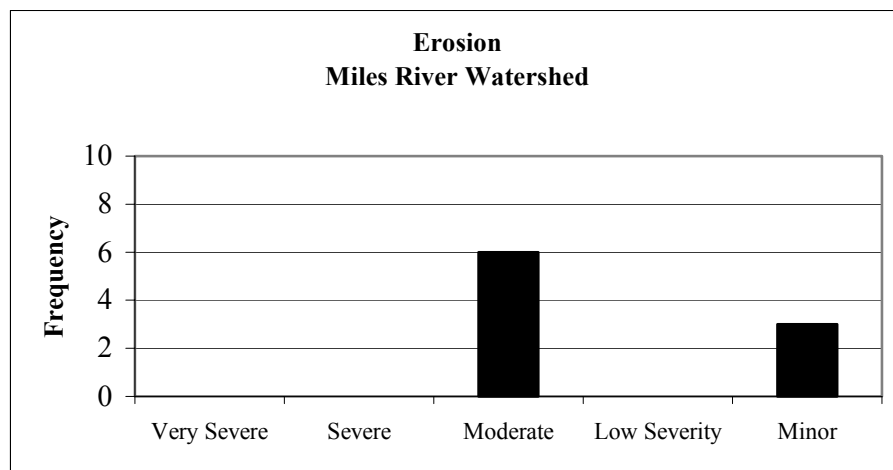
Figure 7a. Histogram showing the frequency of severity ratings given to erosion sites during the Miles River SCA survey.

The SCA survey found 9 eroding stream banks over the length of 6,360 feet (1.2 miles) of stream, or about 4 percent of the 30 miles streams surveyed. The severity and location of erosion sites is shown in Figure 7b. All the sites were ranked either moderate or minor in severity. (Figure 7a)

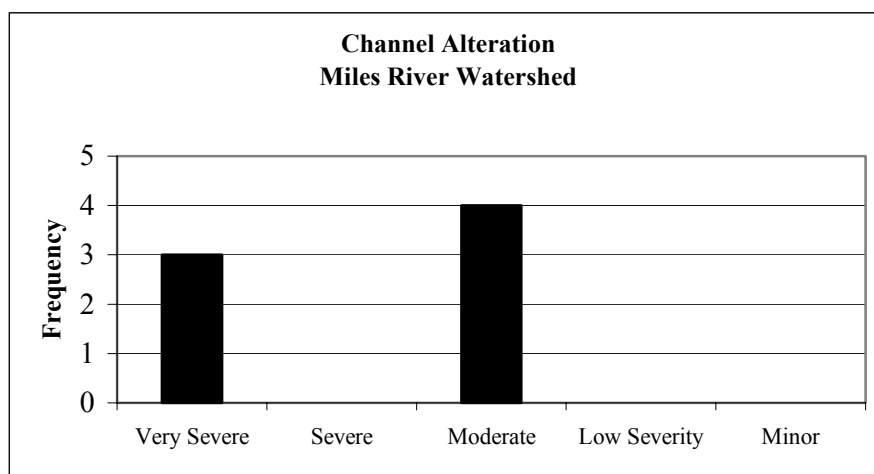
Figure 8a. Histogram showing the frequency of severity ratings given to channel alteration sites during the Miles River SCA survey.

Results of this survey show recognizably altered stream channels at 7 sites. The severity and location of channel alteration sites is shown in Figure 8b. The total length of stream affected by channelization is estimated to be 14,800 feet (2.8 miles). Severity rankings for the sites range from very severe to moderate (Figure 8a).

Restoring channel alteration sites can increase fish and wildlife habitat and may allow for more time for nutrient uptake in the waterway. In its simplest form, restoration for earth channels would include allowing vegetation and/or tree roots to stabilize the sediment along the channel, causing sinuosity to re-form naturally. This sinuosity may reform within the bed of the channelization or along its banks, depending on the site and the depth of the channel alteration.

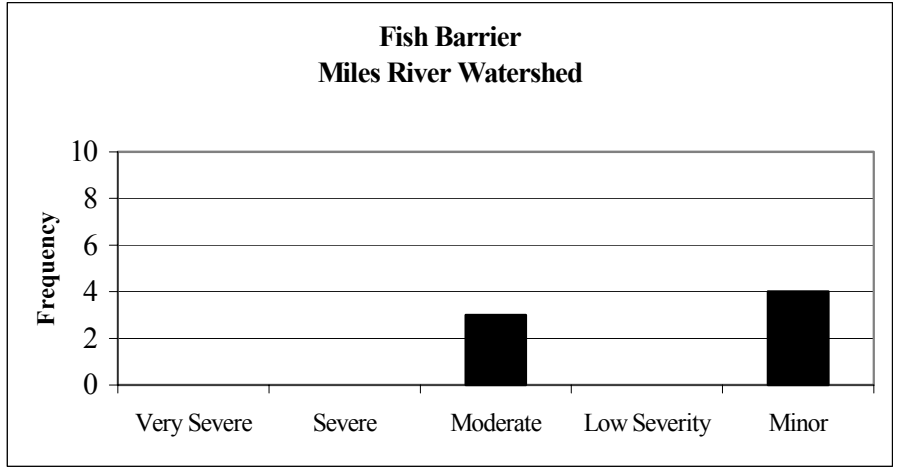
Figure 9a. Histogram showing the frequency of severity ratings given to fish barrier sites during the Miles River SCA survey.

The Miles River SCA survey found 7 fish migration barriers. The locations of fish blockages are shown in Figure 9b. Fish barriers in this watershed are due to road crossings (6), and debris dams (1). Three of these sites received a moderate rating (033001, 033002, 049001). They were all at road crossings. The three moderate sites were all underpasses of Route 50 (Ocean Gateway) north of Easton.

In restoration work, priority is given to removing fish barriers that will yield access to the greatest quality and quantity of upstream habitat per dollar spent. The mainstem is ideally kept as barrier-free as possible, allowing anadromous fish to migrate to spawn and a source of fish species for tributaries in the event of a disturbance. Restoration planning includes targeting barriers for removal that isolate entire tributaries, those that isolate significant portions of the upper tributary, and those that isolate quality fish habitat. The best restoration sites also are far from other existing fish barriers.
