**Stream Corridor Assessment Survey for the Prettyboy Reservoir Watershed,
Baltimore County, Maryland**

April 2006

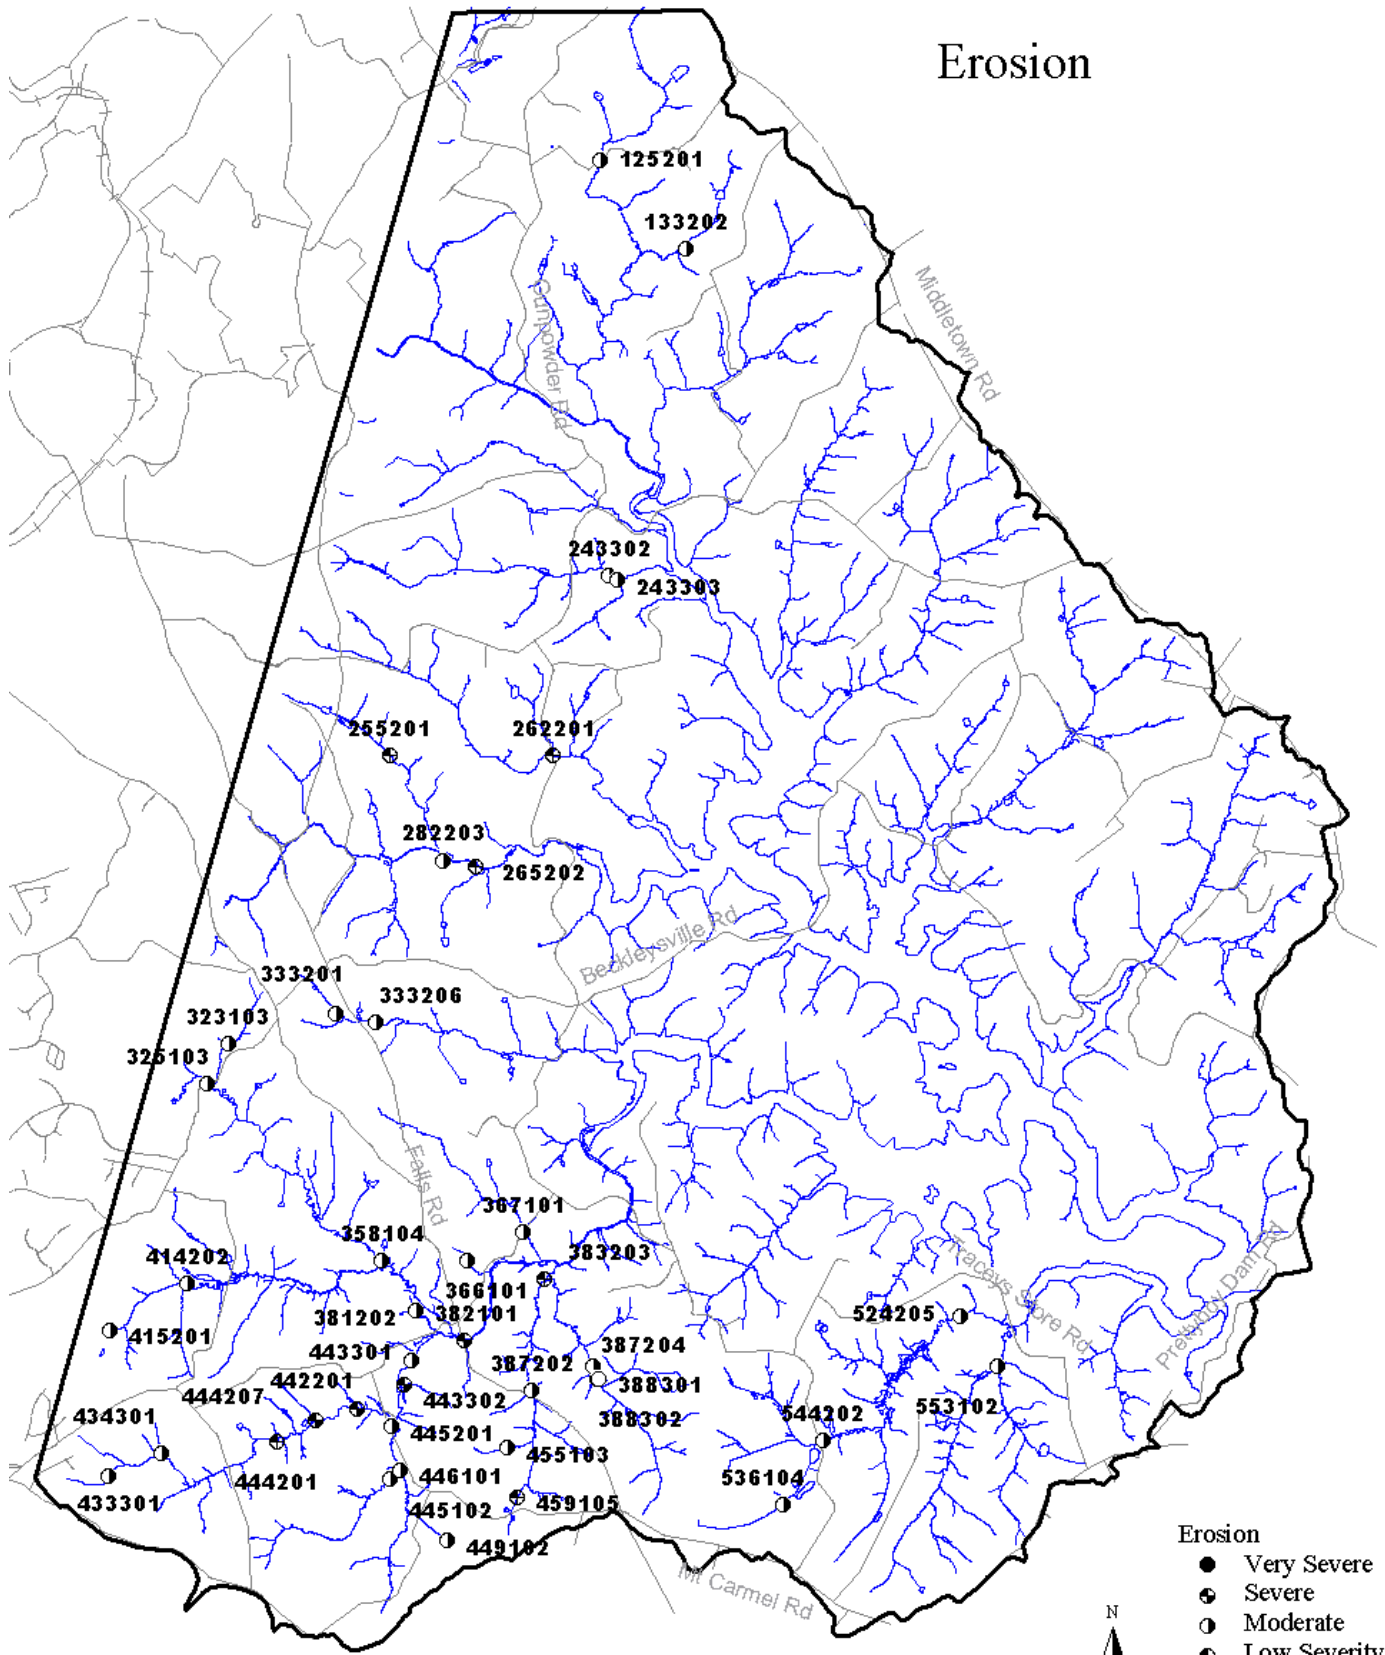
Figure 5b: Map showing the locations of the Erosion sites in the Prettyboy Reservoir
 5000 0 5000 Feet

The SCA survey found 41 eroding stream banks over the length of 61,900 feet (11.7 miles) of stream, or about 14 percent of the 85 miles streams surveyed. The severity and location of erosion sites is shown in Figure 5b. Four of the sites are ranked as severe (Figure 5a). (Appendix B).

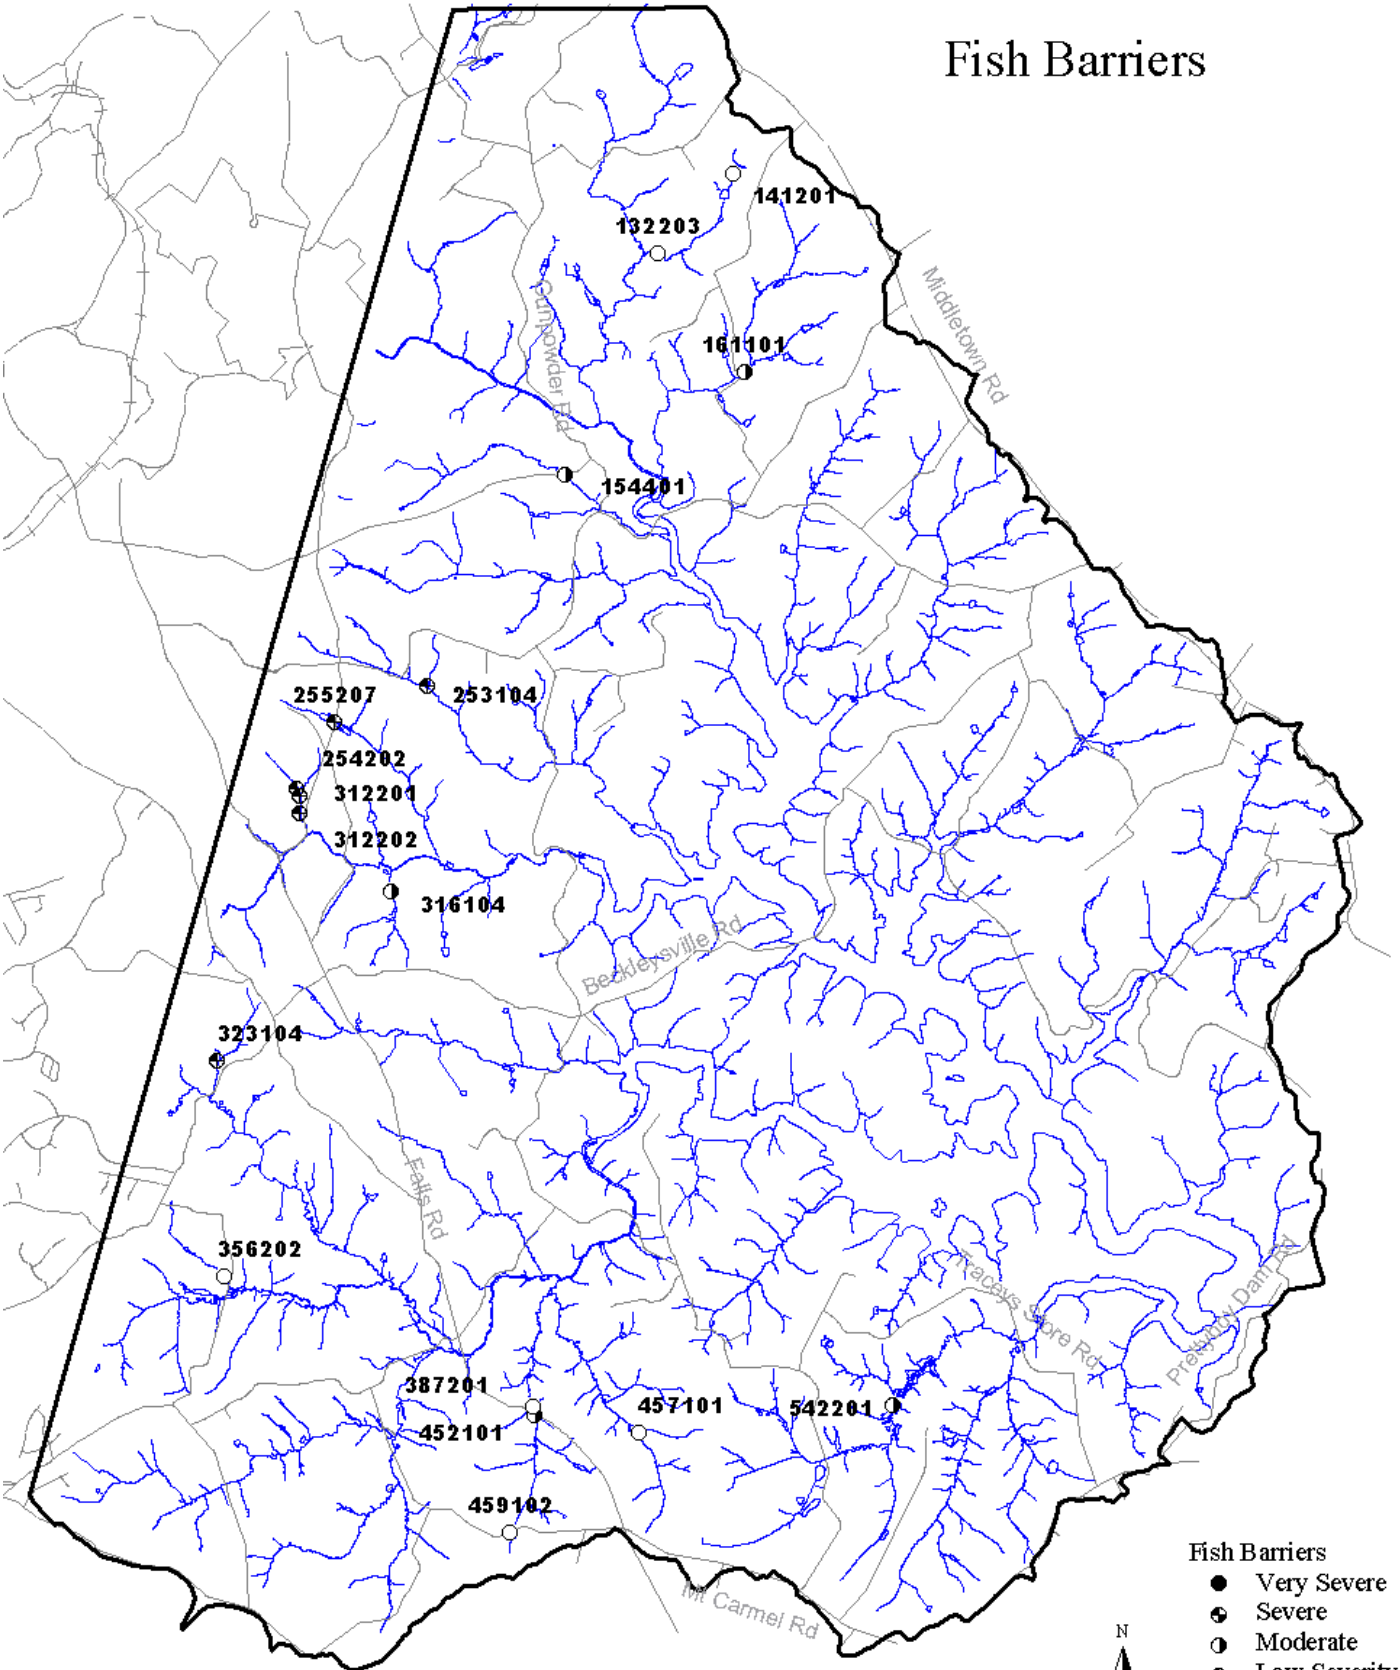
Figure 7b: Map showing the locations of the Fish Barriers in the Prettyboy Reservoir

The Prettyboy Reservoir SCA survey found 17 fish migration barriers. The locations of fish blockages are shown in Figure 7b. Fish barriers in this watershed are due natural falls (2), road crossings (10), dams (2), and debris dams (2). Five of these sites received a moderate rating. They were all at road crossings.
