**UPS4—Unnamed Tributary to the Patuxent River.**

**UPS6—Unnamed Tributary to the Patuxent River.**

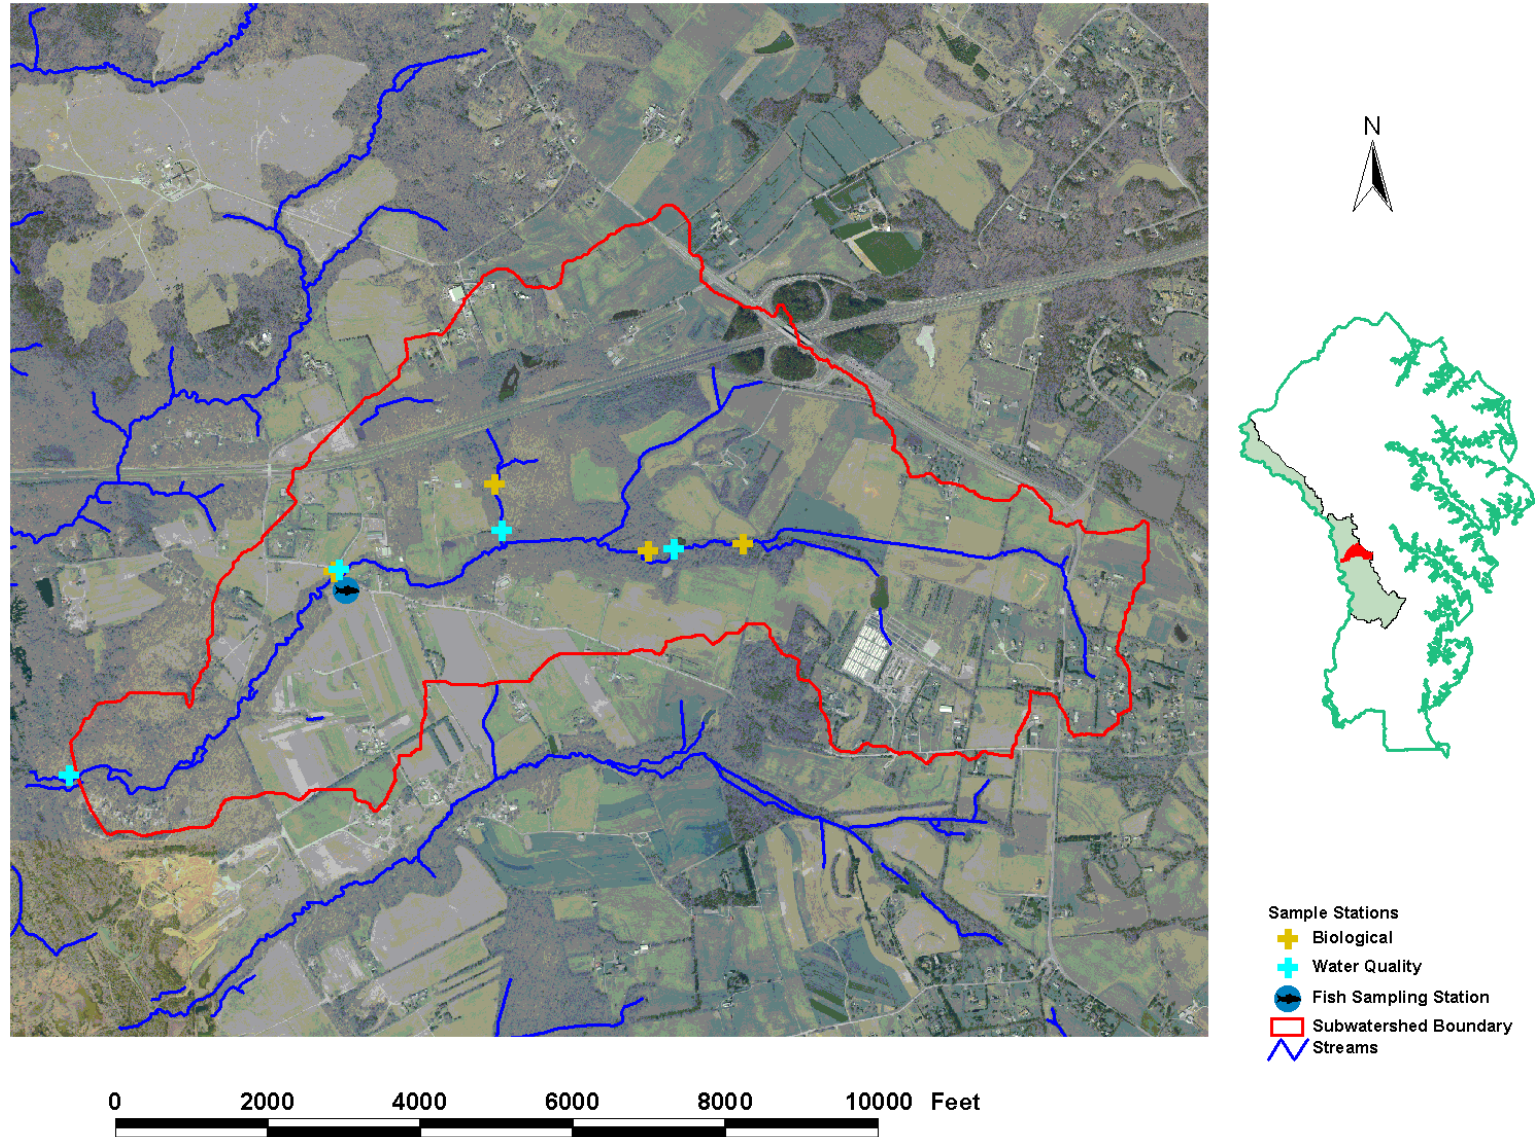
Figure 17. Overview of UPS4.

As illustrated in Figure 17, this subwatershed has over 50% of its area dedicated to agricultural land uses while approximately 16% is used for residential land. Most of the nearly 19% of vacant land is currently forested and is zoned residential agriculture. The current level of watershed impervious surface is approximately 2% and is
