Isle Of Wight Stream Corridor Assessment Survey

Watershed Restoration Division
Chesapeake & Coastal Watershed Services
Maryland Department of Natural Resources
April 2002

Stephen Czwartacki & Ken Yetman
Watershed Restoration Division
Coastal and Chesapeake Watershed Services
Maryland Department of Natural Resources

April 4, 2002

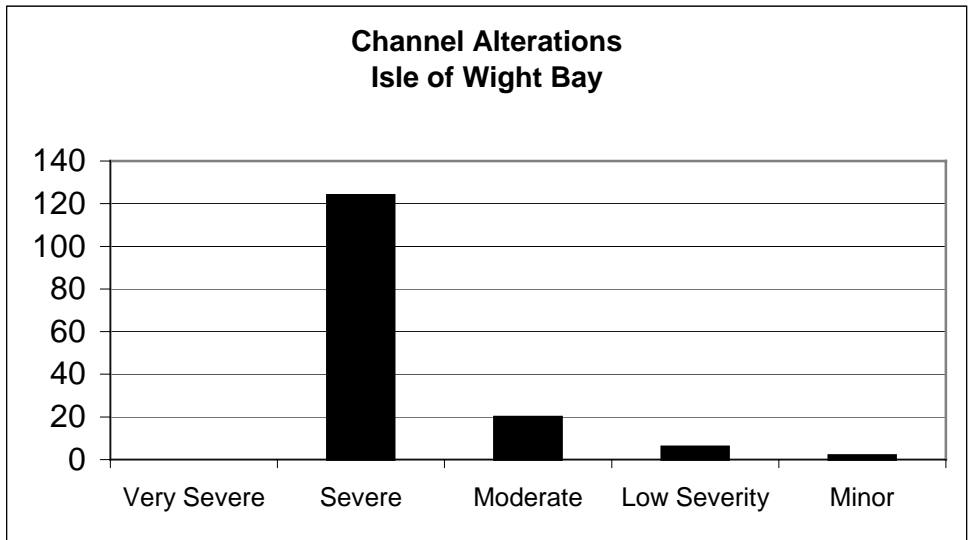
Figure 5a: Histogram showing the frequency of severity ratings given to channel alteration sites during the Isle of Wight Bay SCA survey.

Channel alteration was the most frequently reported problem. Survey crews found 152 areas in the Isle of Wight Watershed where the stream channel had been recognizably altered. Location of channel alteration sites are shown in Figure 5b. The total length of stream affected by channelization was estimated to be 947,401 feet or about 179.43 miles. This accounts for 69.11% of stream miles in the non-tidal area of the Isle of Wight. Channel alterations were found to be widespread throughout the headwaters of the watershed, especially in the watershed northern area. The majority of the sites (146 sites) were earthen channels or agricultural ditches. One site was reported to have rip-rap present in the channel, 1 site had gabion baskets and at 1 site cinder blocks were being used to armor an eroding stream bank. Most of the sites in the Isle of Wight watershed were given a severity rating of severe (Figure 5a). The rating reflects the extensive nature of most of the stream canalization sites. In one site (Site IW059109) it was estimated that there were over 11 miles of channelized stream present. Channel alteration sites in the Isle of Wight were not given the highest severity rating of very severe because this rating is usually only given in areas where cement channels have been constructed and there is virtually no natural in-stream habitat present. The lengths of stream present at channel alteration sites varied from 7ft to 61,073ft. Bottom widths ranged from 3 inches to 50 feet. Perennial flow was reported to be present at 90 % (136 sites) and sediment deposition was reported at 70 sites.

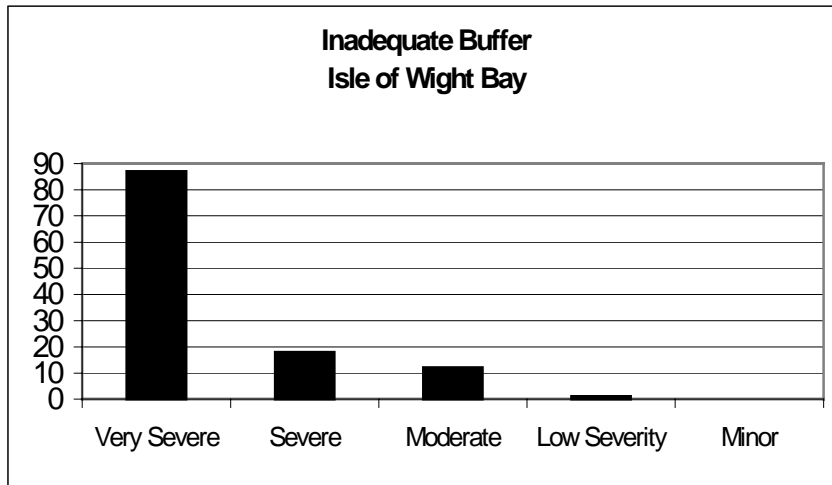
Fig. 6a: Histogram showing the frequency of severity ratings given to inadequate buffer sites during the Isle of Wight Bay SCA survey.

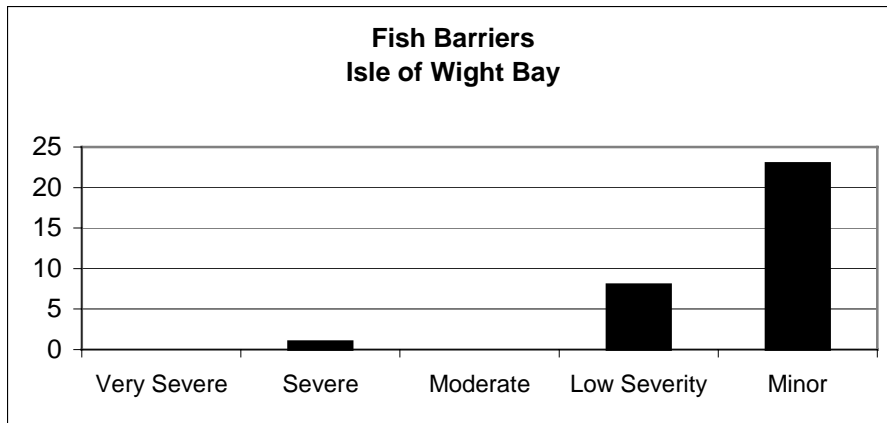
Figure 7a: Histogram showing the frequency of severity ratings given to fish migration blockages seen during Isle of Wight Bay SCA survey.

The majority (20 of 32 sites) of the fish migration blockages were characterized as being either temporary or partial fish migration barriers. Most of the fish migration blockages were also given a minor or low severity rating (Figure 7a). The only exception was at the dam near Bishopville (Site IS005206), which was given a severe rating because it may be interfering with the migration of some anadromous fish.

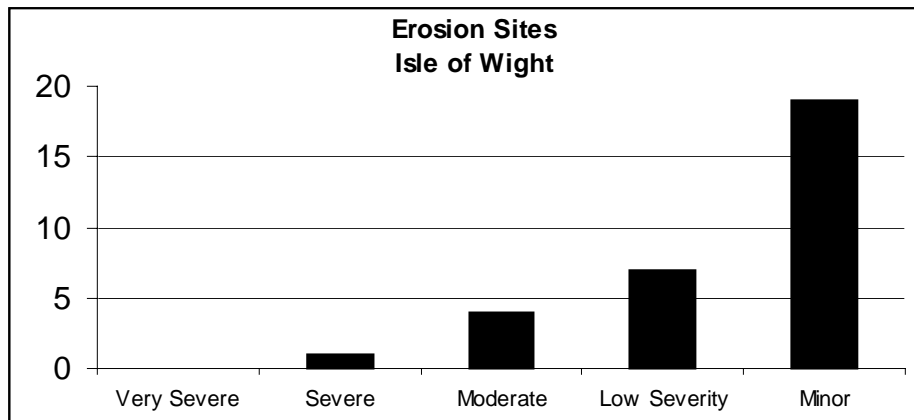
Figure 8a: Histogram showing the frequency of severity ratings given to stream bank erosion site during Isle of Wight Bay SCA survey.

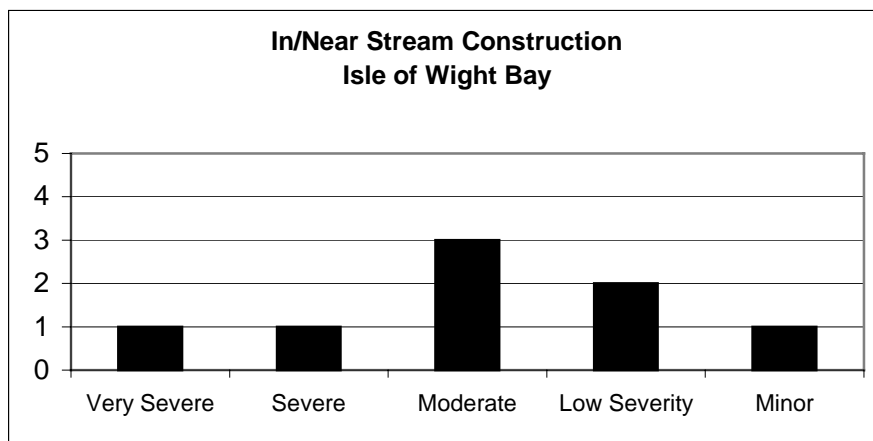
Figure 9a: Histogram showing the frequency of severity ratings given to in/near stream construction sites during Isle of Wight SCA survey

Most sites were given a moderate to minor severity rating (Figure 9a). Two site however, Site 086302 and Site 085104, were given very severe and sever ratings respectively. At Site 086302 survey crews reported that an unknown company was constructing a park and ride just south of Rte. 50 in the lower Isle of Wight Bay watershed. Field crews indicated that they did not believe the construction site had adequate sediment control and reported excess sediment washing into several streams. At Site 085104 field crews reported that a road construction project with inadequate sediment control was washing excessive sediment into lower Isle of Wight also.

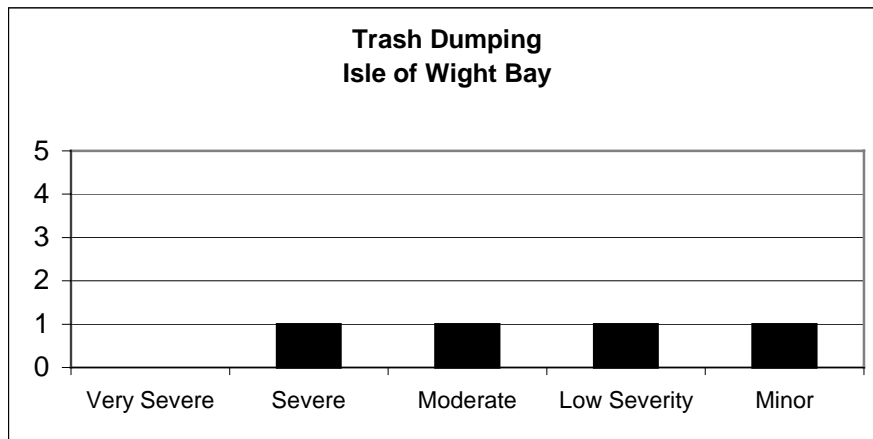
Figure 10a: Histogram showing the frequency of severity ratings given to trash dumping sites during Isle of Wight SCA survey

Trash dumping data sheets are used to record the location of places where large amounts of trash has been dumped inside the stream corridor or to note places where trash tends to accumulate. The field survey crew found 4 sites where there was excessive trash and the locations are shown in Figure 10b. Site 003103 on the Carey Branch of the Bishopville Prong was given a severe rating. This site was found to have a large amount of tires, styrofoam, paper, and scrap metal present next to the stream. Field crews estimated at least 5 pick-up truckloads of trash present at this site. Three more sites were recorded as moderate to minor in severity (Figure 10a). These sites included residential waste, Styrofoam, and car parts.

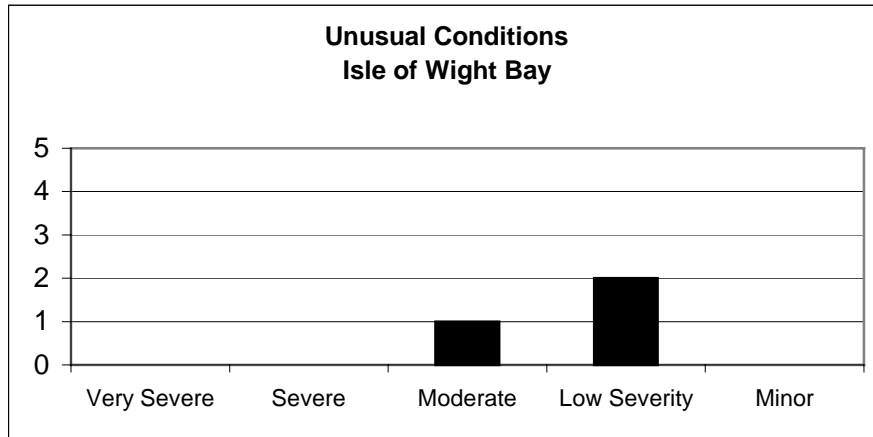
Figure 11a: Histogram showing the frequency of severity ratings given to unusual condition sites during Isle of Wight SCA survey

The unusual condition/comment data sheets are used to record the location of anything out of the ordinary seen during the survey, or to provide some additional written comments on a specific problem. Three unusual condition data sheets were completed during the Isle of Wight Bay survey, and eighty-three comment data sheets were filled out. The locations of the unusual condition sites are shown in Figure 11b. Two unusual conditions were given a low severity rating, and one site was given a moderate rating (Figure 11a). The moderate rating was given to Site 071104 where a dead sheep was found in the stream.

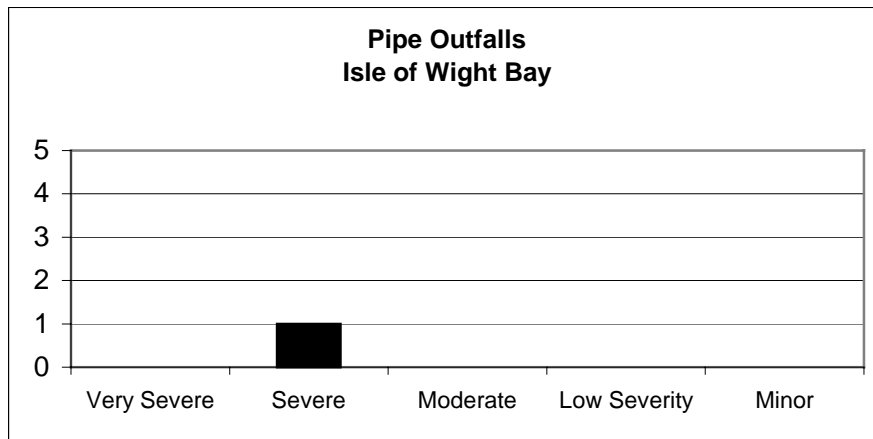
Figure 12a: Histogram showing the frequency of severity ratings given to pipe outfall sites during Isle of Wight SCA survey
