# Liberty Reservoir Stream Corridor Assessment Survey

Watershed Assessment and Targeting  
Watershed Services Unit  
Maryland Department of Natural Resources

# Liberty Reservoir

## STREAM CORRIDOR ASSESSMENT SURVEY

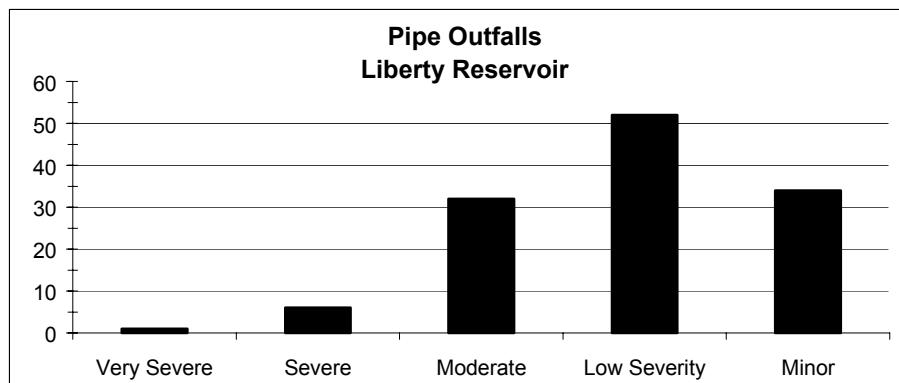
**Figure 5a: Histogram showing the frequency of severity ratings given to Pipe outfall sites during the Liberty Reservoir SCA survey.**

Severity ratings for pipe outfalls were given based on outfall type, discharge, type of discharge, and location in the watershed of the outfall. In the Liberty Reservoir SCA Survey, 1 pipe outfall was given a very severe rating, along with 6 severe, 32 moderate, 52 low severity, and 34 minor sites (Figure 5a).

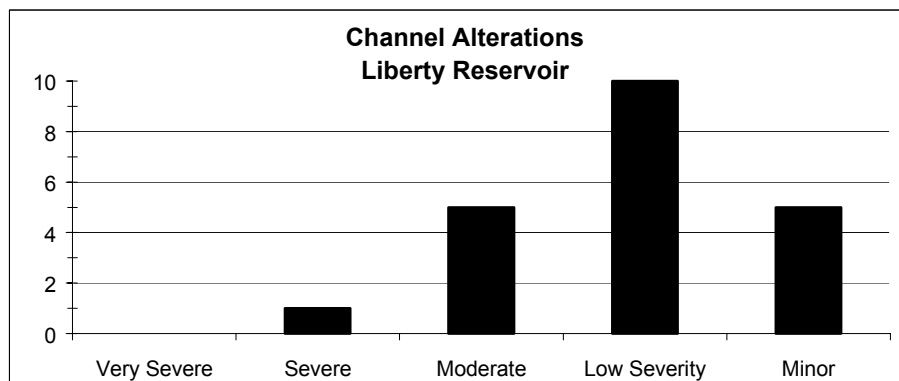
**Figure 9a: Histogram showing the frequency of severity ratings given to channel alteration sites during the Liberty Reservoir SCA Survey.**

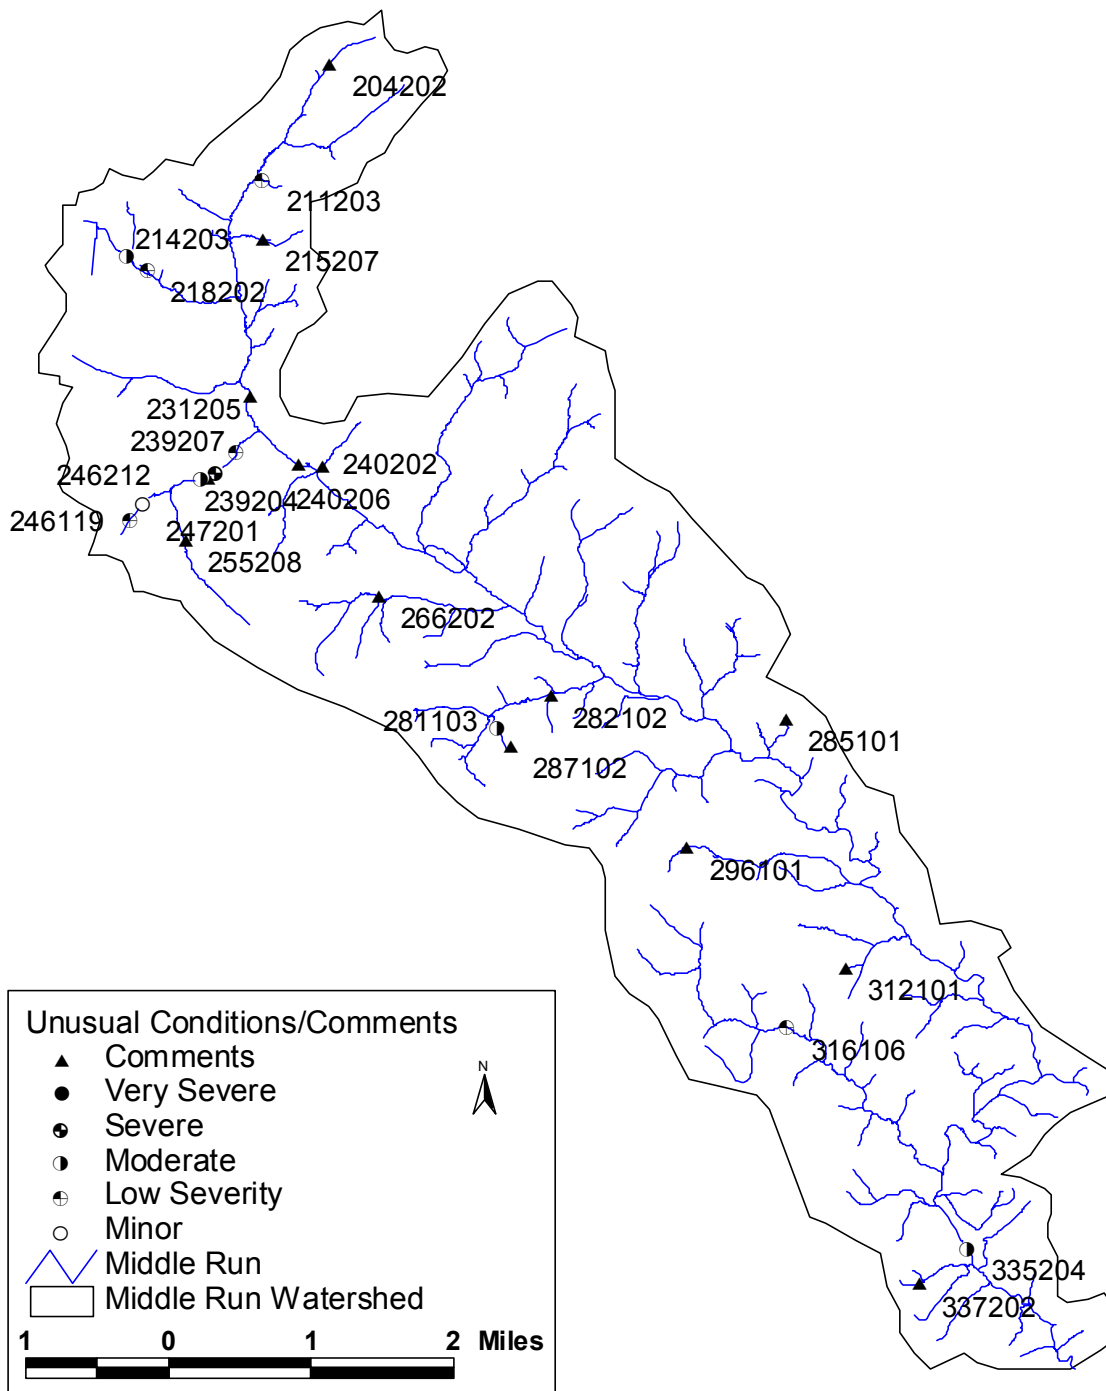
**Figure 10d: West Branch Unusual Condition/Comments Locations.**

Eleven unusual condition sheets were recorded in the West Branch. One of these sites was identified as a severe site. At site 239204 there was what appears to be a springhead with heavy iron deposits and bacteria bubbling to the surface. It was noted that the site is near Monumental Wood Mill Works.

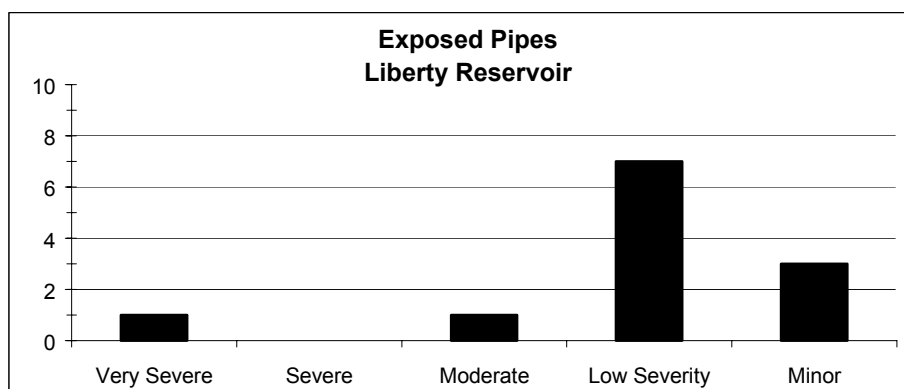
**Figure 11a: Histogram showing the frequency of severity ratings of exposed pipes seen during the Liberty Reservoir SCA survey.**

In urban areas, it is very common for pipelines and other utilities to be located in the stream corridor. This is especially true for gravity sewage lines that depend on the continuous downward slope of the pipeline to move sewage to a pumping station or treatment plant. Since streams are located at the lowest points of the local landscape, engineers often build sewage lines paralleling streams to collect sewage from adjacent neighborhoods. While the pipelines are stationary, streams can migrate and over time can expose previously buried pipelines. When this occurs, the pipeline becomes vulnerable to being punctured by debris in the stream. Fluids in the pipelines can be discharged into the stream, causing a serious water quality problem. Severity ratings were given based on how exposed the pipe is, location of the pipe, and contents inside the pipe.

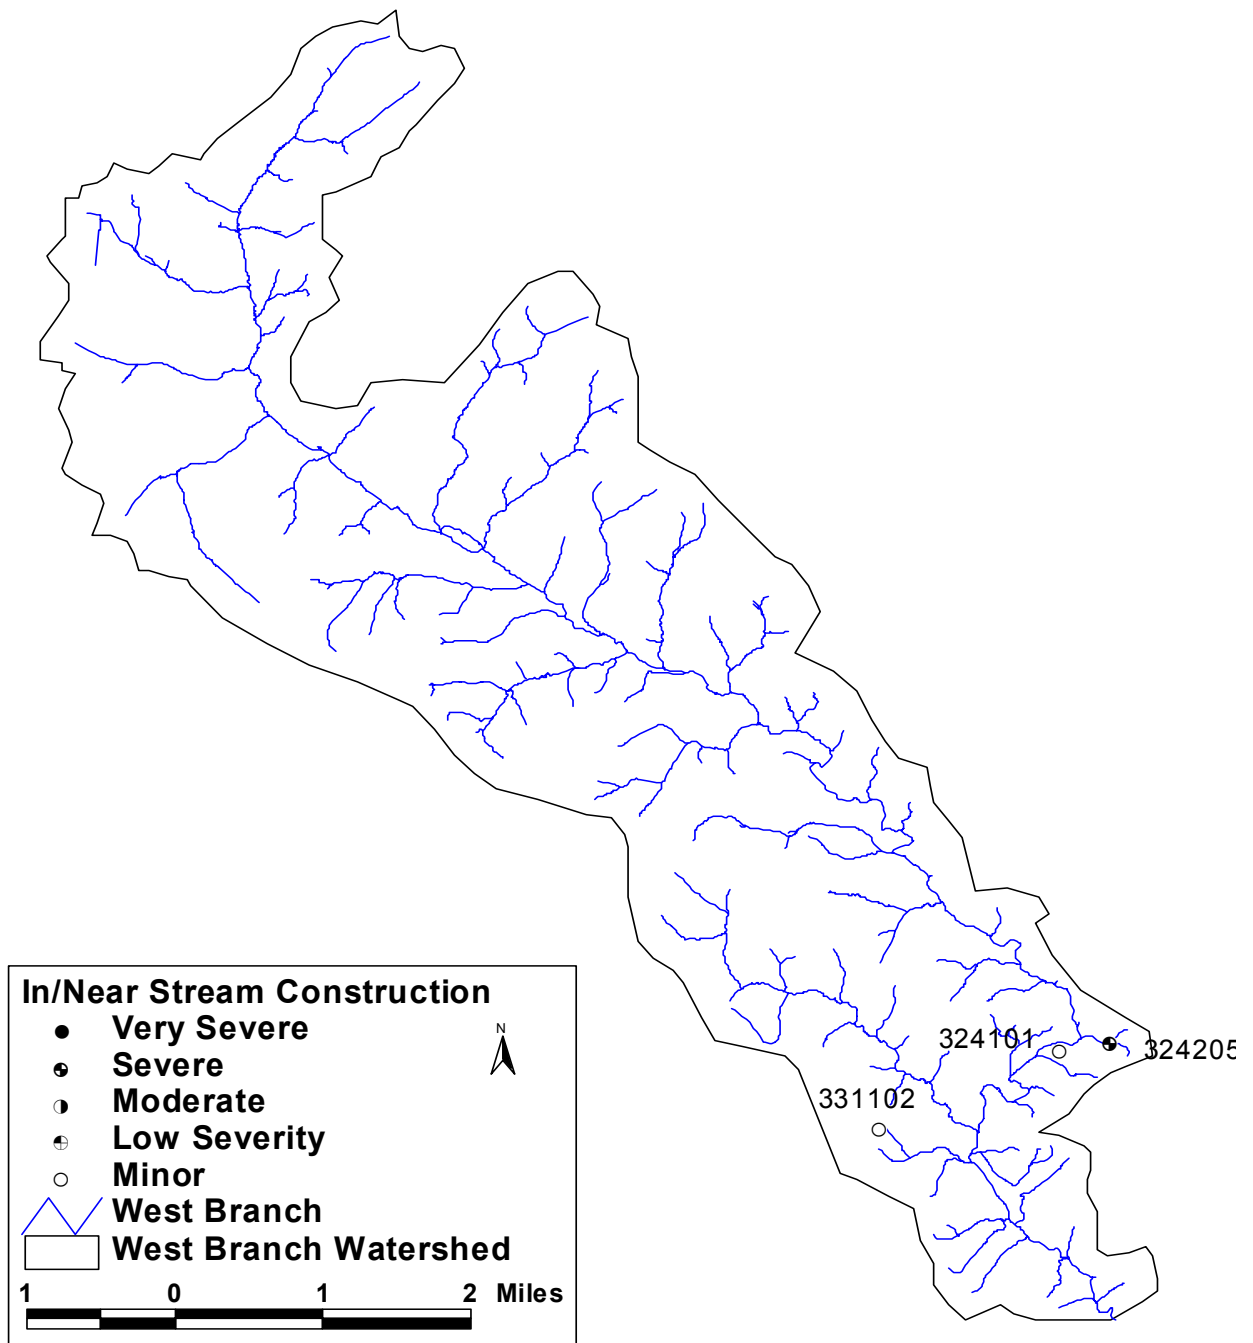
**Figure 12a: West Branch In/Near Stream Construction Sites.**

In or near stream construction data sheets are used to document any construction disturbances seen by the survey teams inside or near the stream corridor. Survey team members are not trained sediment inspectors, but as part of their training they do receive a quick review of the different type of sediment control measures they may see while doing a SCA survey. Survey teams report evidence of inadequate sediment control measures or if sediment pollution from the site has affected the stream. In or near stream construction was reported at 3 sites during the Liberty Reservoir survey. All sites were found in the lower West Branch. The locations of in/near stream construction sites are shown in Figure 12b.
