Maryland Department of Natural Resources
Watershed Services
Technical and Planning Services
April 2005

DEEP RUN AND PATAPSCO RIVER STREAM CORRIDOR ASSESSMENT SURVEY In Howard County

PREPARED BY
Robin Pellicano and Kenneth T. Yetman

WATERSHED SERVICES
TECHNICAL AND PLANNING SERVICES
MARYLAND DEPARTMENT OF NATURAL RESOURCES
ANNAPOLIS, MARYLAND

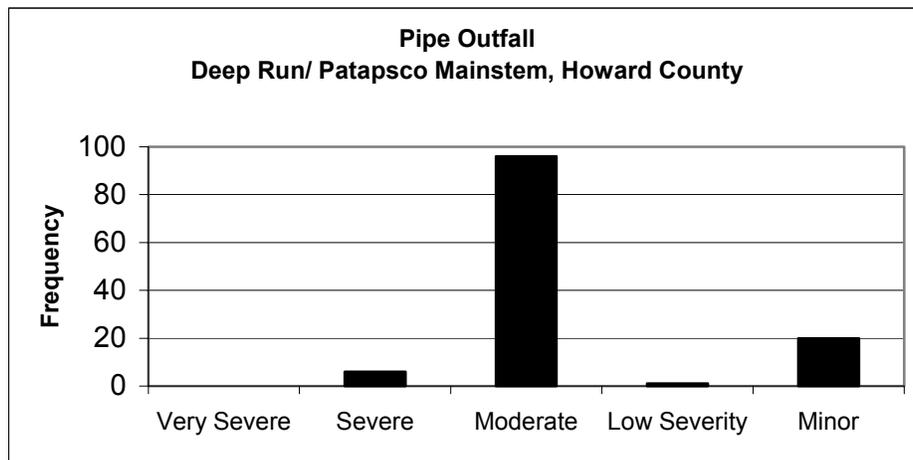
Figure 4a. Histogram showing the frequency of severity ratings given to pipe outfall sites during the Patapsco SCA survey in Howard County

Pipe outfalls include any pipes or small, constructed channels that discharge into the stream through the stream corridor. Pipe outfalls are considered a potential environmental problem in the survey because they can carry uncontrolled runoff and pollutants such as oil, heavy metals and nutrients to a stream system. The survey crew identified a total of 123 pipe outfalls (Figure 4a). The locations of pipe outfalls are shown in Figures 4b-c.

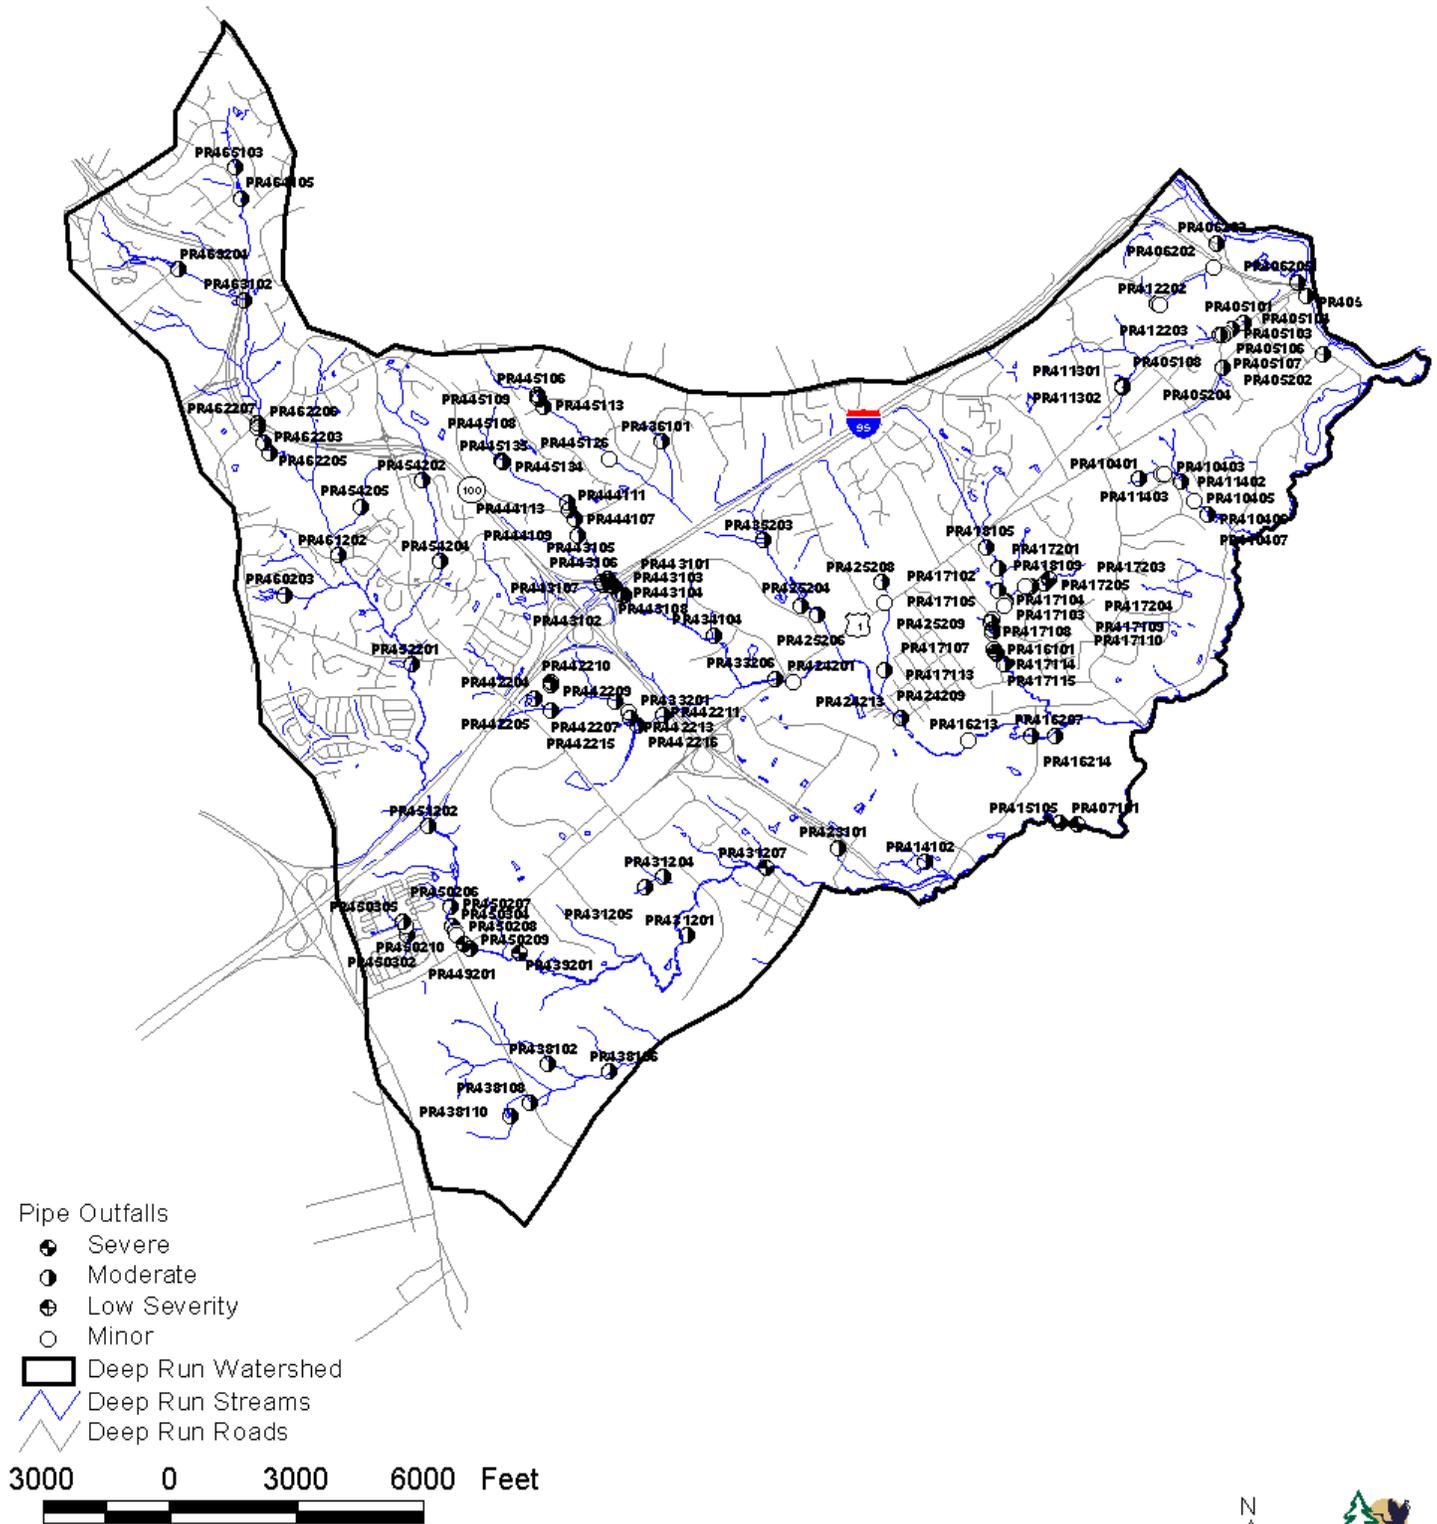
Figure 4b: Map showing the location of the Pipe Outfalls in Deep Run

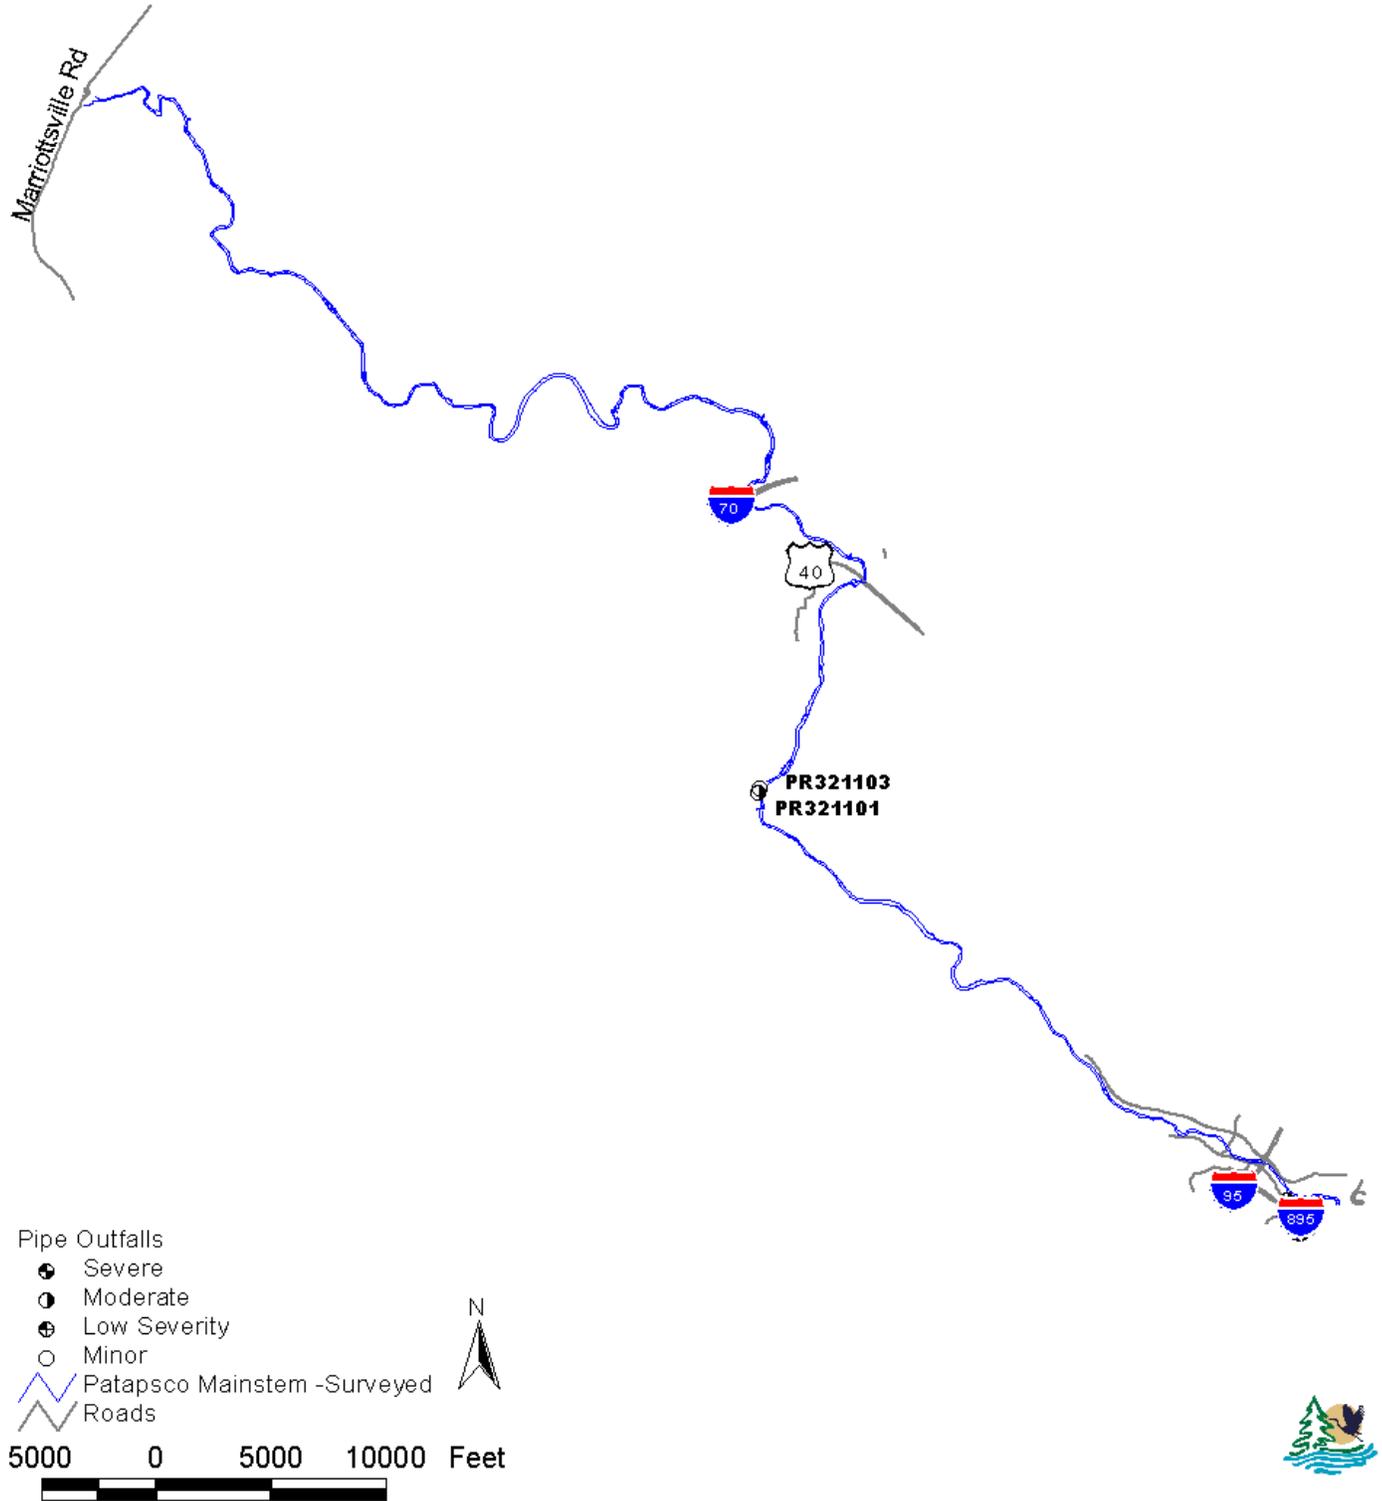
Figure 4c: Map showing the location of the Pipe Outfalls on the surveyed Patapsco Mainstem

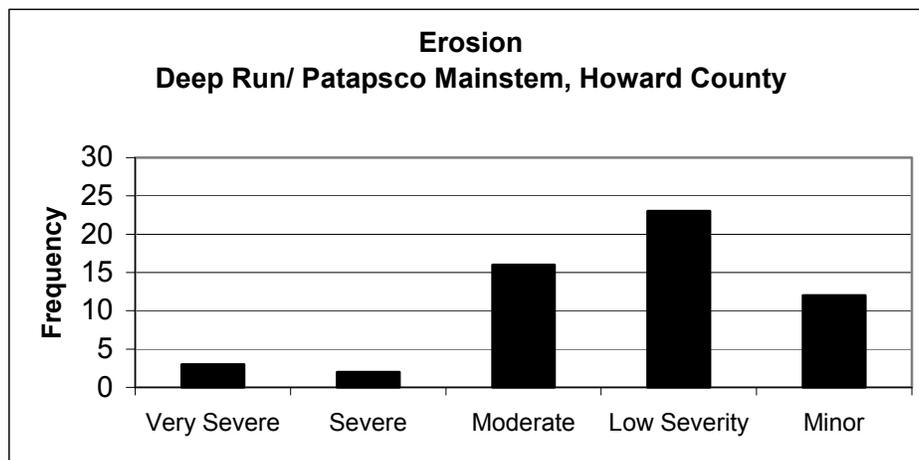
Figure 5a. Histogram showing the frequency of severity ratings given to erosion sites during the Patapsco SCA survey in Howard County.

This survey found 56 unstable eroding banks sites with a total length of approximately 4.7 miles of stream (Appendix B). Figure 5a shows the frequency of the severity rating given to erosion sites. Within this watershed, there were three very severe erosion sites (PR406204, PR417106, PR418111) and two severe sites (PR416205, PR444103). The majority of erosion sites were minor- to moderate-in severity. The lengths of stream segments with unstable banks varied from 20 feet to 3,300 feet of stream (Appendix B).

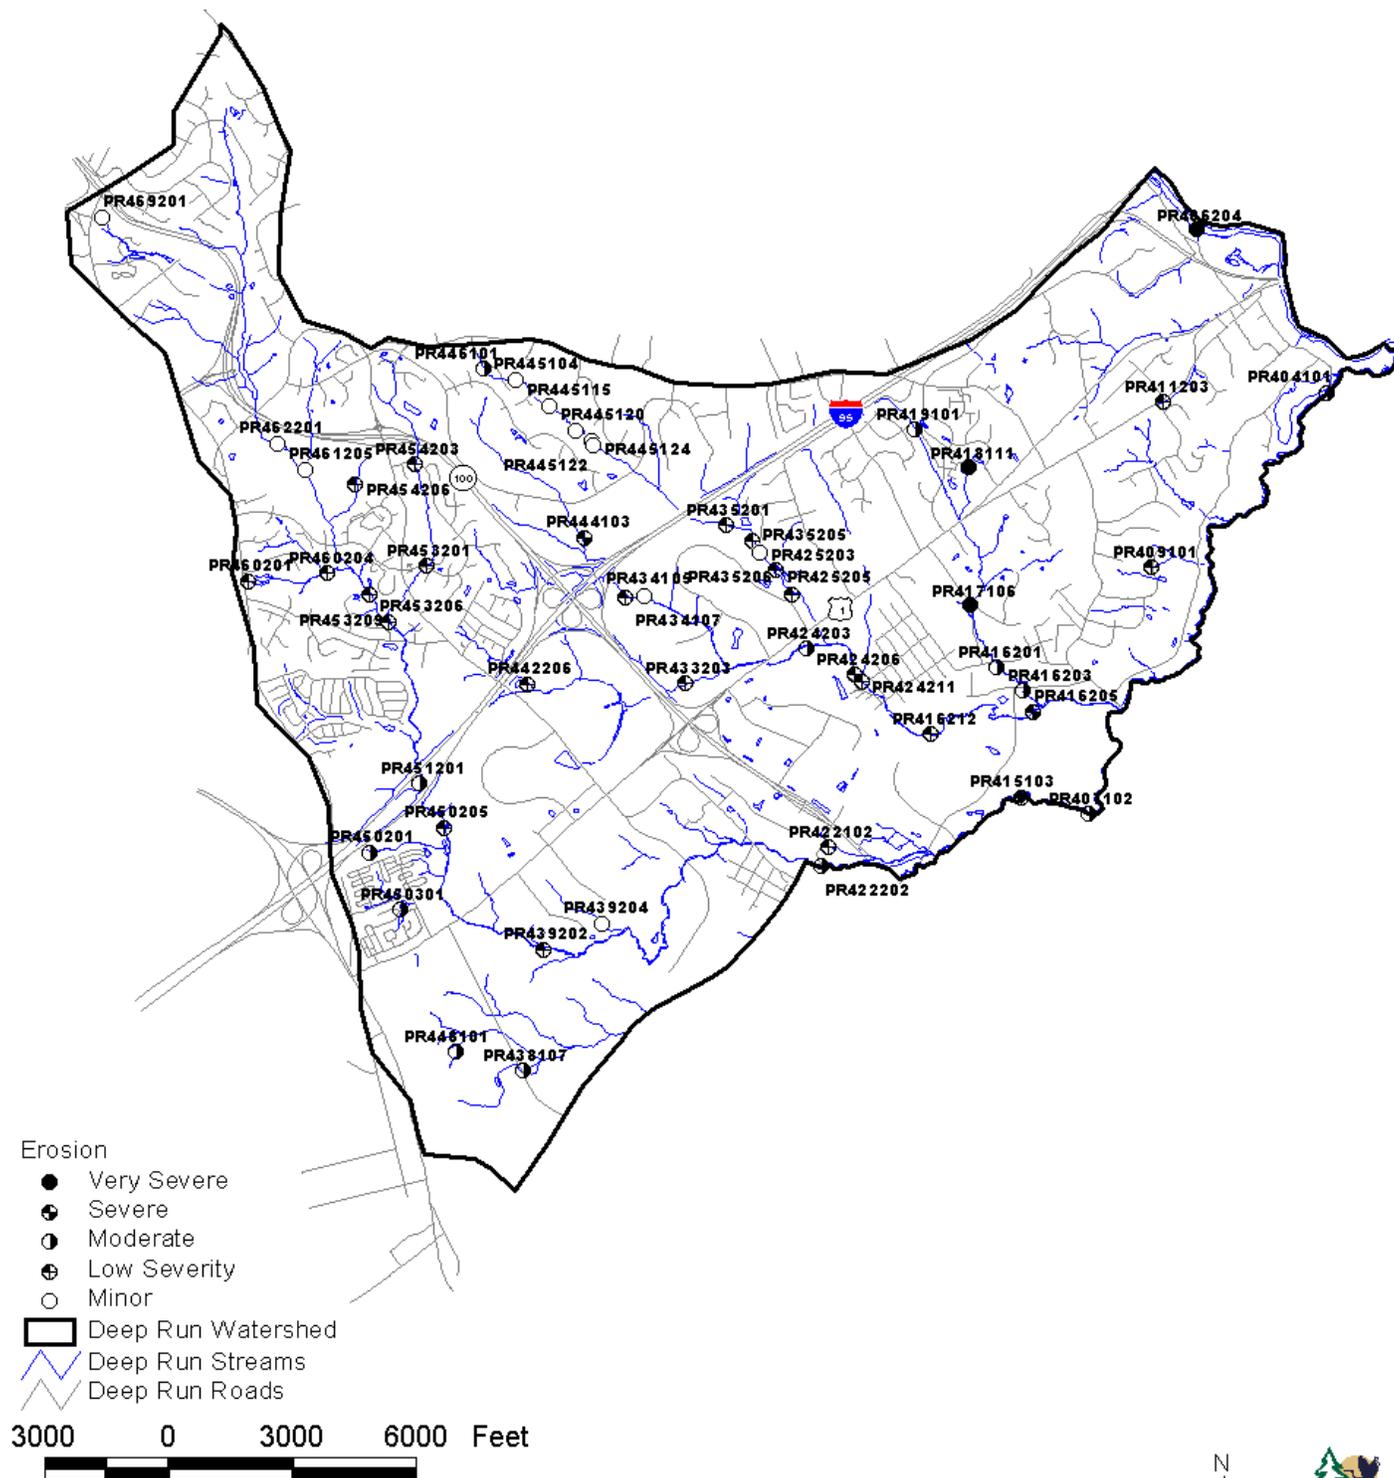
Figure 5b: Map showing the location of the Erosion Sites in Deep Run

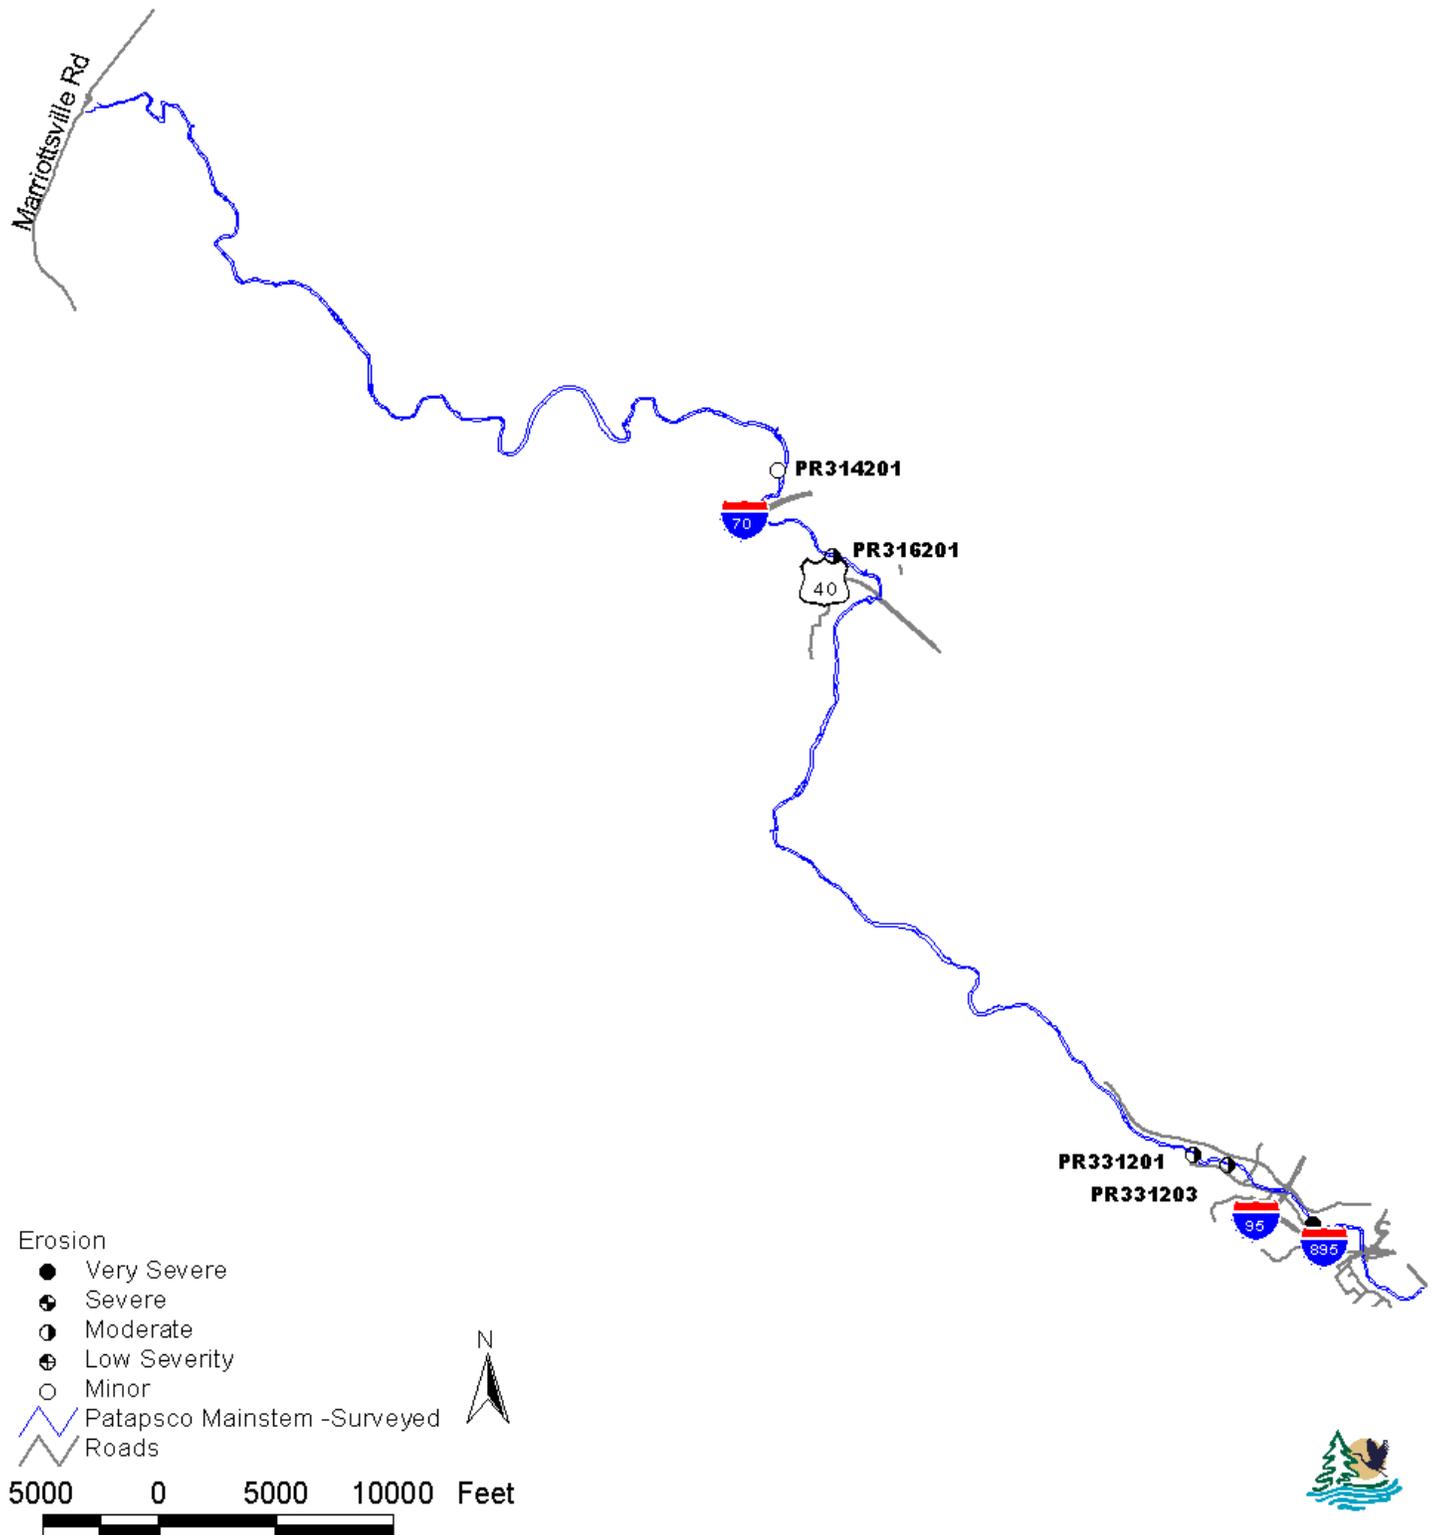
Figure 5c: Map showing the location of the Erosion Sites the surveyed Patapsco Mainstem

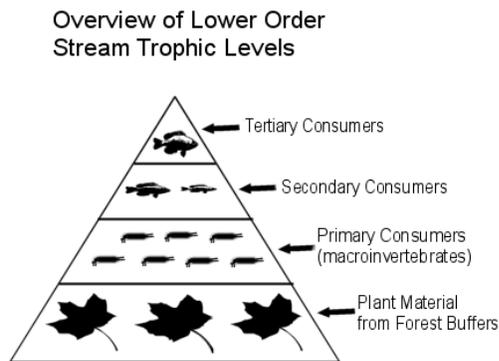
Illustration 1. Schematic diagram of stream trophic levels in lower order streams within historically forested regions.

surveyed, terrestrial plant material falling into the stream is the primary source of plant food for stream life (Illustration 1). Tree leaves provide seasonal, instant food for stream life, while fallen tree branches and trunks provide a more consistent, slow-release food source throughout the year. Tree roots and snags also provide necessary fish habitat. Maintaining healthy streams is important in reducing the nutrient and sediment loadings to the Chesapeake Bay. Therefore, Maryland is committed to recreating forest buffers along streams because they are essential to healthy stream function and habitat.

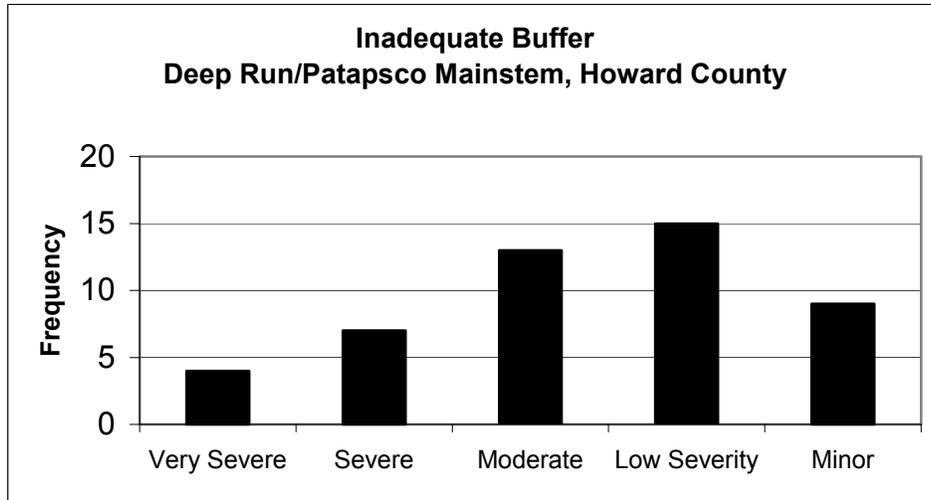
Figure 6a. Histogram showing the frequency of severity ratings given to inadequate buffers during the Patapsco SCA survey in Howard County.

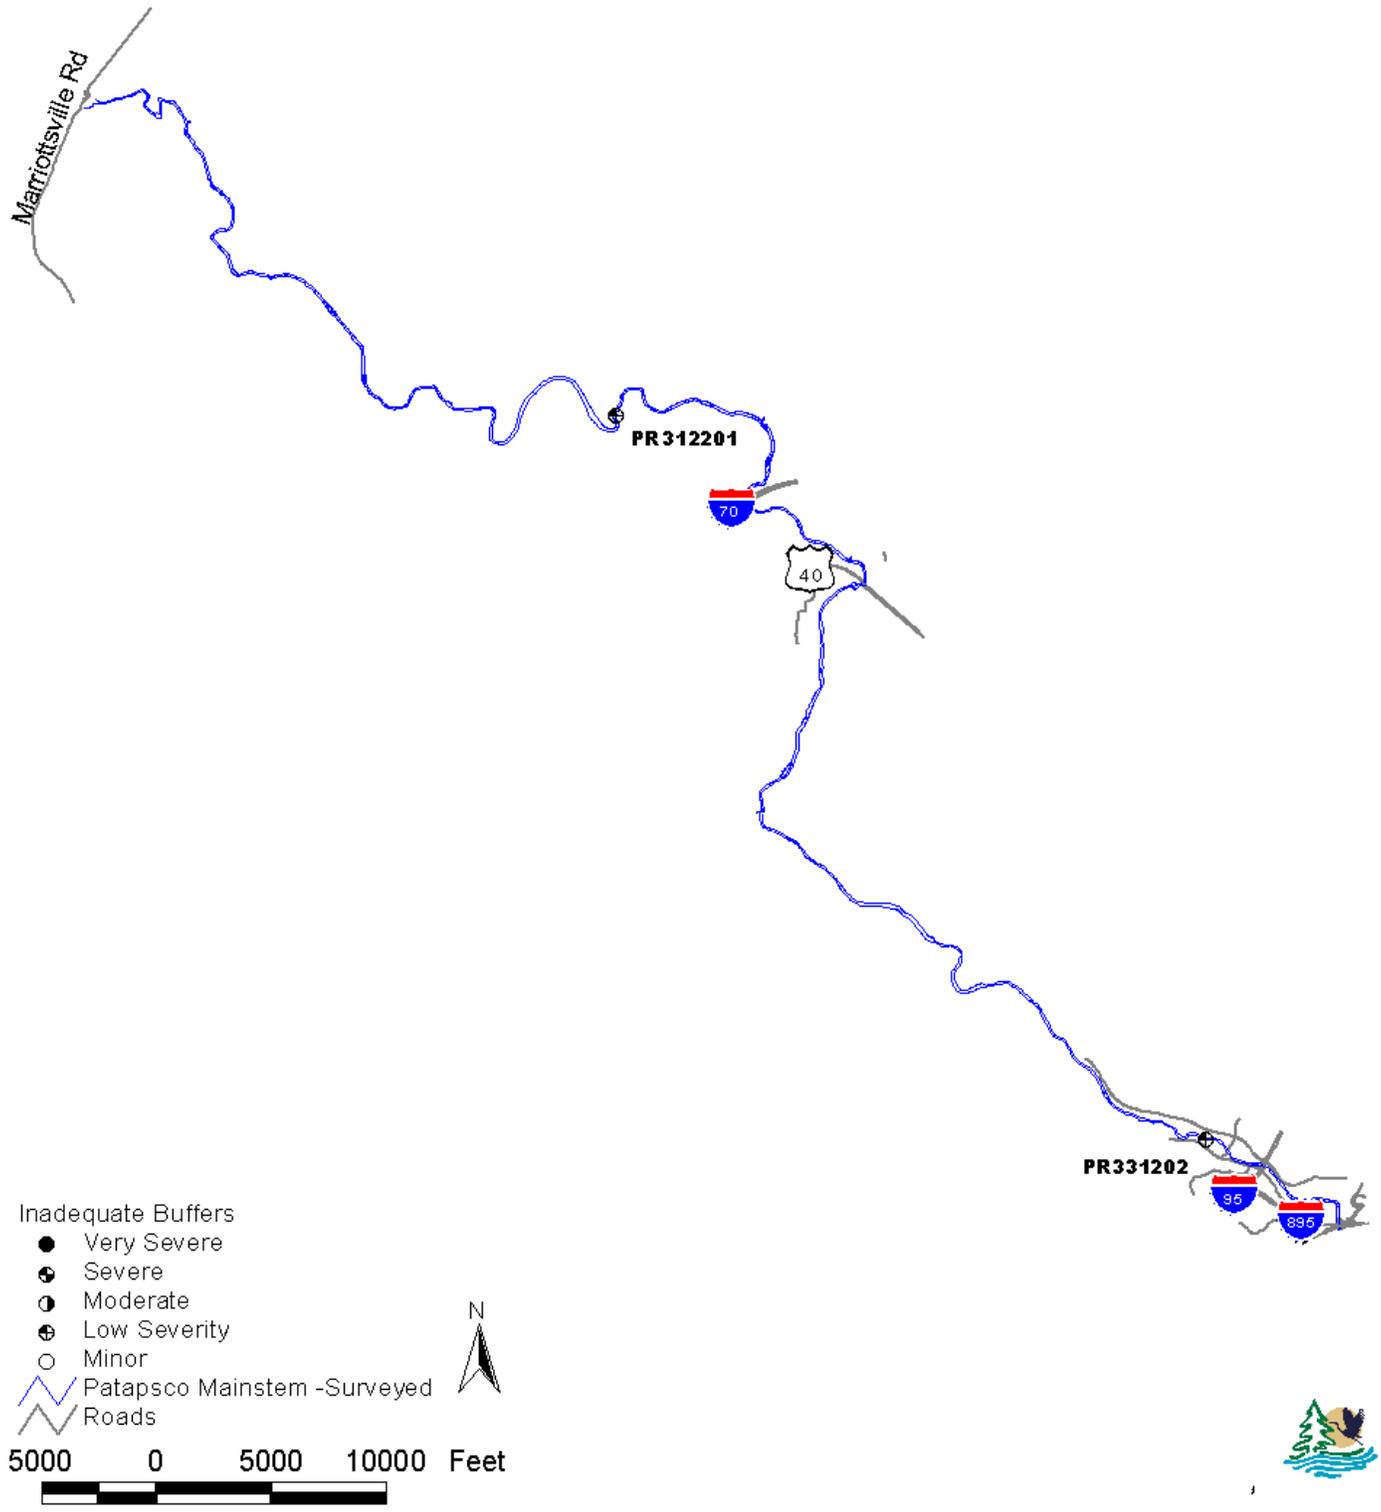
Figure 6c: Map showing the location of the Inadequate Buffers on the surveyed Patapsco Mainstem

While there is no single minimum standard for how wide a stream buffer should be in Maryland, for the purposes of this study a buffer is considered inadequate if it is less than 50 feet wide, measured from the edge of the stream. The survey crew identified 48 inadequate buffers sites (Figures 6b-c), and provided an estimate of the length of the inadequate stream buffer at all sites (Appendix B). Based on the collected data, there are approximately 45,600 feet (8.6 miles) of inadequate buffers.

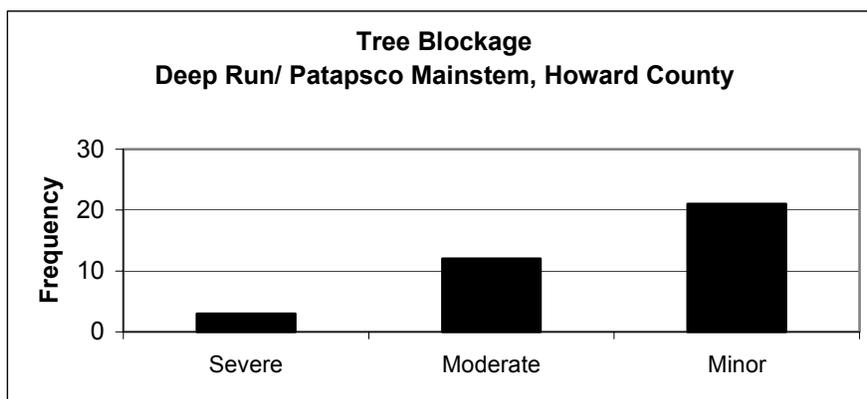
Figure 7a. Histogram showing the frequency of severity ratings given to tree blockage sites during the Patapsco SCA survey in Howard County.

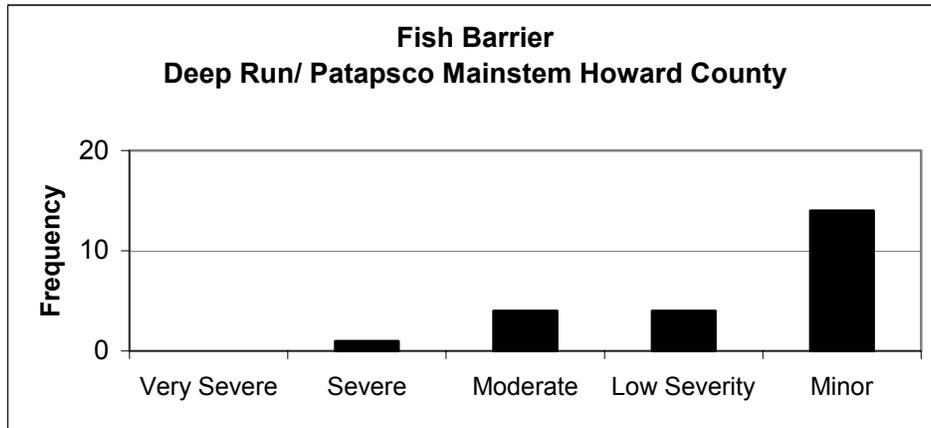
Figure 8a. Histogram showing the frequency of severity ratings given to fish migration barrier sites during the Patapsco SCA survey in Howard County.

The Patapsco SCA survey observed 23 fish migration barriers. The locations of fish blockages are shown in Figure 8b-c. The fish barriers are due to natural falls (5), road crossings (7), channelized stream sections (2), debris dams (5), Beaver dams (1), pipe crossings (1), and constructed dams (2). The majority of fish migration barriers are moderate to minor in severity, with one severe site recorded (Figure 8a). This site (PR317101) was located on the main stem approximately 600 feet below Route 40.

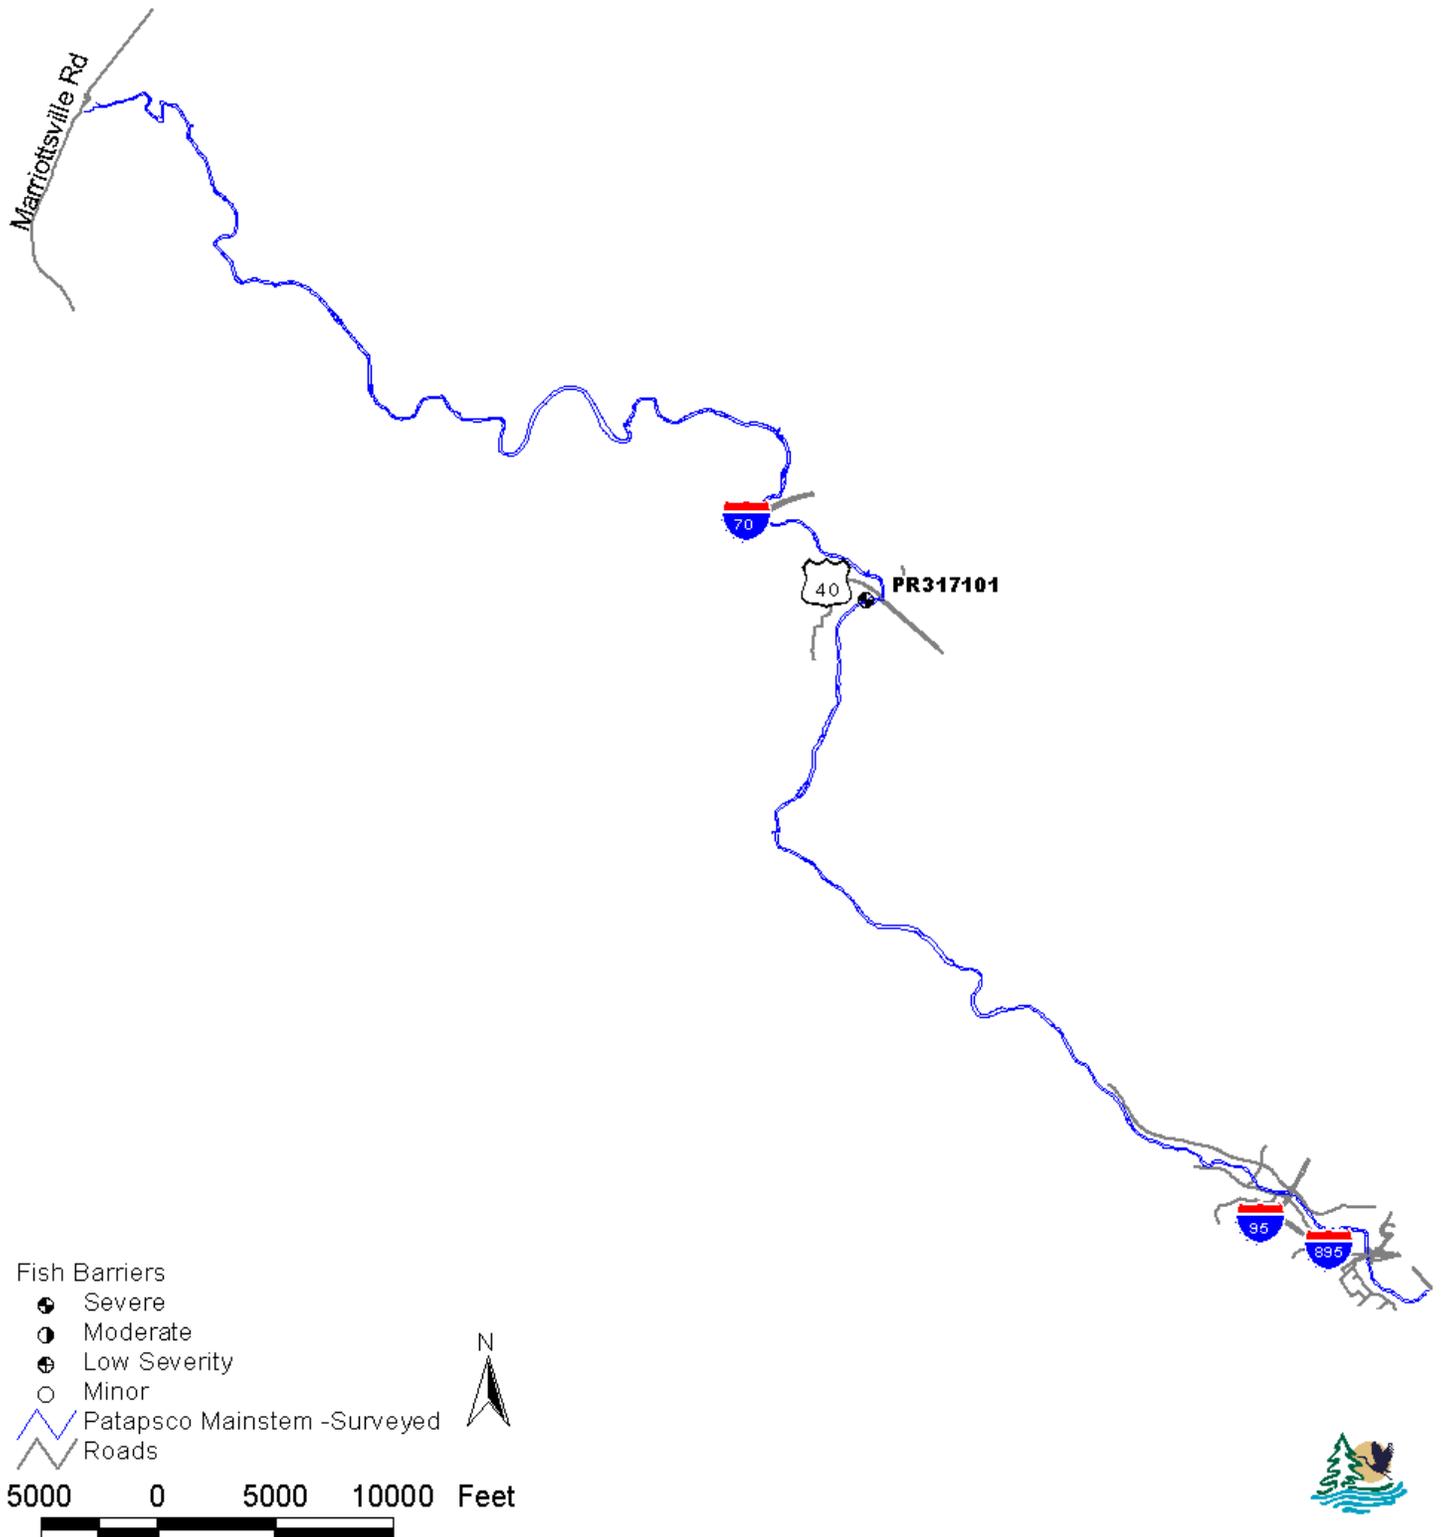
Figure 8c: Map showing the location of the Fish Barriers on the surveyed Patapsco Mainstem

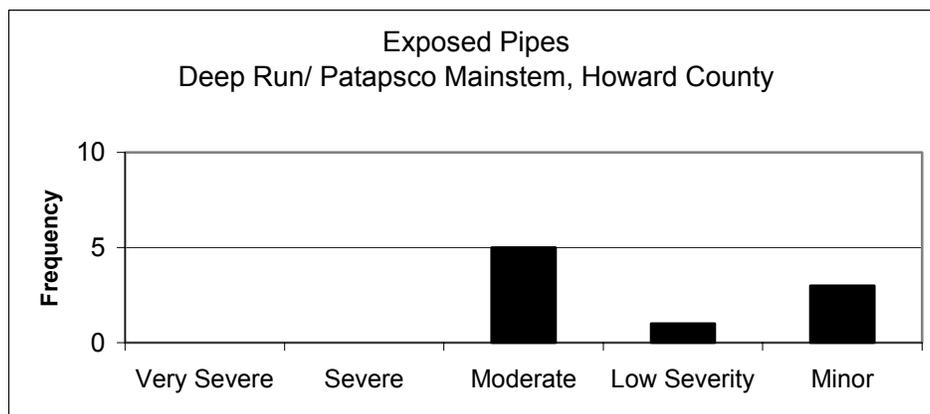
Figure 9a. Histogram showing the frequency of severity ratings given to exposed pipe sites during the Patapsco SCA survey in Howard County.

Field crews observed nine exposed pipes during the survey, all moderate to minor in severity (Figure 9a). Locations of these sites are shown in Figures 9a-b. Four pipes were recorded as being sewage. The remaining exposed pipes are recorded as unknown in purpose.

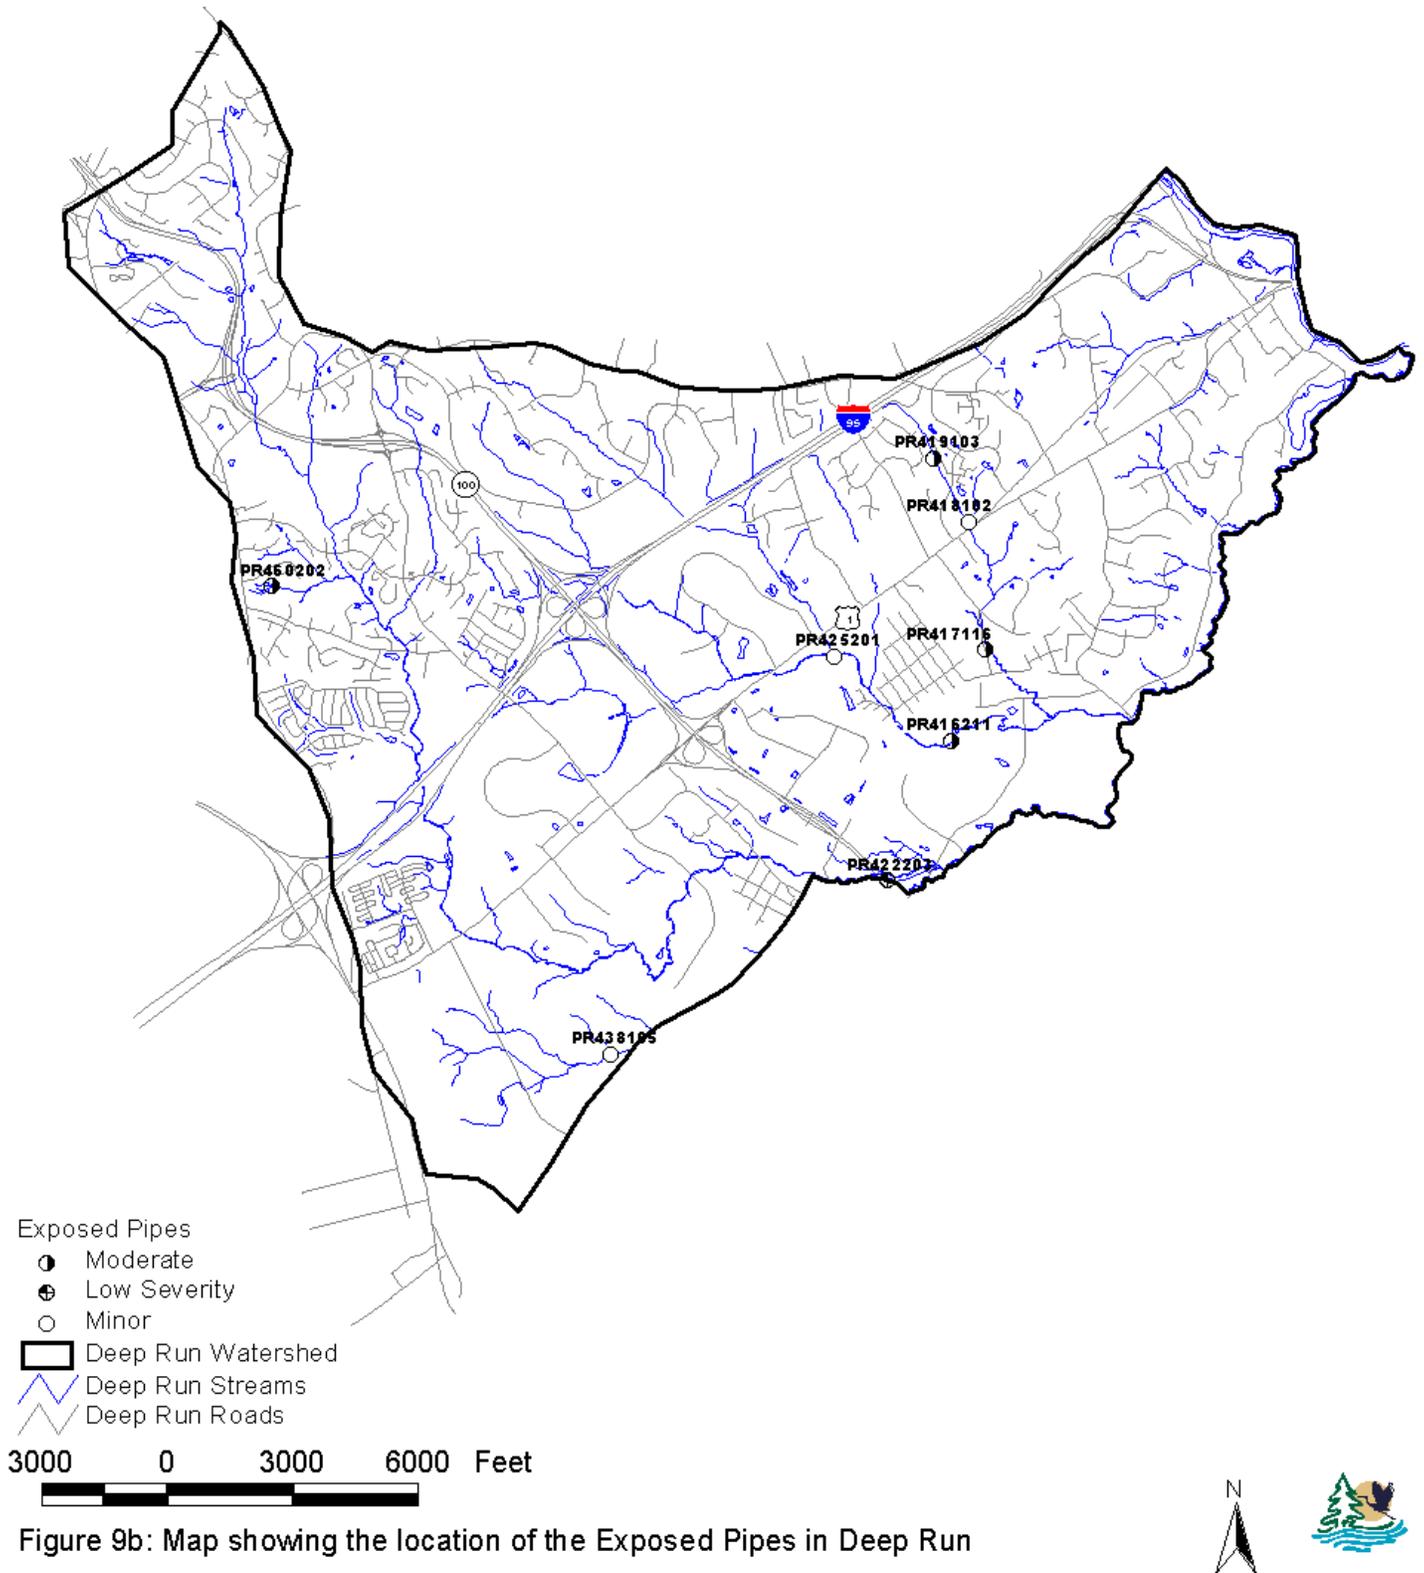
Figure 9b: Map showing the location of the Exposed Pipes in Deep Run

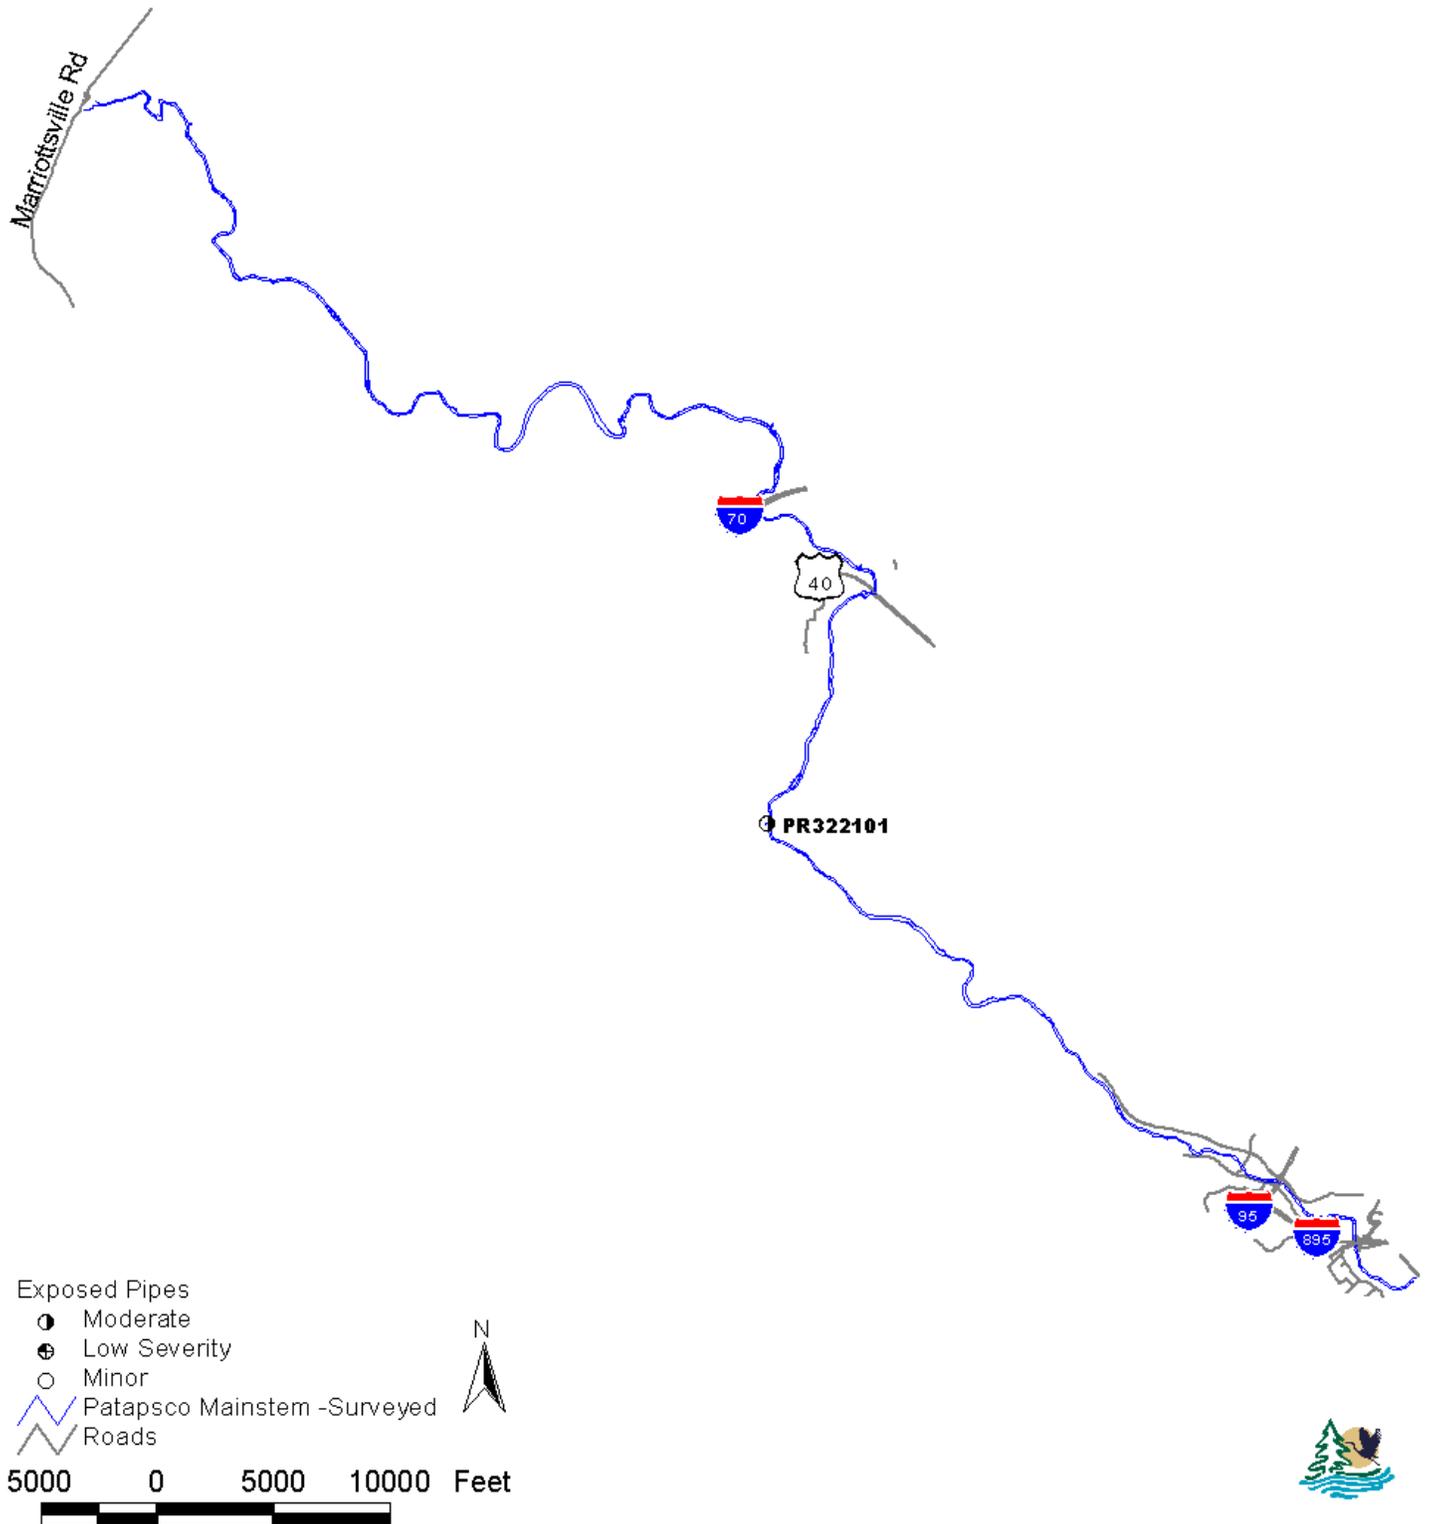
Figure 9c: Map showing the location of the Exposed Pipe on the surveyed Patapsco Mainstem

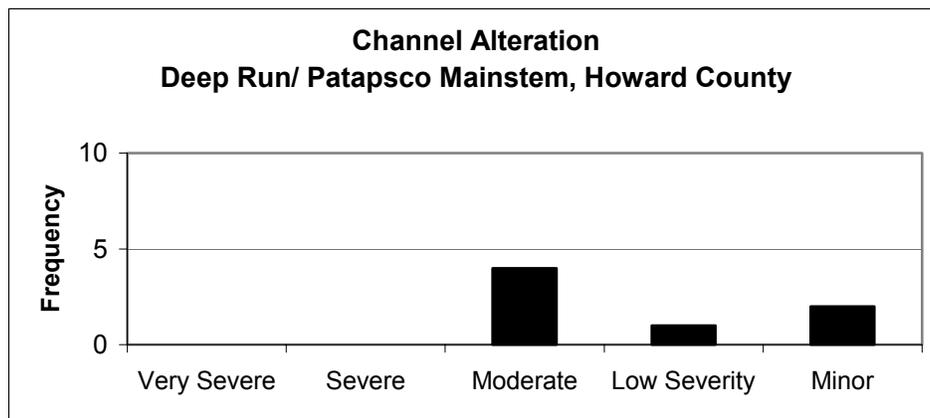
Figure 10a. Histogram showing the frequency of severity ratings given to channel alteration sites during the Patapsco SCA survey in Howard County.

The channel alteration in this watershed is most often over a short stretch and constructed of a variety of materials, from concrete to earth channels. All of sites are rated as moderate to minor in severity (Figure 10a). These channel alterations are a made of earth channels, gabion baskets, rip-rap, and concrete.
