Maryland Department of Natural Resources
Watershed Services
Technical and Planning Services
April 2005

DEEP RUN AND PATAPSCO RIVER STREAM CORRIDOR ASSESSMENT SURVEY In Howard County

PREPARED BY
Robin Pellicano and Kenneth T. Yetman

WATERSHED SERVICES
TECHNICAL AND PLANNING SERVICES
MARYLAND DEPARTMENT OF NATURAL RESOURCES
ANNAPOLIS, MARYLAND

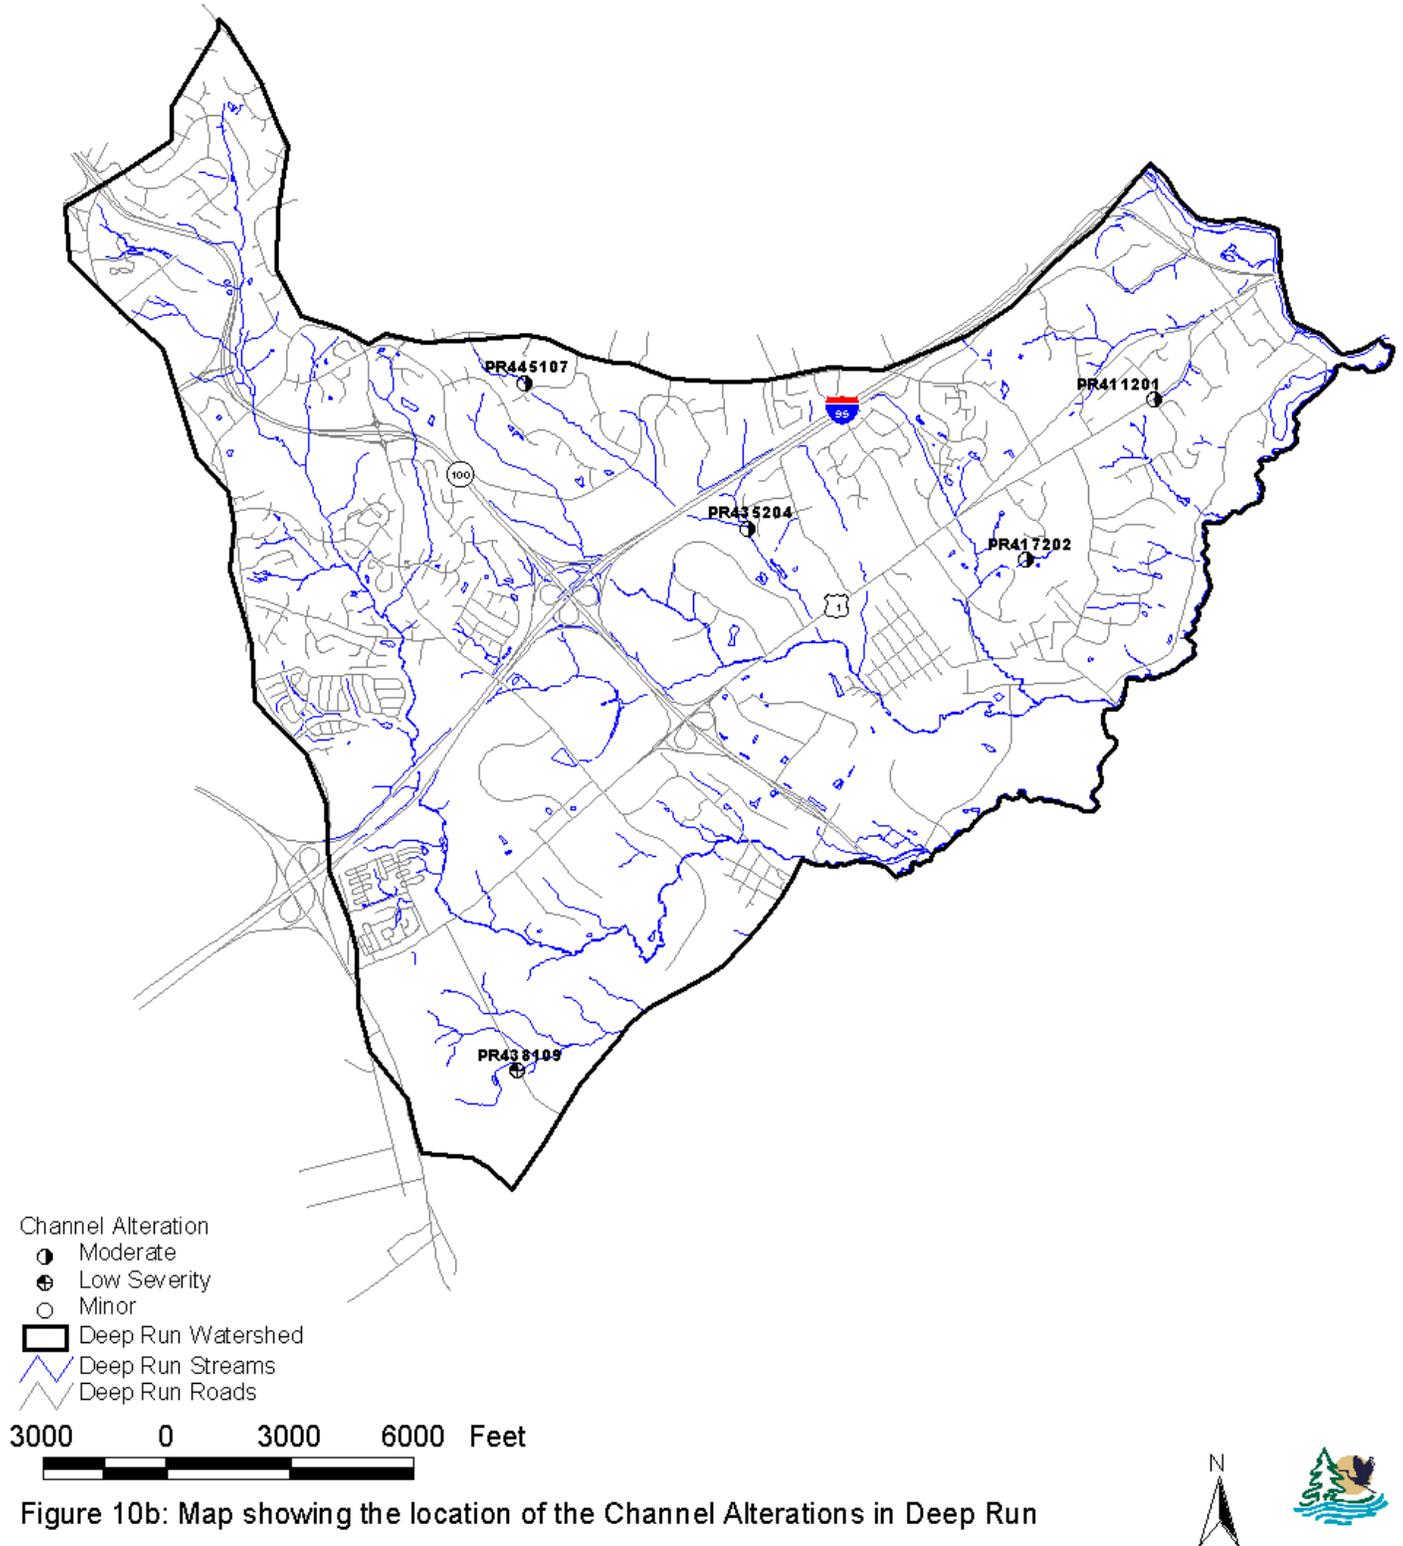
Figure 10b: Map showing the location of the Channel Alterations in Deep Run

Results of this survey show recognizably altered stream channels at seven sites. The severity and location of channel alterations are shown in Figure 10b-c. The total length of stream affected by channelization is estimated to be 2,580 feet (0.48 miles).

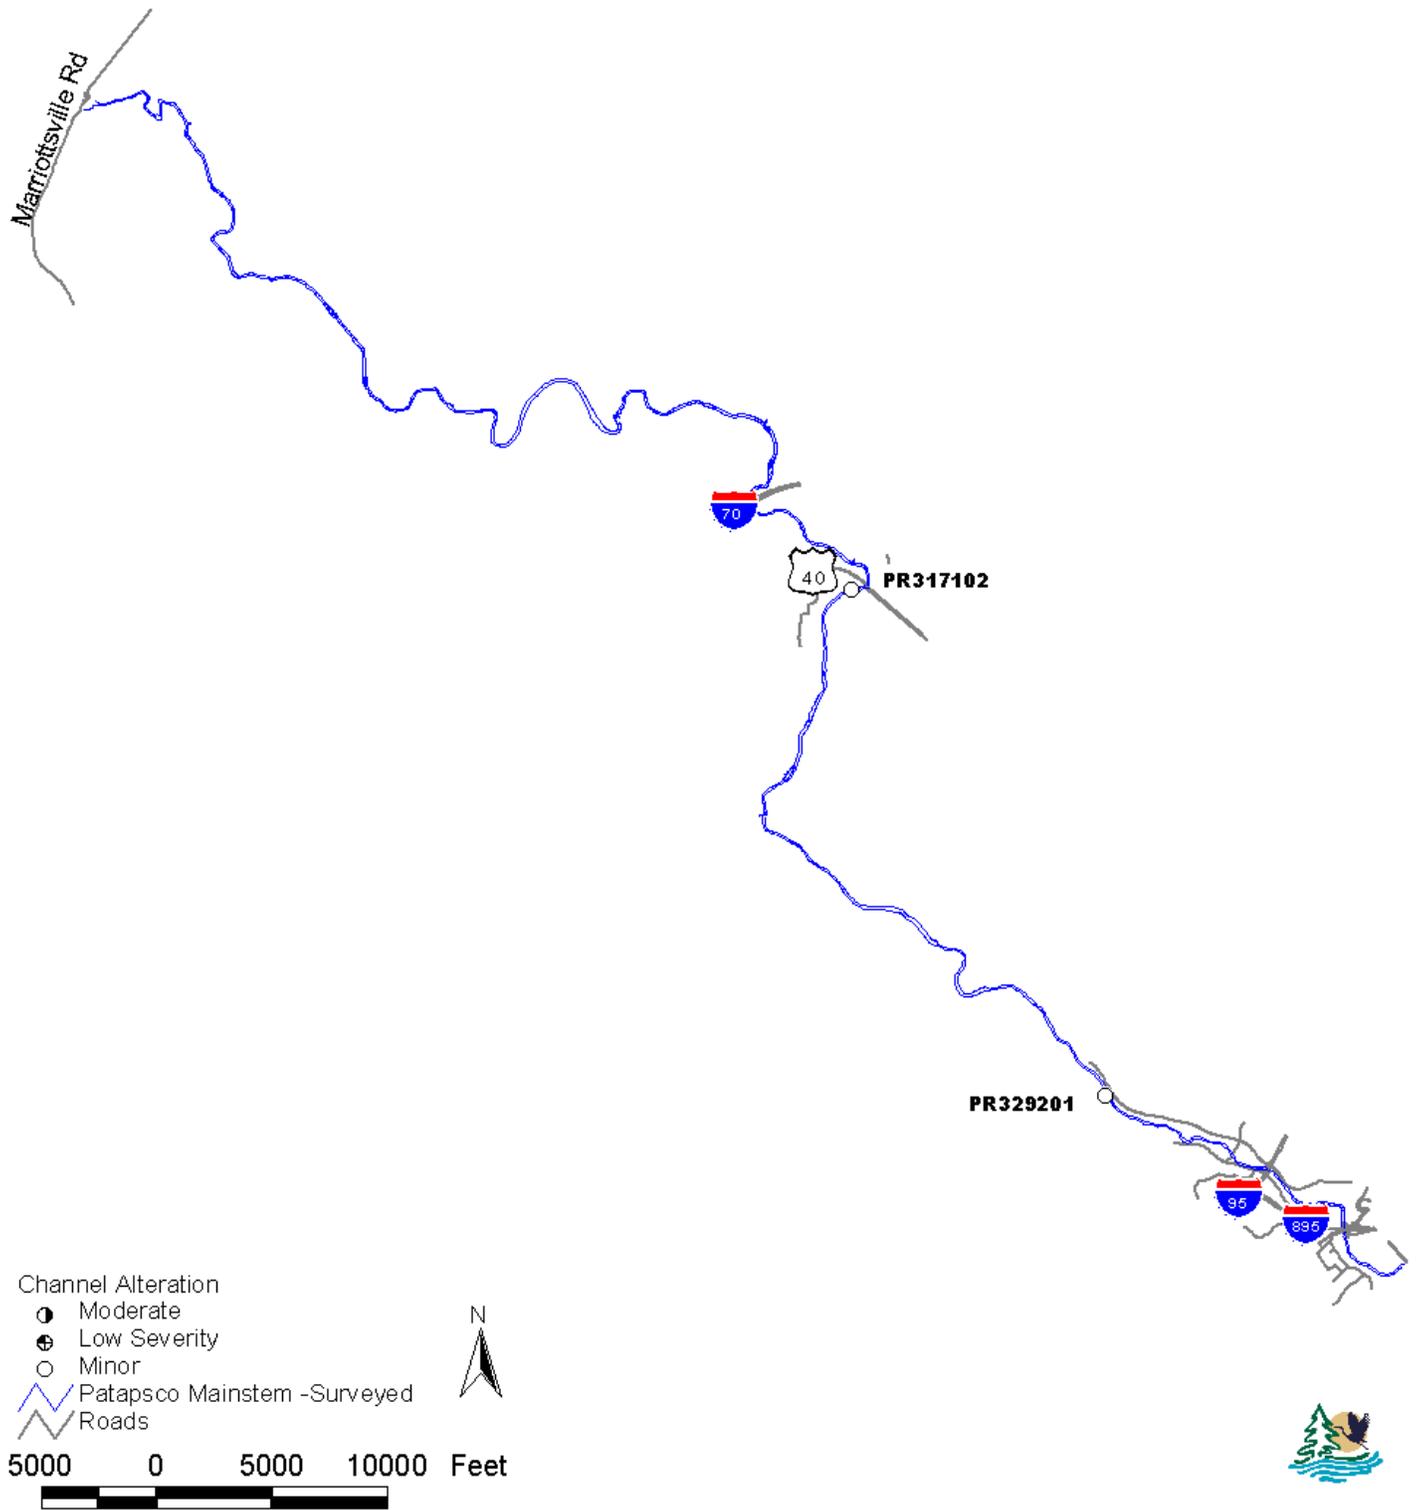
Figure 10c: Map showing the location of the Channel Alterations on the surveyed Patapsco Mainstem

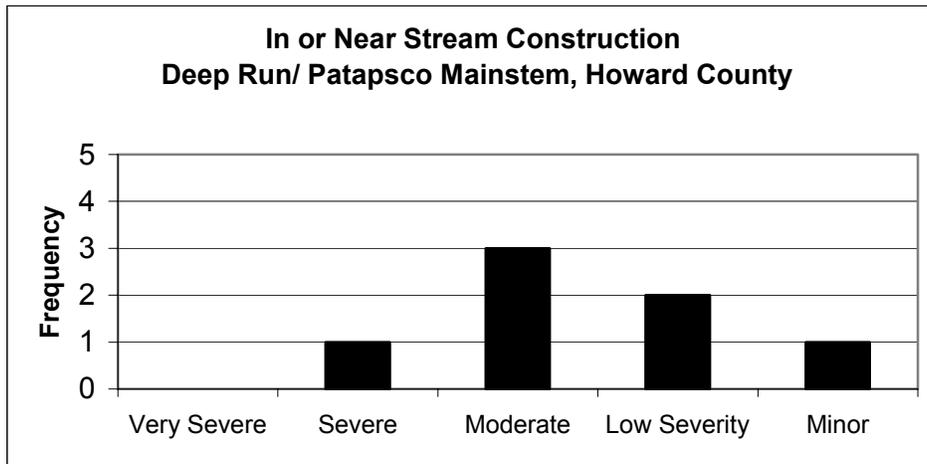
Figure 11a. Histogram showing the frequency of severity ratings given to in or near stream construction sites during the Patapsco SCA survey in Howard County.

Seven construction sites affected a nearby stream during the time of the survey. Types of construction included: residential construction (2), a golf course (1), road crossings (2), industrial construction (1) and an unknown (1). All but one site was rated as moderate to minor in severity (Figure 11a).

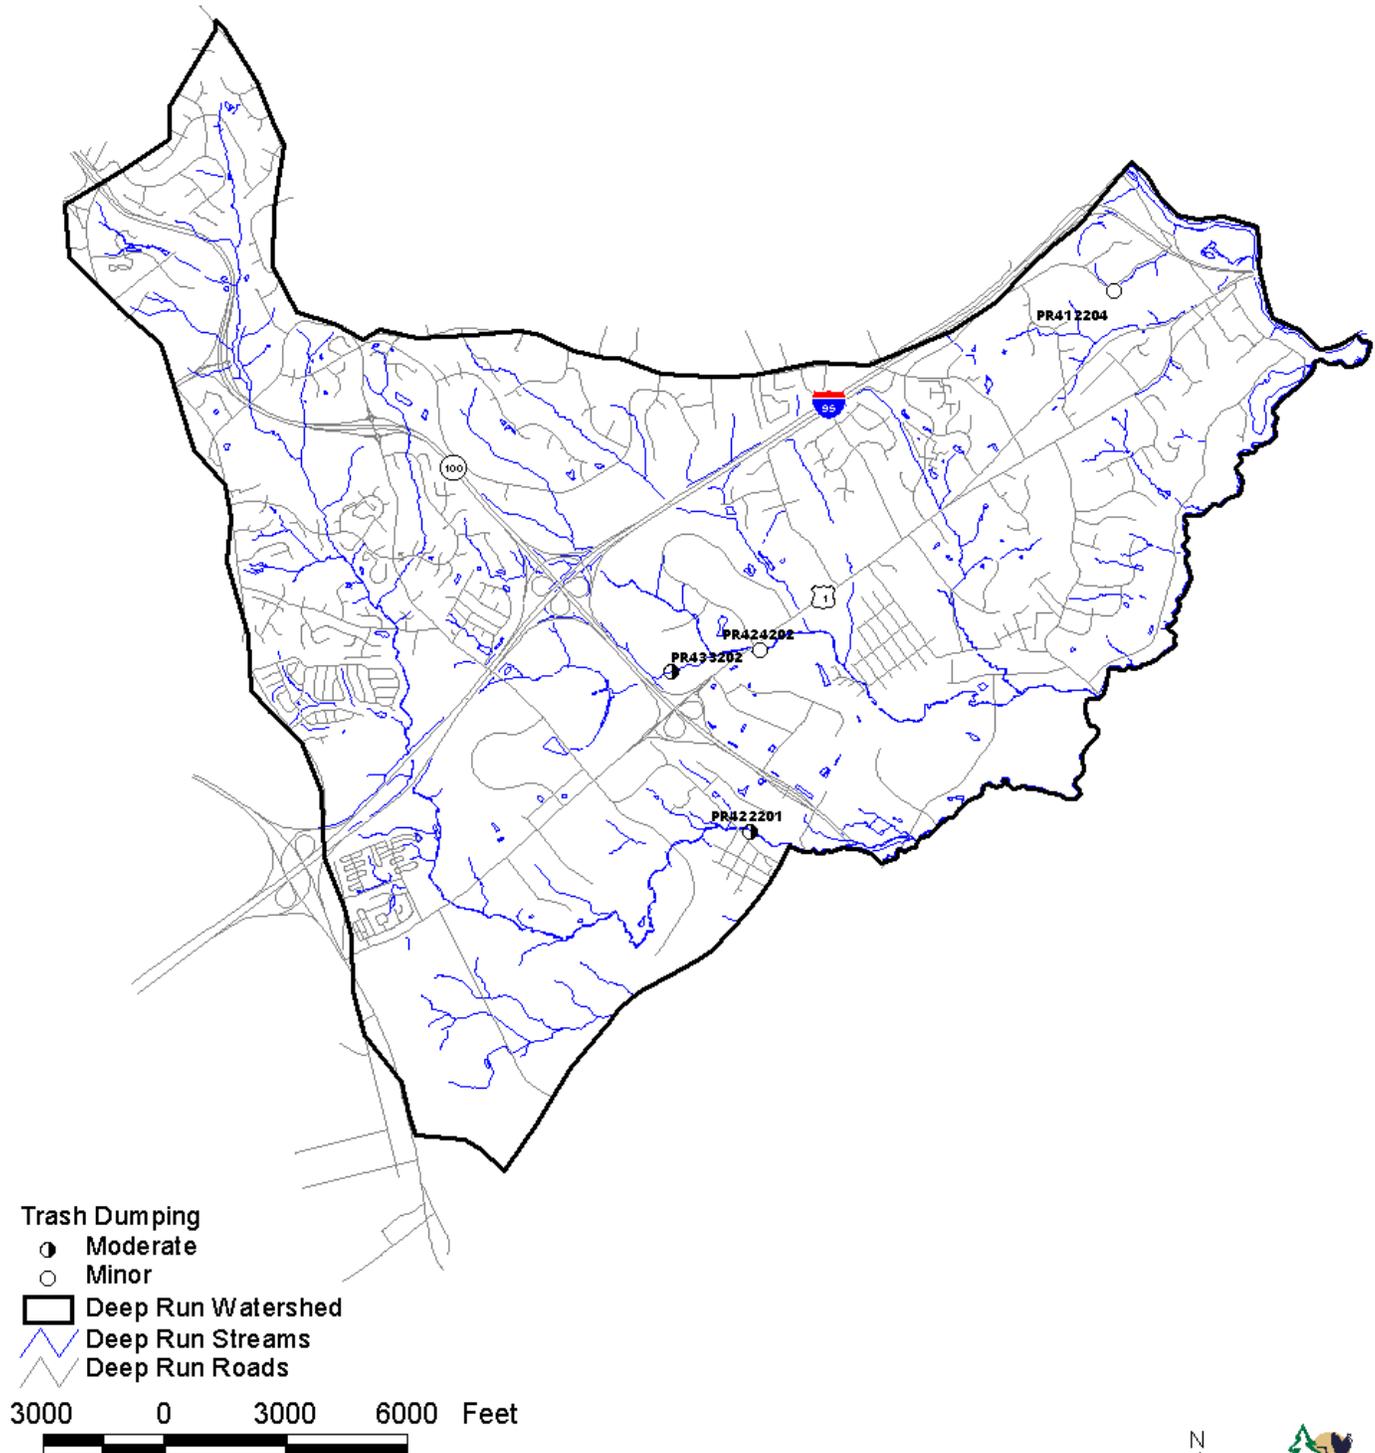
Figure 12 : Map showing the location of the Trash Dumpings in Deep Run

Trash dumping sites are places where large amounts of trash are inside the stream corridor, either as a site of deliberate dumping or as a place where trash tends to accumulate (often a result of storm drainage). The field survey crew found four trash dumping sites; locations are listed in Figure 12.

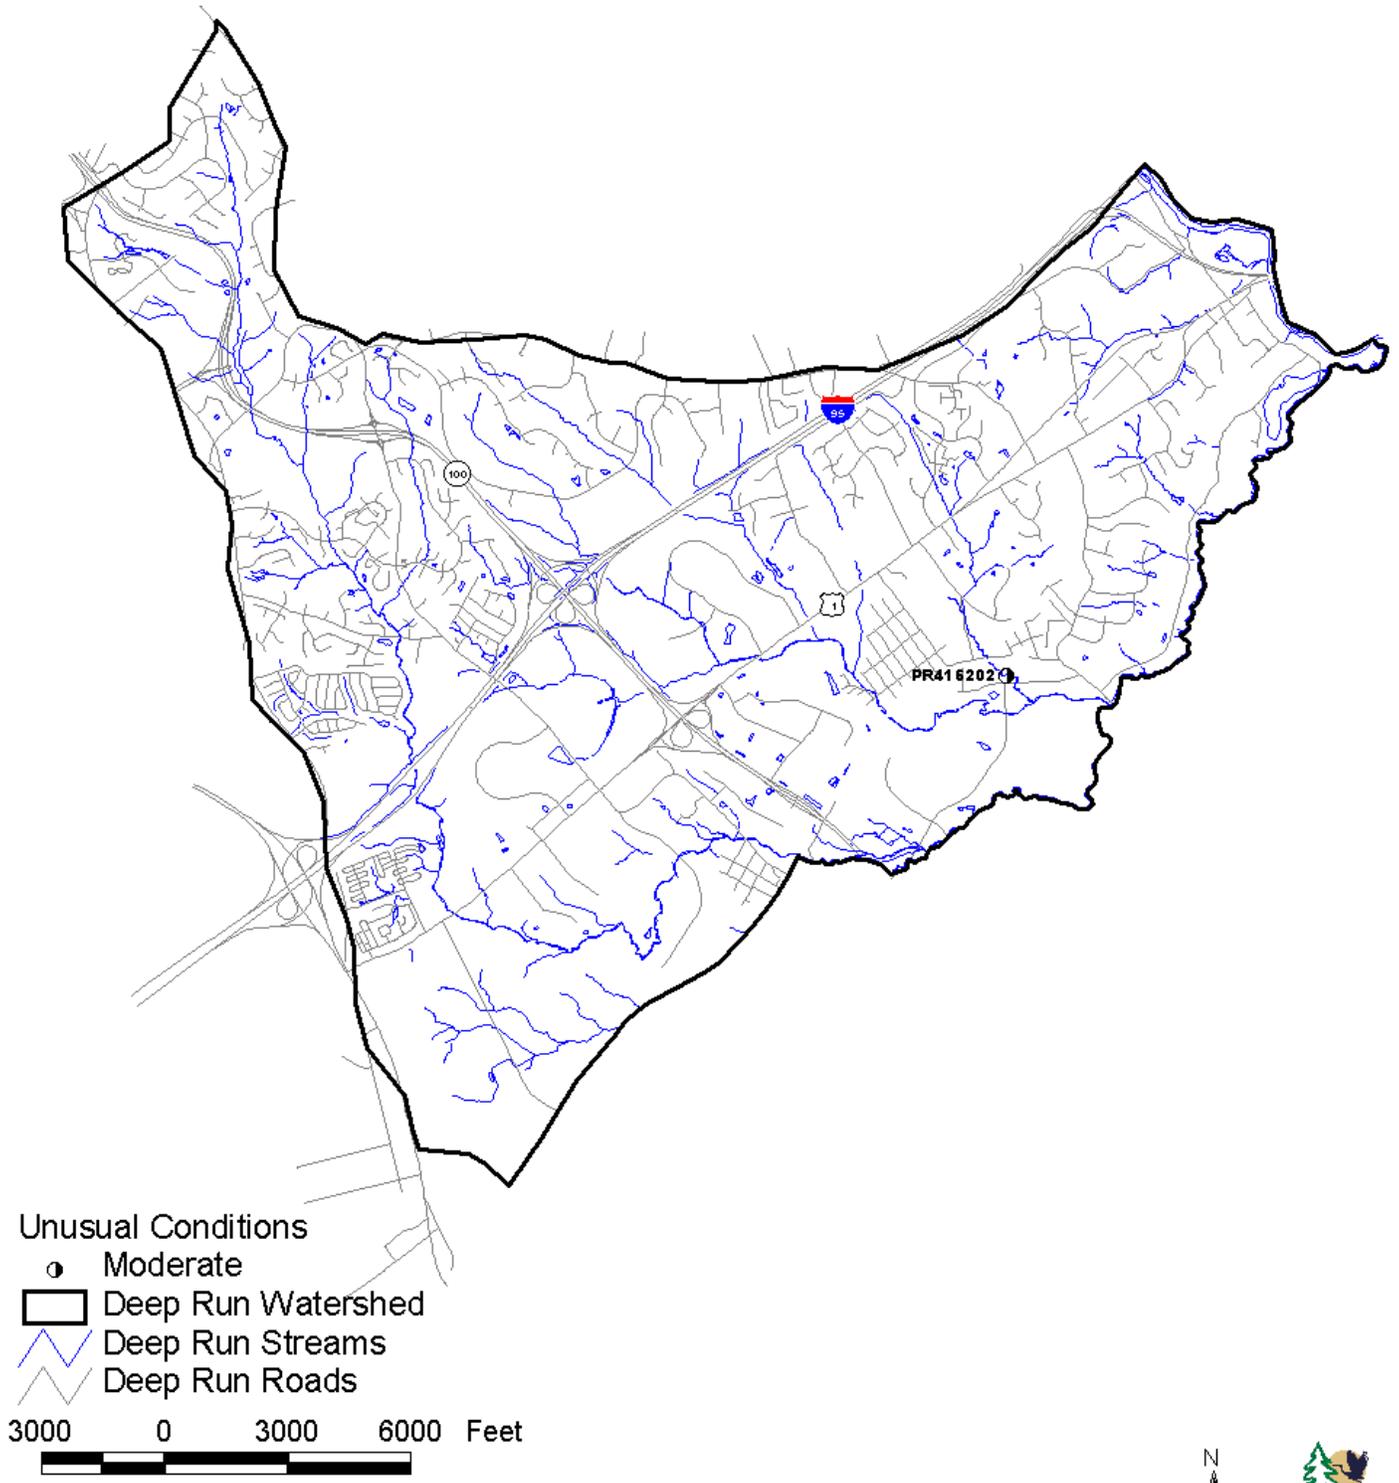
Figure 13 : Map showing the location of the Unusual Conditions in Deep Run

Survey teams record unusual conditions or comments to note the location of anything out of the ordinary observed during the survey or to provide additional written comments on a specific problem site. The survey crew identified one unusual condition site during the survey (Figure 13). It was moderate in severity. There were concrete road barriers in stream. They could have been placed for bank protection but they are now located in the middle of the stream.

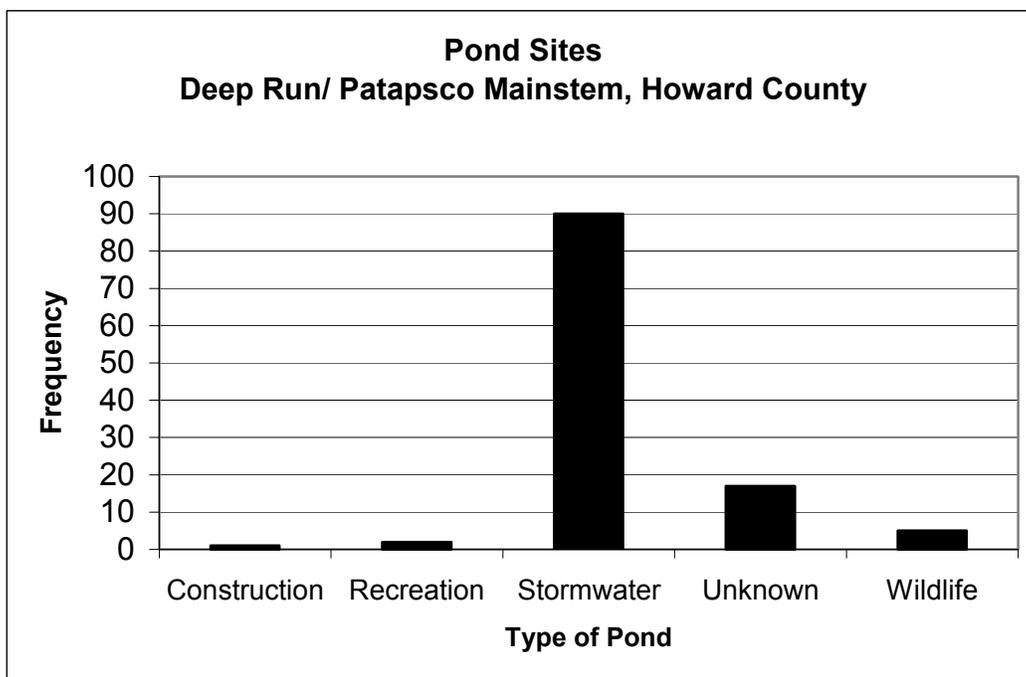
Figure 14a. Histogram showing the number of pond types given to pond sites during the Patapsco SCA survey in Howard County

One hundred and fifteen pond sites are recorded from this survey, and their locations are shown in Figures 14b. The majority of the watershed's ponds (90) are stormwater ponds (Figure 14a). Of these, seven are recorded as not maintained or abandoned (Appendix B).

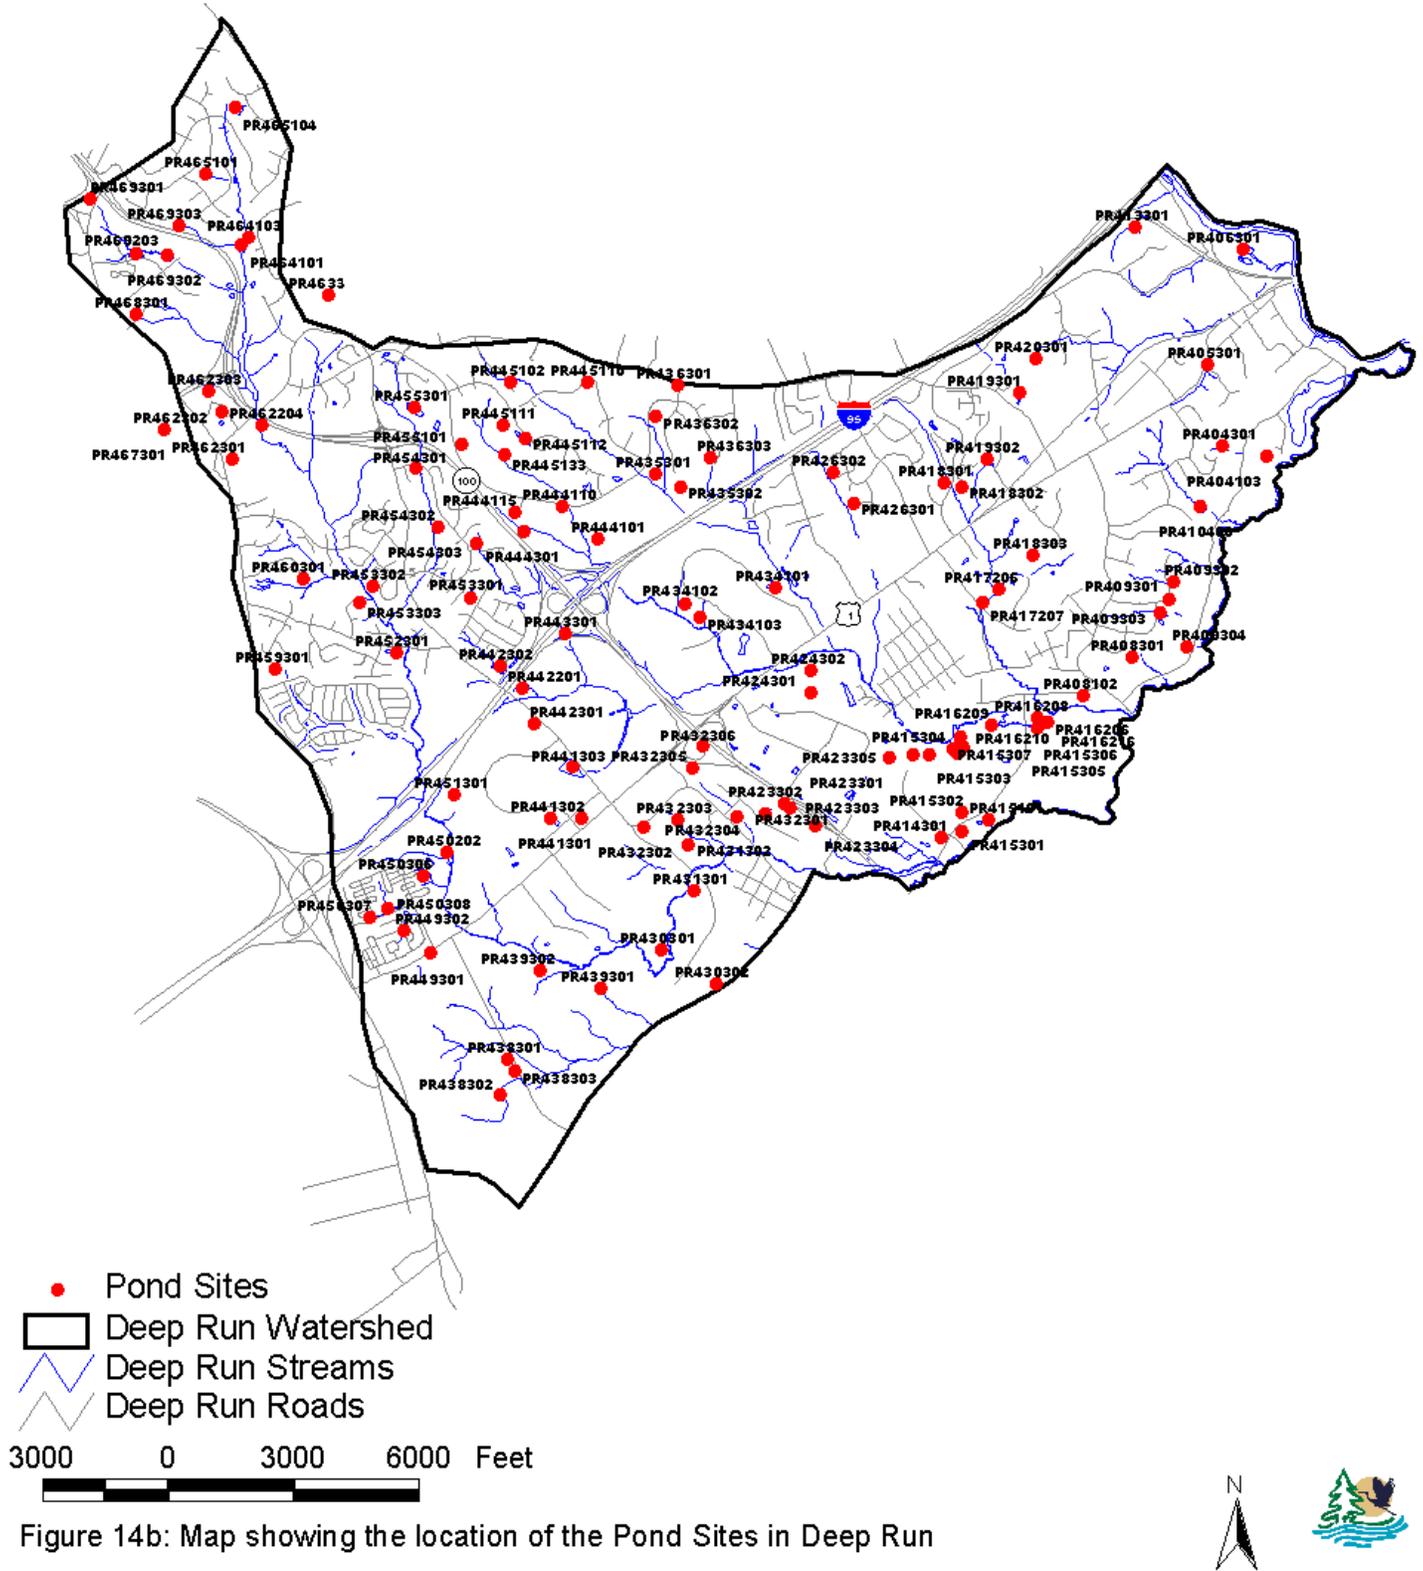
Figure 14b: Map showing the location of the Pond Sites in Deep Run

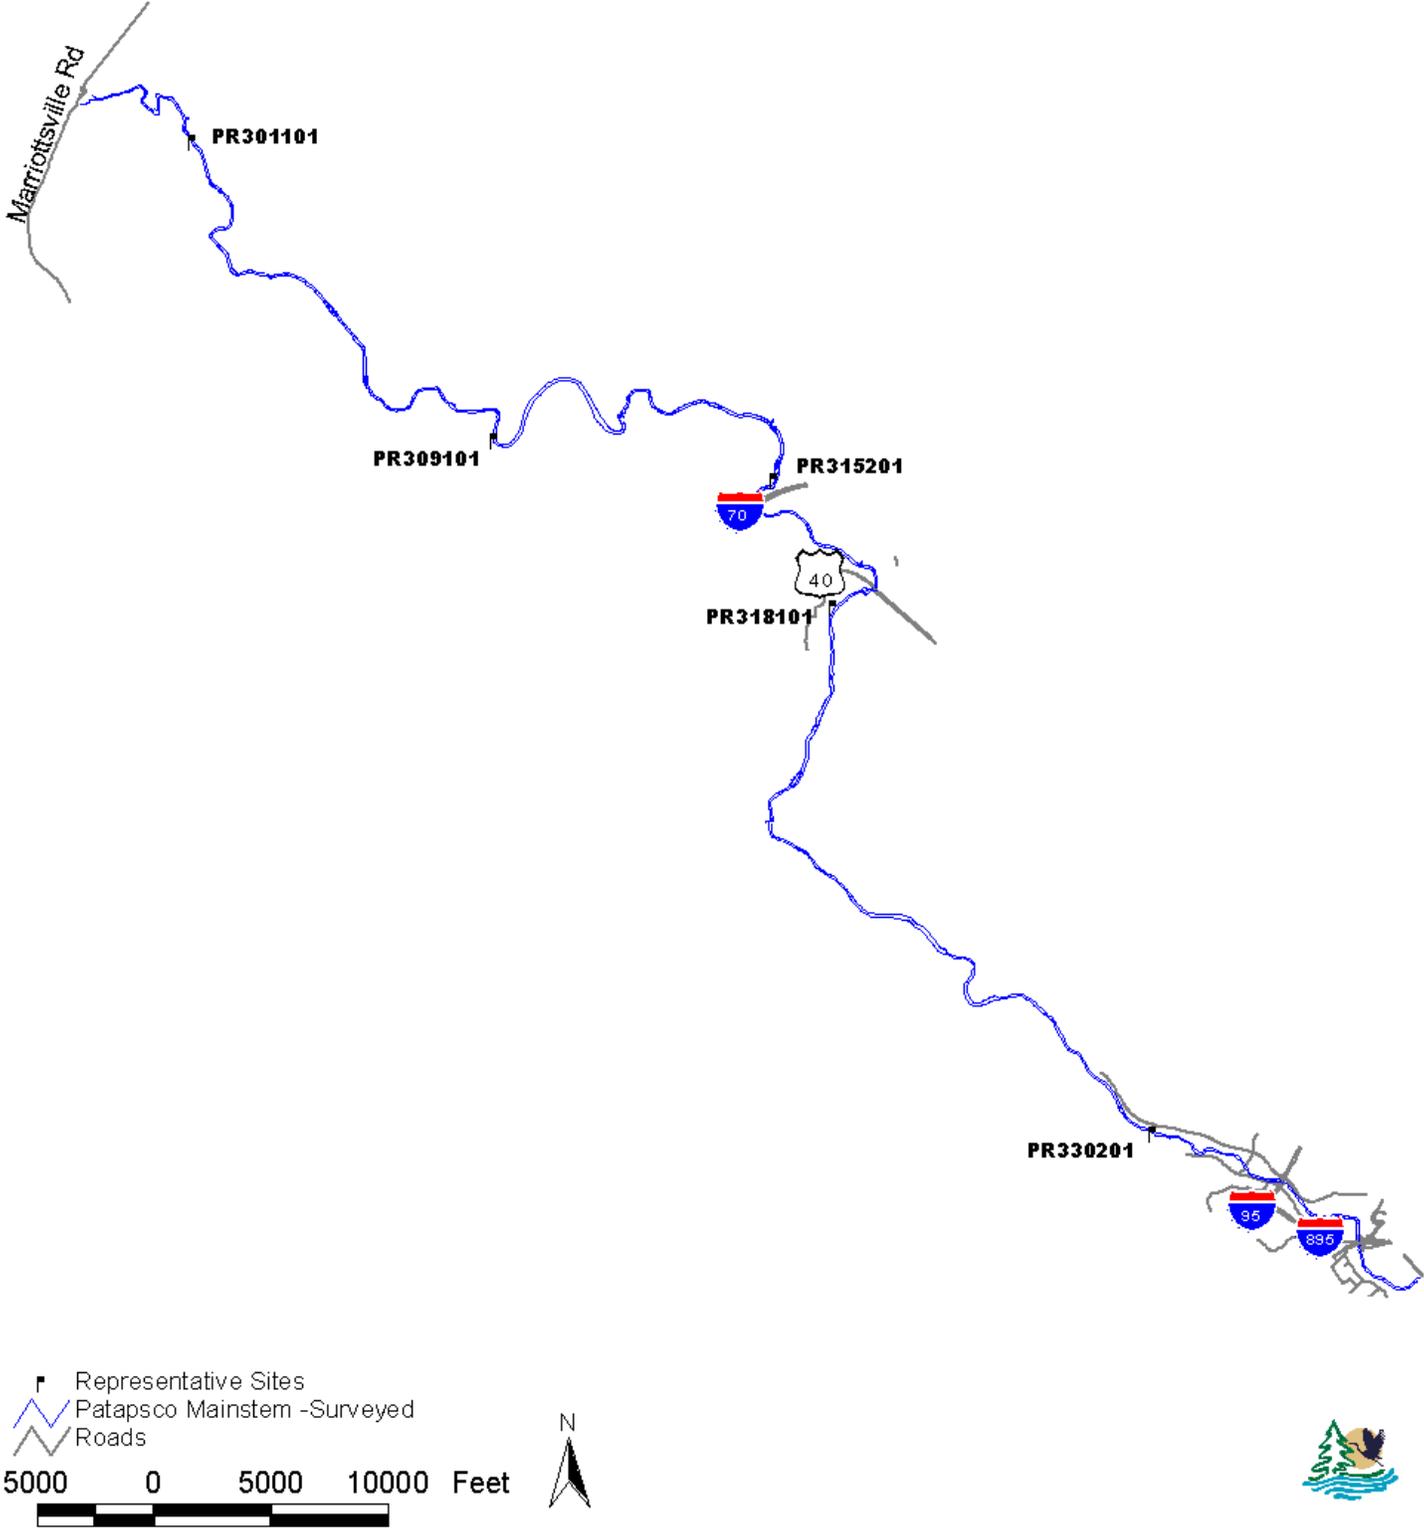
Figure 15c: Map showing the location of the Representative Sites on the surveyed Patapsco Mainstem

Under each category, field crews base a rating of optimal, suboptimal, marginal or poor on established grading criteria developed to reflect ideal wildlife habitat for rocky bottom streams. In addition to the habitat ratings, teams collect data on the stream's wetted width and pool depths at both runs and riffles at each representative site. Depth measurements are taken along the stream thalweg (main flow path). At representative sites, field crews also indicate whether the bottom sediments are primarily silt, sand, gravel, cobble, boulder, or bedrock. Representative sites are located at approximately ½ mile intervals along the stream. Survey crews evaluated 25 representative sites in the Deep Run/Patapsco mainstem watershed. Locations of representative sites are shown in Figure 15b-c, and data collected for all categories are listed in Appendix B
