Stream Corridor Assessment Survey for the Port Tobacco River Watershed, Charles County, Maryland

April 2006

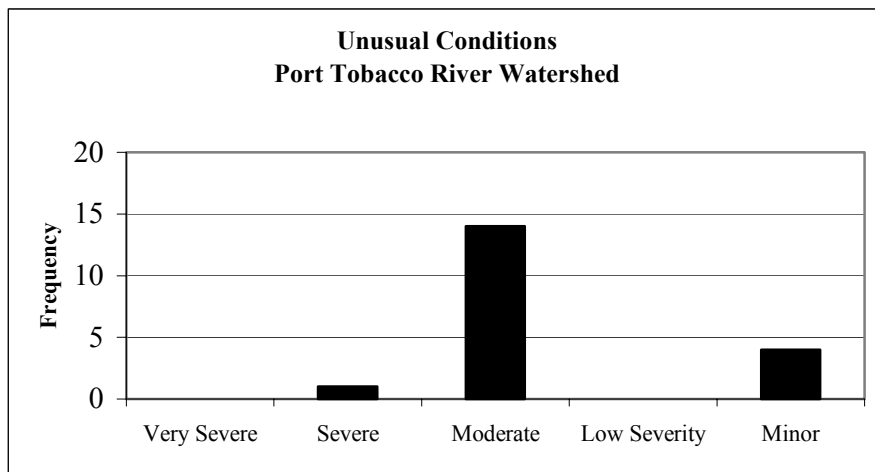
Figure 9a. Histogram showing the frequency of severity ratings given to unusual condition sites during the Port Tobacco River SCA survey.

The nineteen unusual conditions sites included those with excessive algae (7), large numbers of trees down (3), piped streams (2), water clarity/color issues (2) and one site (PT165102) with a blockage causing the stream to be diverted into a nearby cow pasture. This last site was given a severe ranking (Figure 9a).

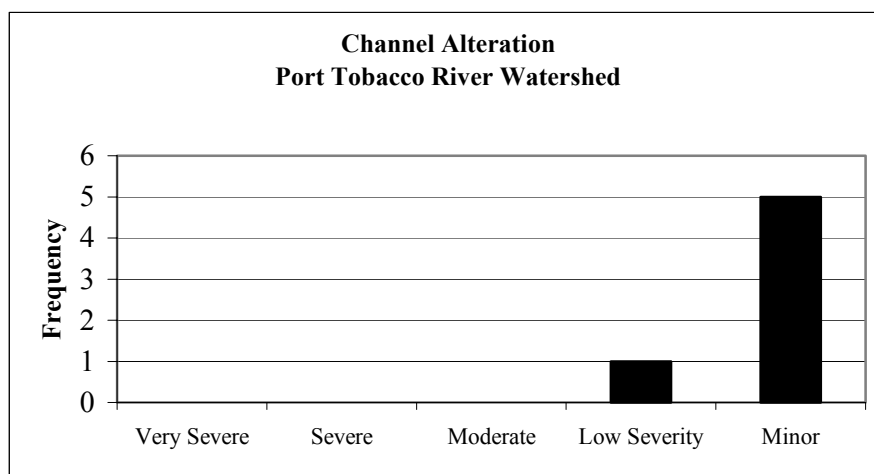
Figure 10a. Histogram showing the frequency of severity ratings given to channel alteration sites during the Port Tobacco River SCA survey.

Results of this survey show recognizably altered stream channels at 6 sites. The severity and location of channel alteration sites is shown in Figure 10b. The total length of stream affected by channelization is estimated to be 1,255 feet (-.24 miles). Severity rankings for the sites range from low severity to minor with most sites ranked minor in severity (Figure 10a).
