Channel Alteration Inadequate Buffer Erosion  
Fish Migration Barrier Pipe Outfall Exposed Pipes  
Trash Dumping Unusual Condition In/Stream  
Construction Channel Alteration Inadequate Buffer  
Channel Alteration Inadequate Buffer Erosion  
**Upper Chester River  
Stream Corridor  
Survey**  
Channel Alteration Inadequate Buffer Erosion  
Fish Migration Barrier Pipe Outfall Exposed Pipes  
Trash Dumping Unusual Condition In/Stream  
Construction Channel Alteration Inadequate Buffer  
Channel Alteration Inadequate Buffer Erosion  
Fish Migration Barrier Pipe Outfall Exposed Pipes  
Channel Alteration Inadequate Buffer Erosion  
Fish Migration Barrier Pipe Outfall Exposed Pipes  
Trash Dumping Unusual Condition In/Stream  
Construction Channel Alteration Inadequate Buffer  
Channel Alteration Inadequate Buffer Erosion  
Fish Migration Barrier Pipe Outfall Exposed Pipes

Watershed Assessment and Targeting Division  
Watershed Services  
Maryland Department of Natural Resources  
May 2005

# UPPER CHESTER STREAM CORRIDOR ASSESSMENT

Adam Gregory, Matthew Stover,  
& Ken Yetman

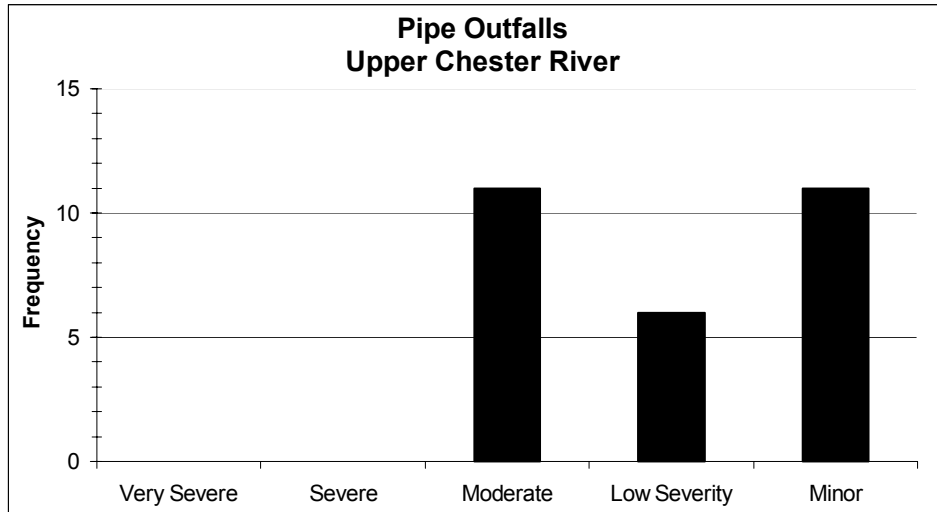
**Figure 7a: Histogram showing the frequency of severity ratings given to pipe outfall sites during the Upper Chester SCA survey.**

Severity ratings for pipe outfalls were given based on outfall type, discharge, and type of discharge. In the Upper Chester SCA Survey there were 11 moderate, 6 low severity, and 11 minor sites (Figure 7a). The severity rating of moderate is for pipes with a discharge that is either clear with no odor or has a color and/or odor, but the amount of discharge is very small compared to the stream's base flow and any impact appears to be minor and localized (Yetman, 2001).

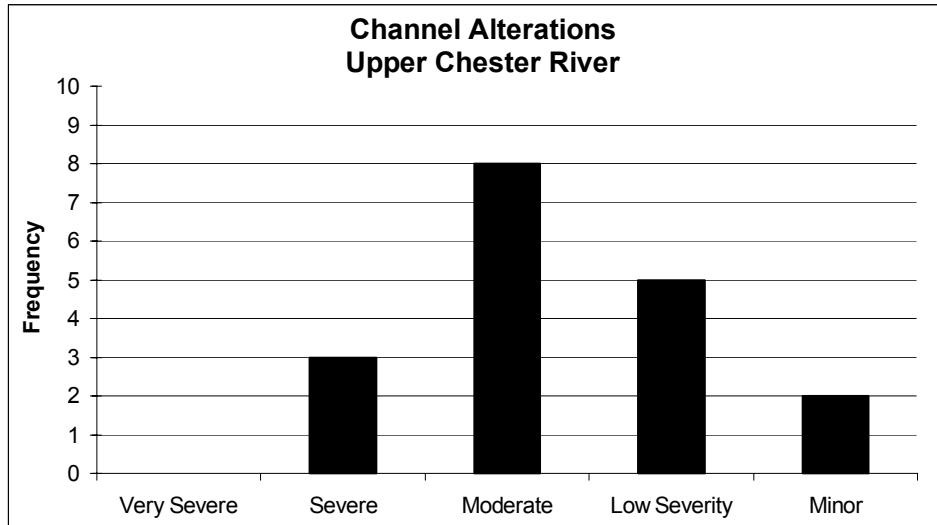
**Figure 8a: Histogram showing the frequency of severity ratings given to channel alteration sites during the Upper Chester SCA Survey.**

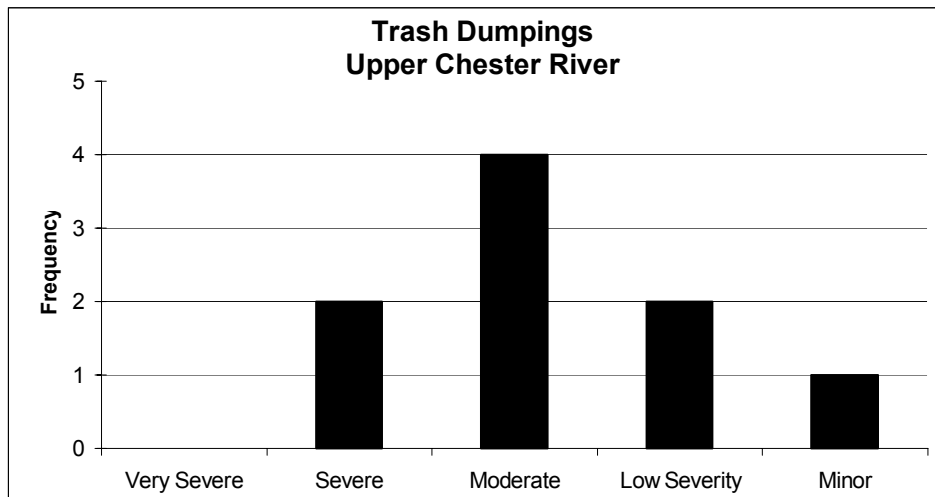
**Figure 9a: Histogram showing the frequency of severity ratings given to trash dumping sites seen during the Upper Chester SCA survey**
