Watershed Restoration Division  
 Chesapeake & Coastal Watershed Services  
 Maryland Department of Natural Resources  
 November 2002

# UPPER PATUXENT IN ANNE ARUNDEL CO. STREAM CORRIDOR ASSESSMENT SURVEY

Robin Pellicano and  
Kenneth T. Yetman

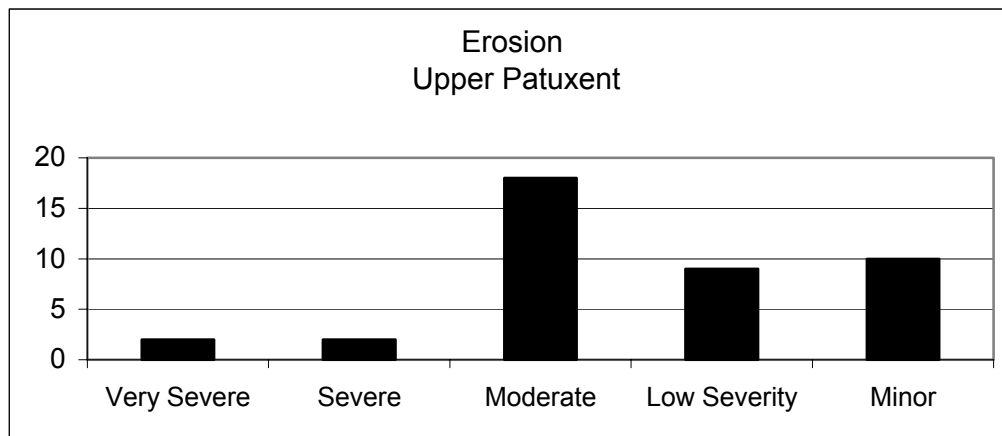
**Figure 5b Histogram showing the frequency of severity ratings given to erosion sites during Upper Patuxent River SCA survey.**

Unstable eroding streams are areas where the stream banks are almost vertical and the roots from the vegetation along the stream's banks are unable to hold the soil on the banks. Unstable eroding stream banks were reported at 41 sites during the survey (Figure 5a). Figure 5c shows the locations of the sites found in the North Patuxent 1 watershed. The majority of the erosion sites showed moderate to minor erosion that extended over long distances. The lengths of stream segments that were recorded as having unstable banks varied from 10 feet in some areas, to other areas where up to 5,000 feet of stream was found to have an erosion problem (Appendix B). Overall, results indicate approximately 8.0 miles of unstable eroding banks in the Upper Patuxent watershed. Figure 5b shows the frequency of the severity rating given to erosion sites. Only two sites received a very severe rating.

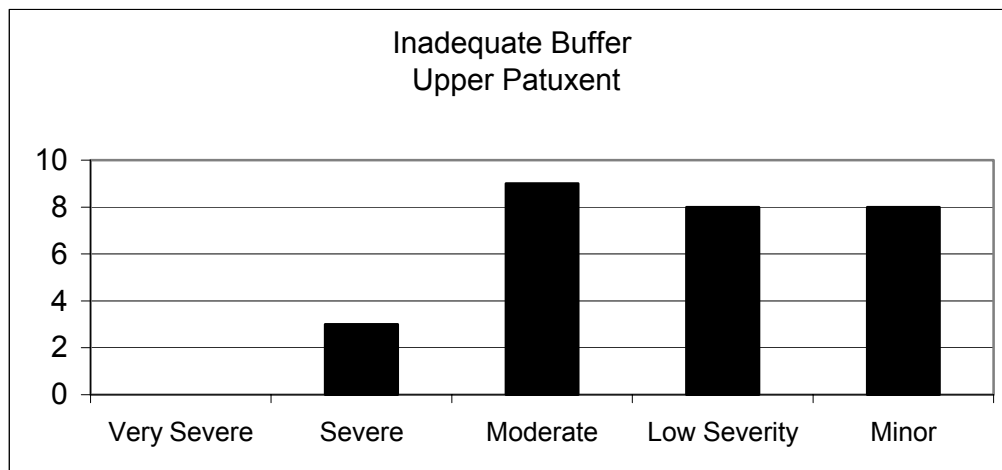
**Figure 7b Histogram showing the frequency of severity ratings given to Inadequate buffer sites during Upper Patuxent River SCA survey.**

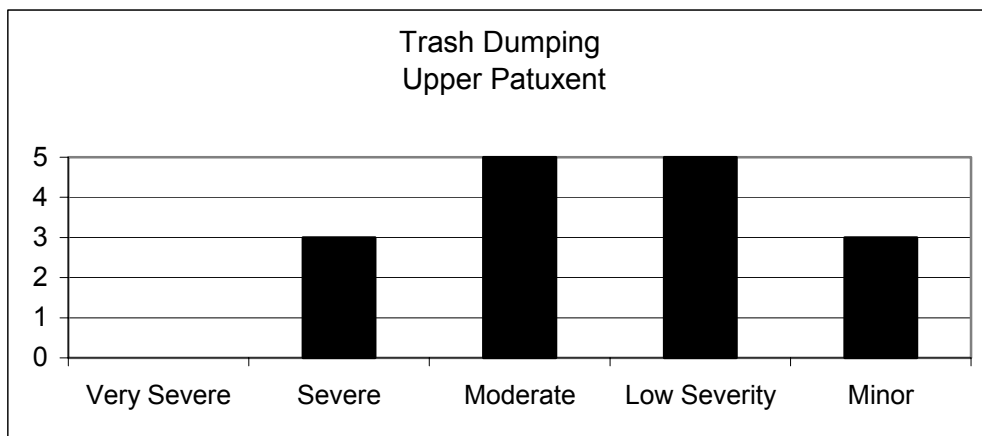
**Figure 9b Histogram showing the frequency of severity ratings given to trash dumping sites during Upper Patuxent River SCA survey.**

The trash dumping data sheets are used to record the location of places where large amounts of trash has been dumped inside the stream corridor or to note places where trash tends to accumulate. The field survey crew found seventeen sites where there was excessive trash and their locations are shown in Figure 9a and Figure9c. Four sites were reported as severe. The sites had mixed types of trash. The trash ranged from recyclables to appliances and engines. Site UPP39104 had large piles of sand along with various old machinery. The sites were estimated to have 20 to 50 pickup truckloads. Six sites were recorded as having yard waste, four had residential waste and one was recorded as newspapers. These sites were given severity ratings ranging from moderate to minor (Figure 9b).

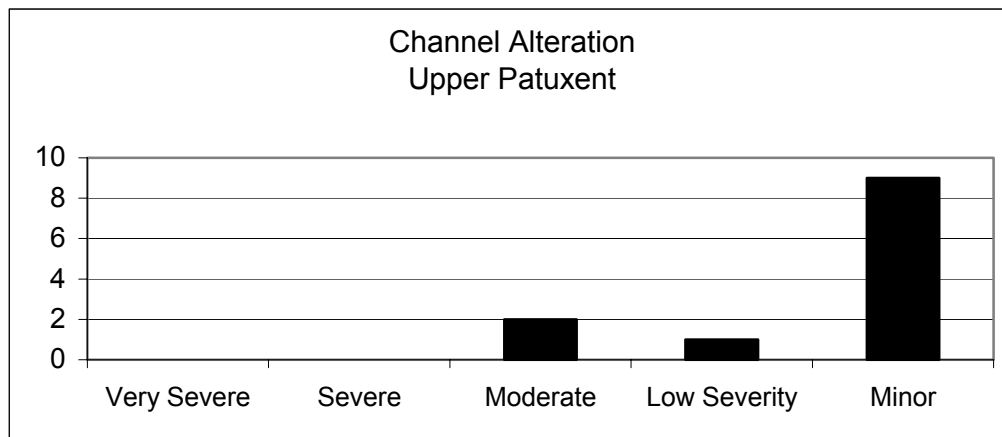
**Figure 10b Histogram showing the frequency of severity ratings given to channel alteration sites during Upper Patuxent River SCA survey.**

Results of this survey indicate that the stream has been recognizably altered in 12 areas and their locations are shown in Figure 10a. The total length of stream affected by channelization was estimated to be 5,798 feet or about 1.1 miles. All sites were given a moderate to minor severity rating (Figure 10b). The sites identified were on small channels. Six were earthen channels, five were armored with rip-rap, and four channels were lined with gabion baskets and one was reported to be channelized with wood. All sites were given moderate to minor severity ratings (Figure 10b).

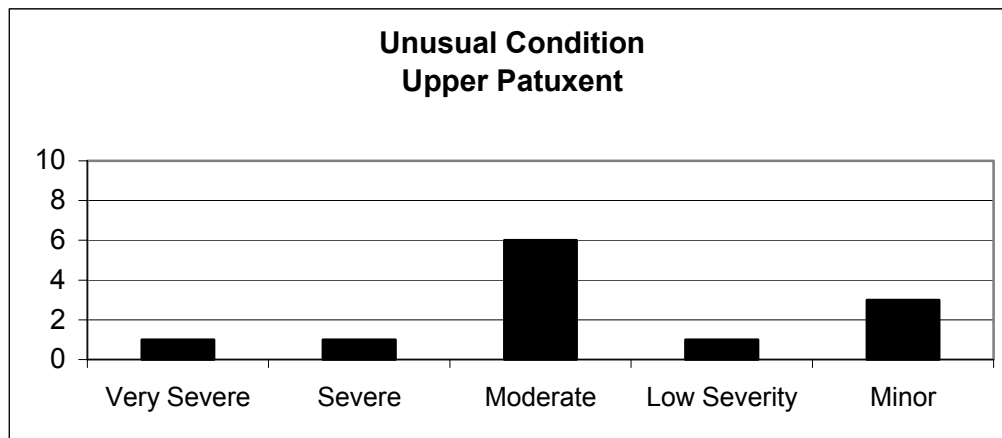
**Figure 11b Histogram showing the frequency of severity ratings given to unusual condition sites during Upper Patuxent River SCA survey.**

The unusual condition/comment data sheets are used by survey teams to record the location of anything out of the ordinary seen during the survey or to provide some additional written comments on a specific problem. Twelve unusual condition sites were found during the Upper Patuxent survey (Figure 11a and Figure 11c). Only one site received a very severe rating. At site UPB07406 Brock Bridge Rd is being undermined by the stream. One site received a severe rating. At site UPR31101, the whole stream is being diverted to pond. For site UPM25101 the road culvert pipe is collapsing. At site UPQ43104 water is being pumped from the stream for a swimming pool and a garden. At site UPP39101 the road crossing is filling with sediment. At site UPN26103 the stream is piped, perhaps for a future road or driveway. The rest of the sites report red flock. These sites were give lower severity ratings (Figure 11b).
